**NINE MILE POINT 1
CORE SHROUD REPAIR
MODIFICATION SUMMARY REPORT**

GENE B13-01739-31

***Nine Mile Point 1
Core Shroud Repair Modification
Summary Report***

Niagara Mohawk Power Corporation

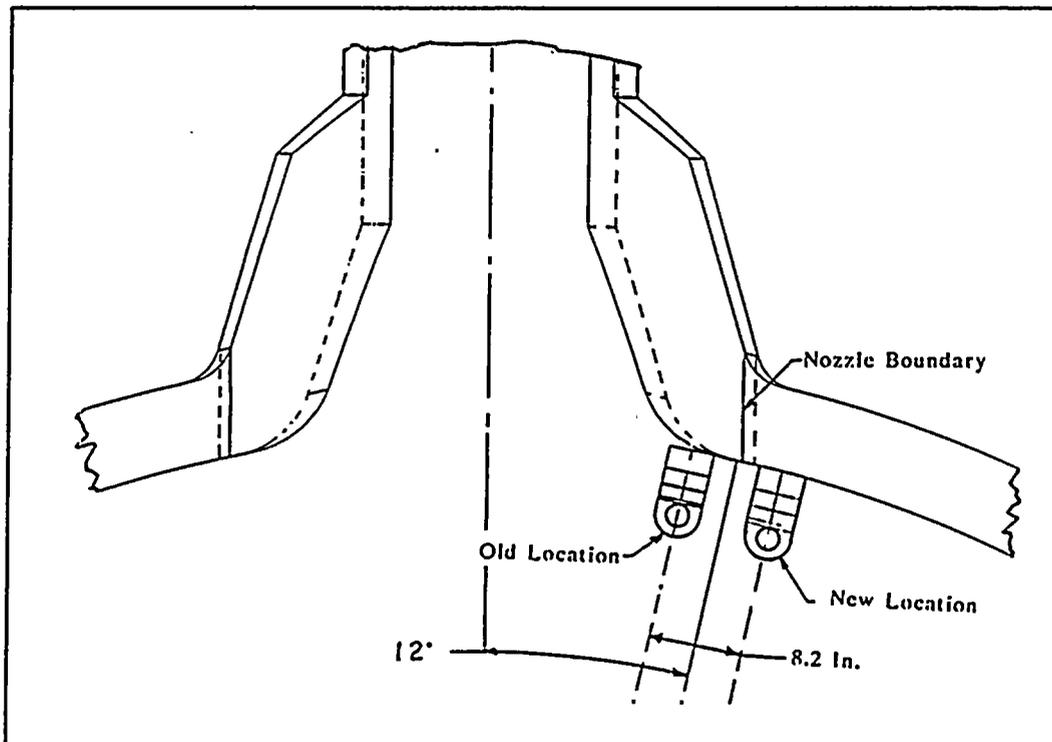
FIGURE 3.1

The lower wedge on the 270° tie rod was found to bear against the blend radius on a recirculation nozzle rather than on the vessel wall. This situation is documented per FDDR EA1-0032 and further evaluated in GENE B13-01739-25. That report addressed concerns about the contact area and the stability of the contact on the inclined surface of the nozzle blend radius.

The lower wedge can be relocated to a position with more completed contact (Figure 3.1) on the vessel by moving the lower spring to the opposite side of the stabilizer assembly. By relocating the lower spring, the concerns about contact stability and contact area are resolved and the stabilizer assembly maintains its intended functional requirements.

Niagara Mohawk Power Corporation purchased a spare tie rod assembly and this assembly is intended to be modified to the alternate configuration. Applicable design and assembly drawings are revised to include the new parts and groups which define the alternate configuration. All additional parts and assemblies are designed and fabricated to the same design basis as the original shroud repair hardware. Moving the lower spring to the opposite side of the stabilizer assembly is accomplished by the steps listed below.

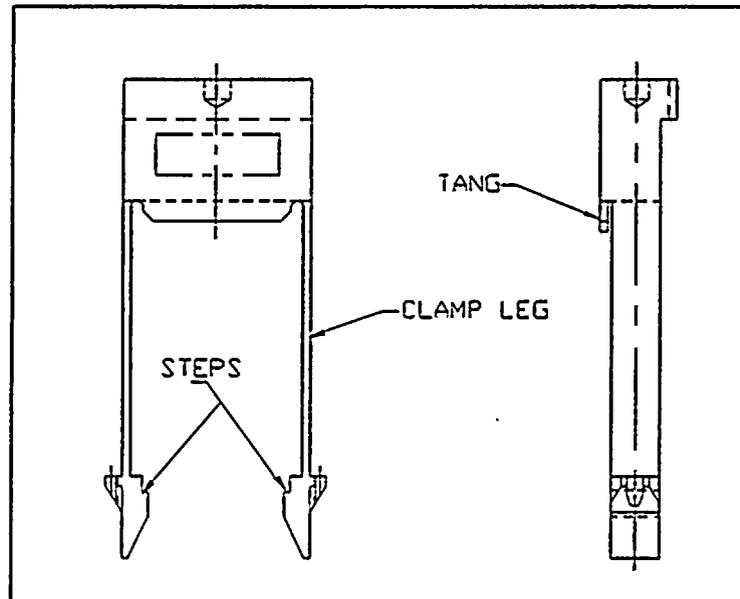
FIGURE 4.1

The lower contacts do not extend above the H6A weld as was intended to satisfy the intended design requirements. The Reactor Modification Drawing, 107E5679 Revision 6, shows the as-installed position of the lower contacts and the H6A weld. The situation resulted from insufficient margin in the lower contact design to account for the uncertainties in the as-built geometry of the shroud support cone.

The lower contacts at azimuths 90°, 166° and 350° are modified to extend beyond the H6A weld by adding a U shaped extension piece shown in Figure 4.1. The extension piece fits over the existing lower contact with the legs of the U extending around the sides of the existing lower contact. The steps at the ends of the legs fit under the lower contact to prevent axial movement. A tang at the top extension fits in the gap between the lower contact and the lower spring to restrict the horizontal movement. The added extension piece is captured in all directions on the existing lower contact. The legs of the extension provide a positive spring clamping force (40 lb to 50 lb) against the sides of the lower contact. This force is sufficient to prevent any free movement or vibrations. With this arrangement, the added extension piece is captured in all directions and is held secure by the spring loaded clamping force.

The added extension pieces are installed with a special tool for handling and to keep the legs sprung apart. When seated in place, the tool releases the legs allowing them to clamp around the lower contact. This method allows the piece to be installed without sliding or having to apply excessive force. The same tool can be used to remove the extension piece if required.
