ACCESSION NBR: 9612130053 DOC. DATE: 96/12/05 NOTARIZED: NO DOCKET #
 FACIL: 50-410 Nine Mile Point Nuclear Station, Unit 2, Niagara Moha 05000410
 AUTH. NAME AUTHOR AFFILIATION
 SMITH, R. Niagara Mohawk Power Corp.
 CONWAY, J.T. Niagara Mohawk Power Corp.
 RECIP. NAME RECIPIENT AFFILIATION

SUBJECT: LER 96-013-00: on 961105, TS violation occurred. Caused by inadequate change management. Service water sys lineups used during RF05 will be evaluated to determine if there were additional deficiencies. W/961205 ltr.

In accordance with 10CFR50.73(a)(2)(i)(B), we are submitting LER 96-13, "Technical Specification Violation Caused by Inadequate Change Management (Both Trains of Service Water Inoperable)."

Technical Specification Violation Caused by Inadequate Change Management (Both Trains of Service Water Inoperable)

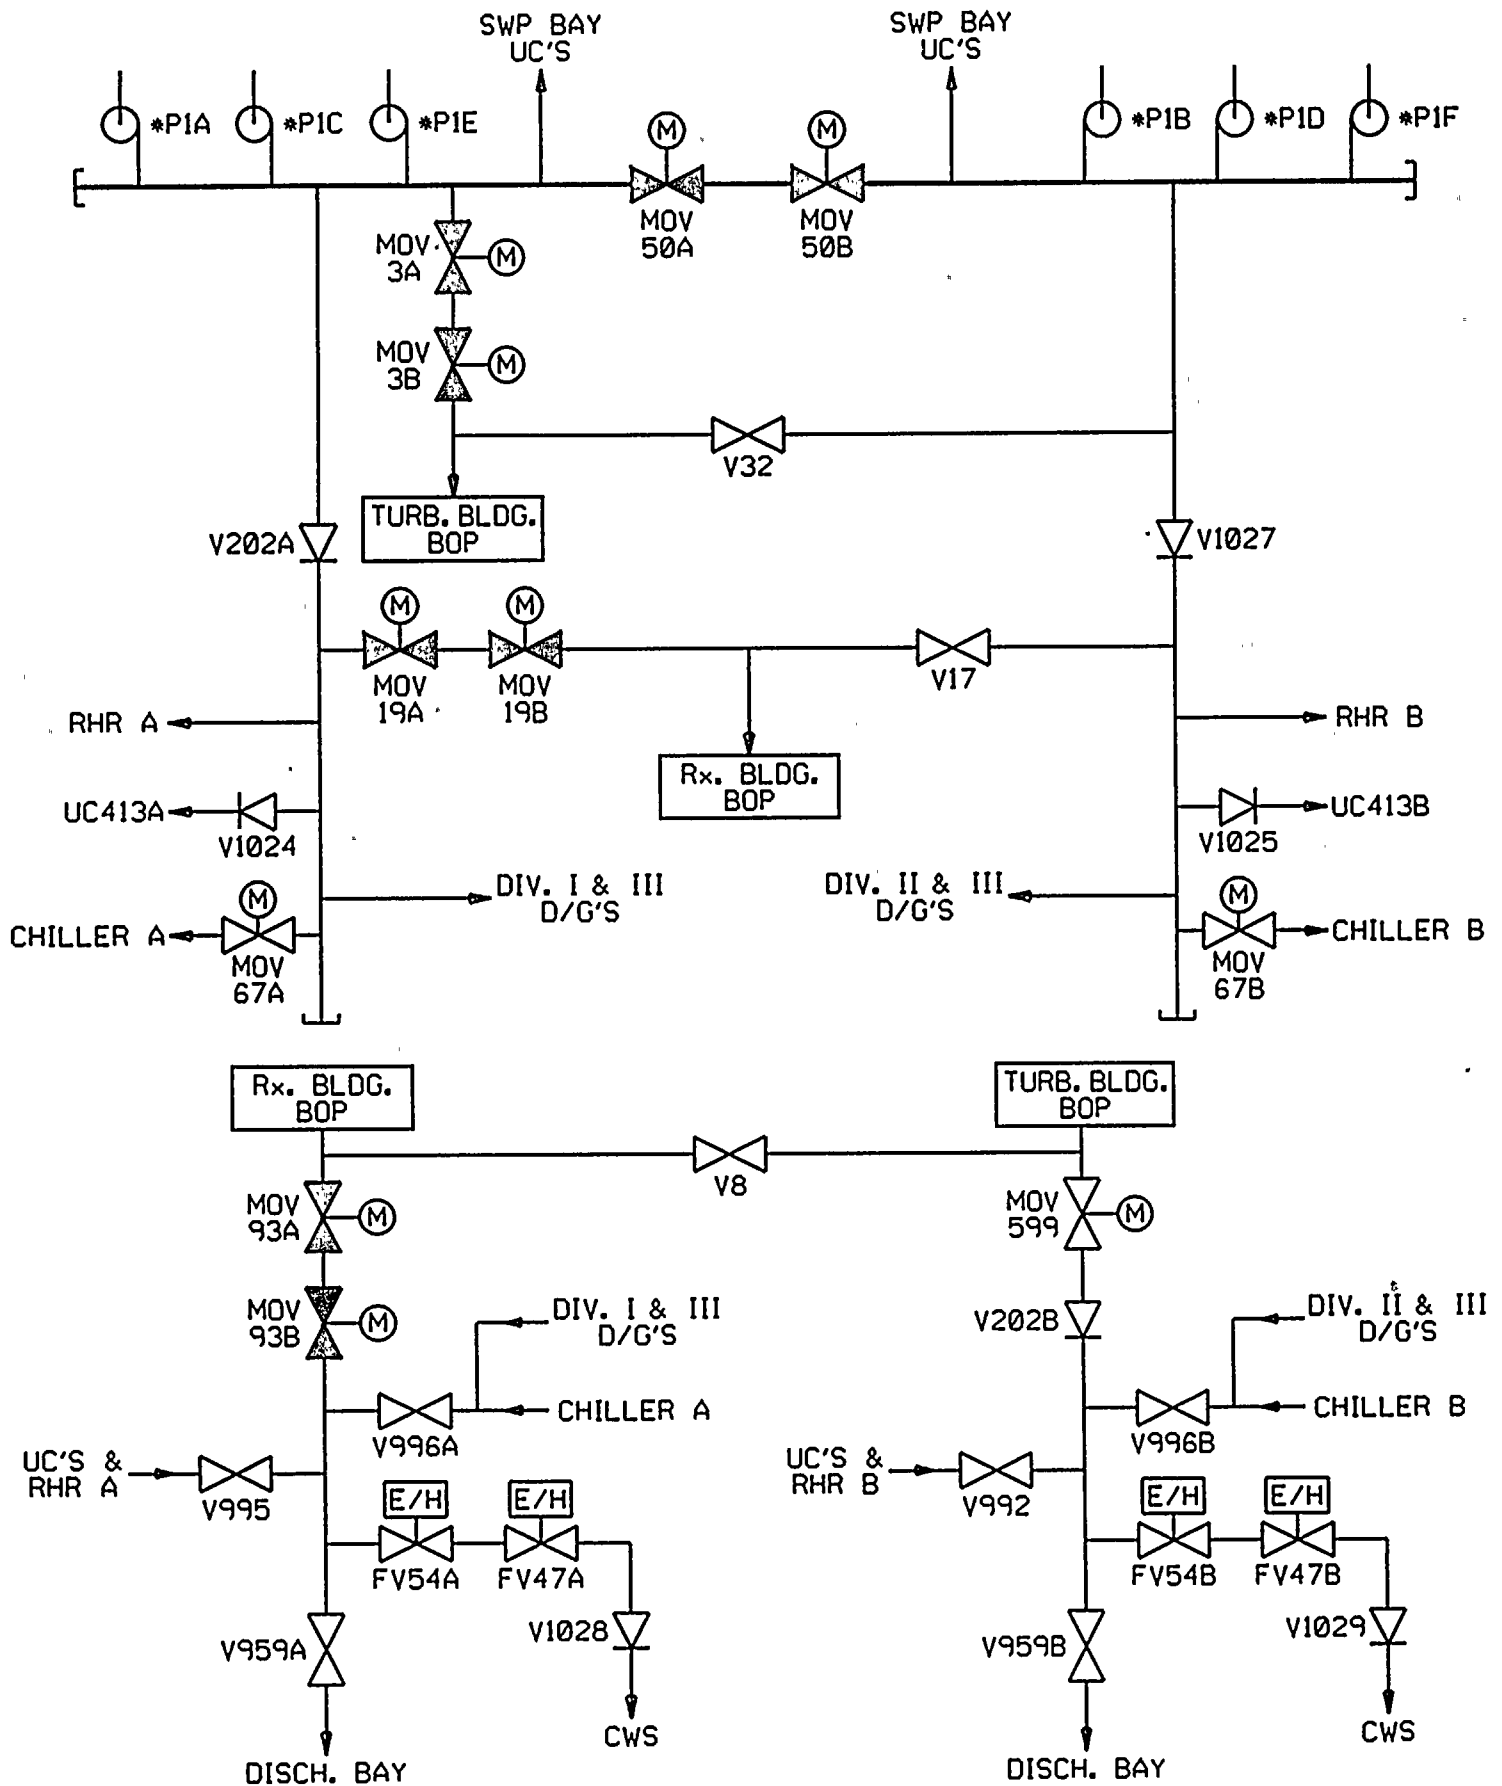
SERVICE WATER CONFIGURATION SKETCH

The attached sketch shows a simplified schematic of the Service Water System immediately prior to the event. Division I is depicted on the left side of the sketch and Division II on the right side. At the time of the event the system was in the following condition: Pumps 1A, 1C, and 1E were off; valves MOV 3A, 3B, 19A, 19B, 50A, 50B, 93A and 93B were shut; manual valves V8, V17 and V32 were open; and MOV599 was open. Three Division II pumps were running to supply service water to Division II safety related components as well as the reactor and turbine building Balance of Plant (BOP) components. As a result of the evaluation of this event, the service water lineups utilized during RFO5 are being further analyzed by engineering to verify that adequate service water flow to required components was capable of being maintained for all conditions. This report will be supplemented as appropriate, should any additional deficiencies be identified as a result of this analysis.

When maintenance and post-maintenance testing were completed on MOV93B, the valve was returned to service and opened. At that point the automatic closure capability of MOV93B was defeated, since there were no Division I service water pumps operating. The control logic of MOV93B is such that, when an automatic isolation signal is present, if the valve is opened using the control switch, the automatic isolation capability is defeated. Since maintenance was completed on MOV93B, dynamic testing of MOV93A, in accordance with the Generic Letter 89-10 testing program, was started at 2200 hours on October 8, 1996. However, the personnel involved in evaluating and approving the schedule change failed to recognize the unique conditions established, and that MOV93B would not automatically close on a loss of offsite power. The resulting condition with MOV93A and MOV93B open caused both divisions of service water to be inoperable, although Division II was still functioning and providing service water to required components. In the event of a Loss of Power (LOOP), however, the non-essential reactor building service water header would not automatically isolate as required by the Technical Specifications.
