March 24, 1997

LICENSEE: Niagara Mohawk Power Corporation

FACILITY: Nine Mile Point Nuclear Station Unit No. 1

SUBJECT: SUMMARY OF TELEPHONE CONVERSATION OF MARCH 20, 1997, ON CORE SHROUD  
INSPECTION OBSERVATIONS (TAC NO. M98170)

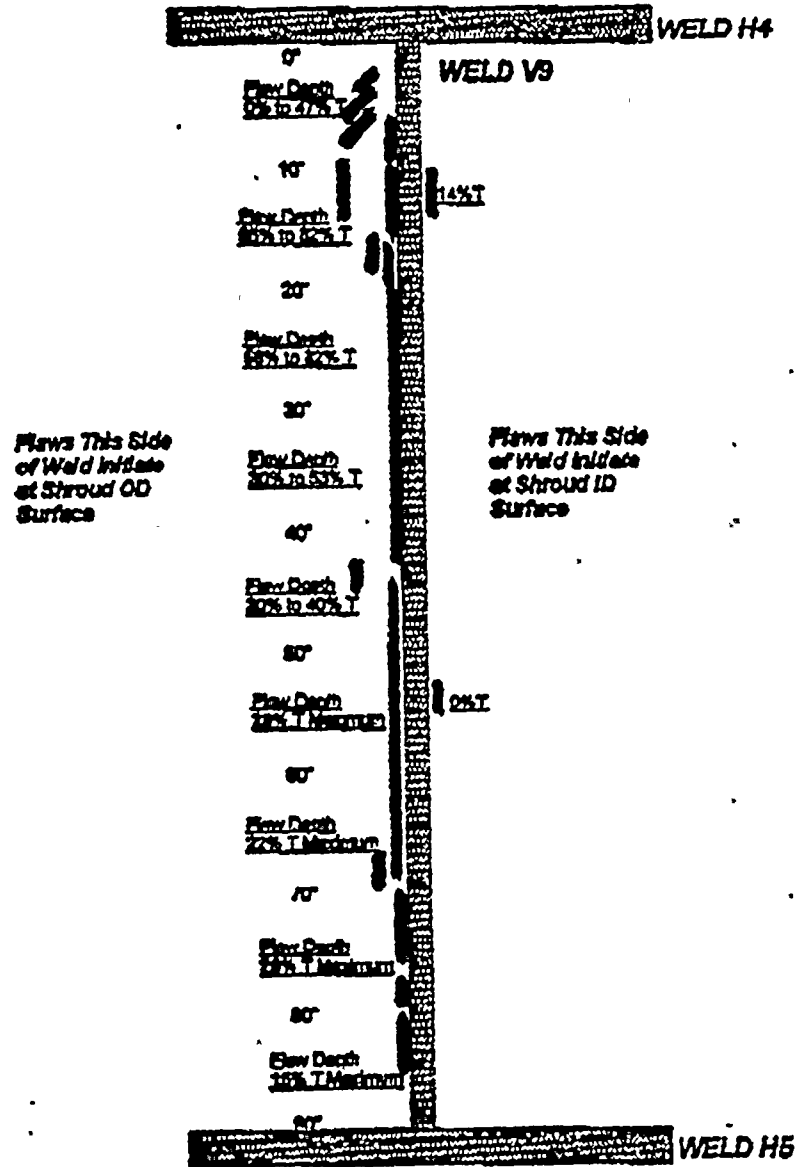
### Ultrasonic Examination Indication Map For Core Shroud Weld V9

The licensee provided Indication Maps showing the extent and depth of flaws during ultrasonic examination of shroud welds V9 and V10 (see pages 2 through 4 of Enclosure 2, handouts). These maps show that the deeper cracks were observed from the shroud outer diameter and are concentrated in the upper third of the height of welds V9 and V10. No through-wall cracks were found and the maximum flaw depth was 82 percent for V9 and 66 percent for V10. All vertical welds are being inspected by a combination of ultrasonic or visual means, depending upon accessibility. Welds are being located by use of an eddy current technique.

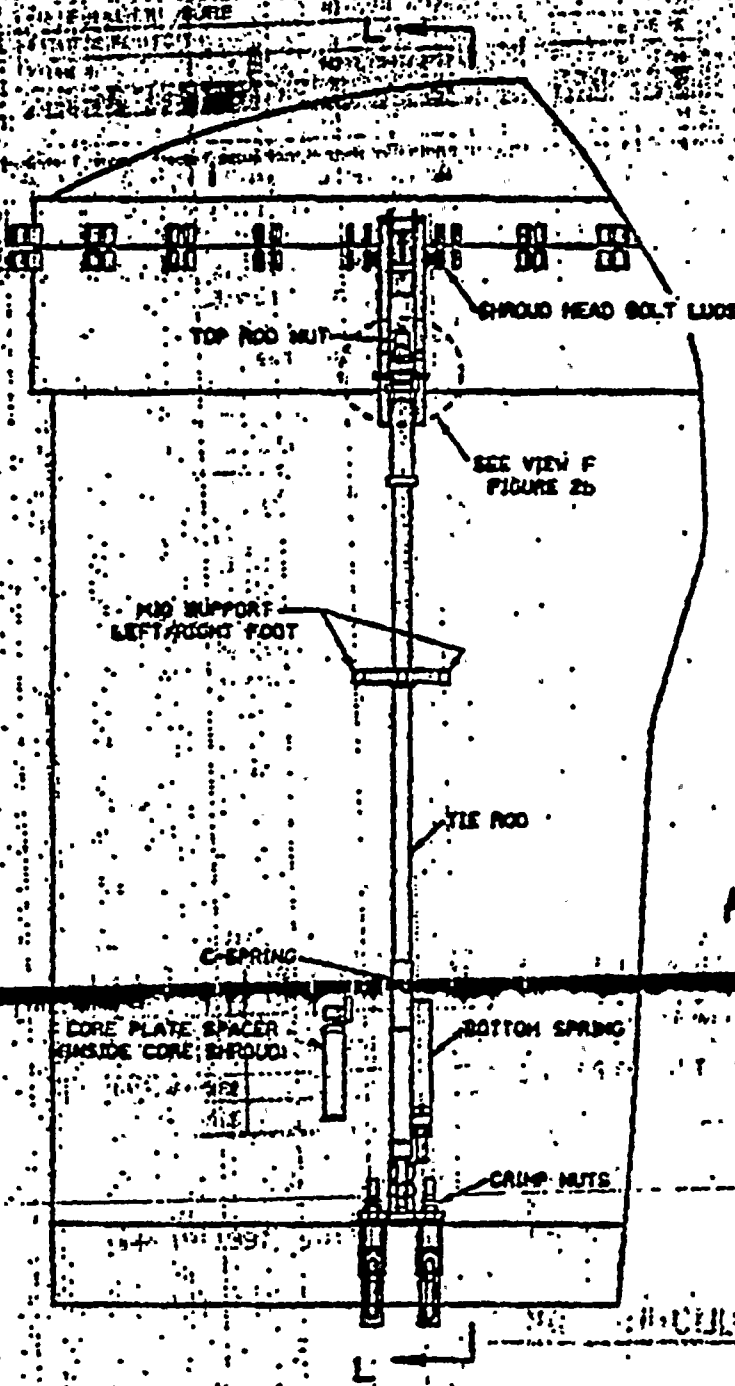
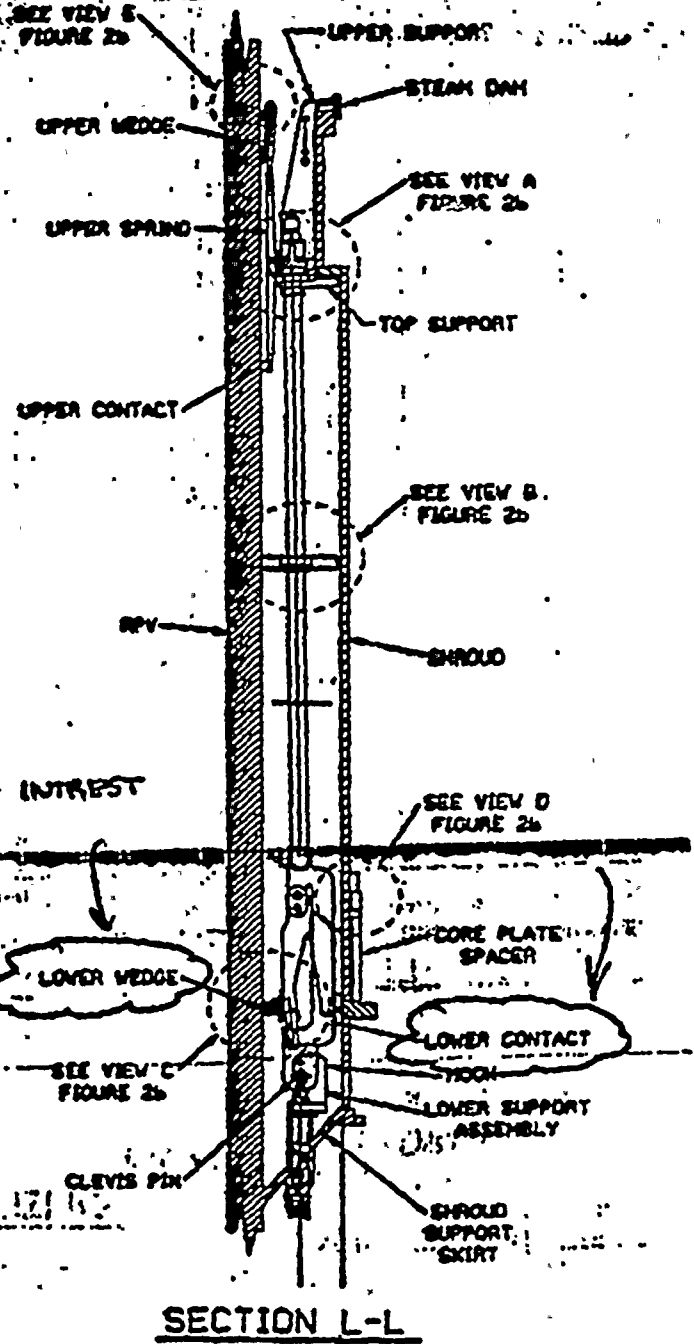
CORE SHROUD STABILIZERS

2. On March 19, 1997, the licensee reported that a core shroud lower tie rod assembly lateral contact, whose function is to restrain the shroud laterally during a seismic event, was not contacting the reactor vessel wall and outside diameter shroud surface as required (see Enclosure 3). The lower contact is supposed to be held by a spring latch device, but inspection revealed that the latch had failed on the tie rod assembly located at the 90° azimuth. The spring latch devices for the 270° and 350° tie rod assemblies were observed to exhibit signs of degradation. The tie rod assemblies had been installed during the previous refueling outage in 1995. The licensee will perform engineering evaluations of the lack of contact for the seismic event and assess the affect on shroud integrity.

The latch (called a "retainer clip" on page 7 of Enclosure 2, handouts) in the lower portion of the 90° tie rod assembly was observed to be missing and the associated lateral support block had shifted downward until encountering a retaining pin. Visual inspection of the other three tie rod assemblies revealed apparent degradation (i.e., "discoloration") of latches in the 270° and 350° tie rod assemblies. The lateral support block for the 350° assembly has shifted downward about 1/4 inch. The licensee is preparing a Deviation/Events Report on the latches and evaluating the potential consequences of a postulated multiple loss of retainer clips.

The licensee also found that the nut at the top of the 270° tie rod had loosened somewhat, although the retaining device for the nut remained in place. The other three tie rod nuts will be checked for tightness. The lateral support for the 270° tie rod assembly, which was contacting the recirculation blend nozzle and was scheduled for replacement, was observed to have shifted slightly.
