***GENE B13-01739-40***  
***Revision 1***

***Shroud Repair Anomalies  
Nine Mile Point Unit 1, RFO14***

***Prepared for:  
Niagara Mohawk Power Corporation***

***Prepared by:  
GE Nuclear Energy  
Reactor Modification Services  
175 Curtner Avenue, M/C 571  
San Jose, California 95125***

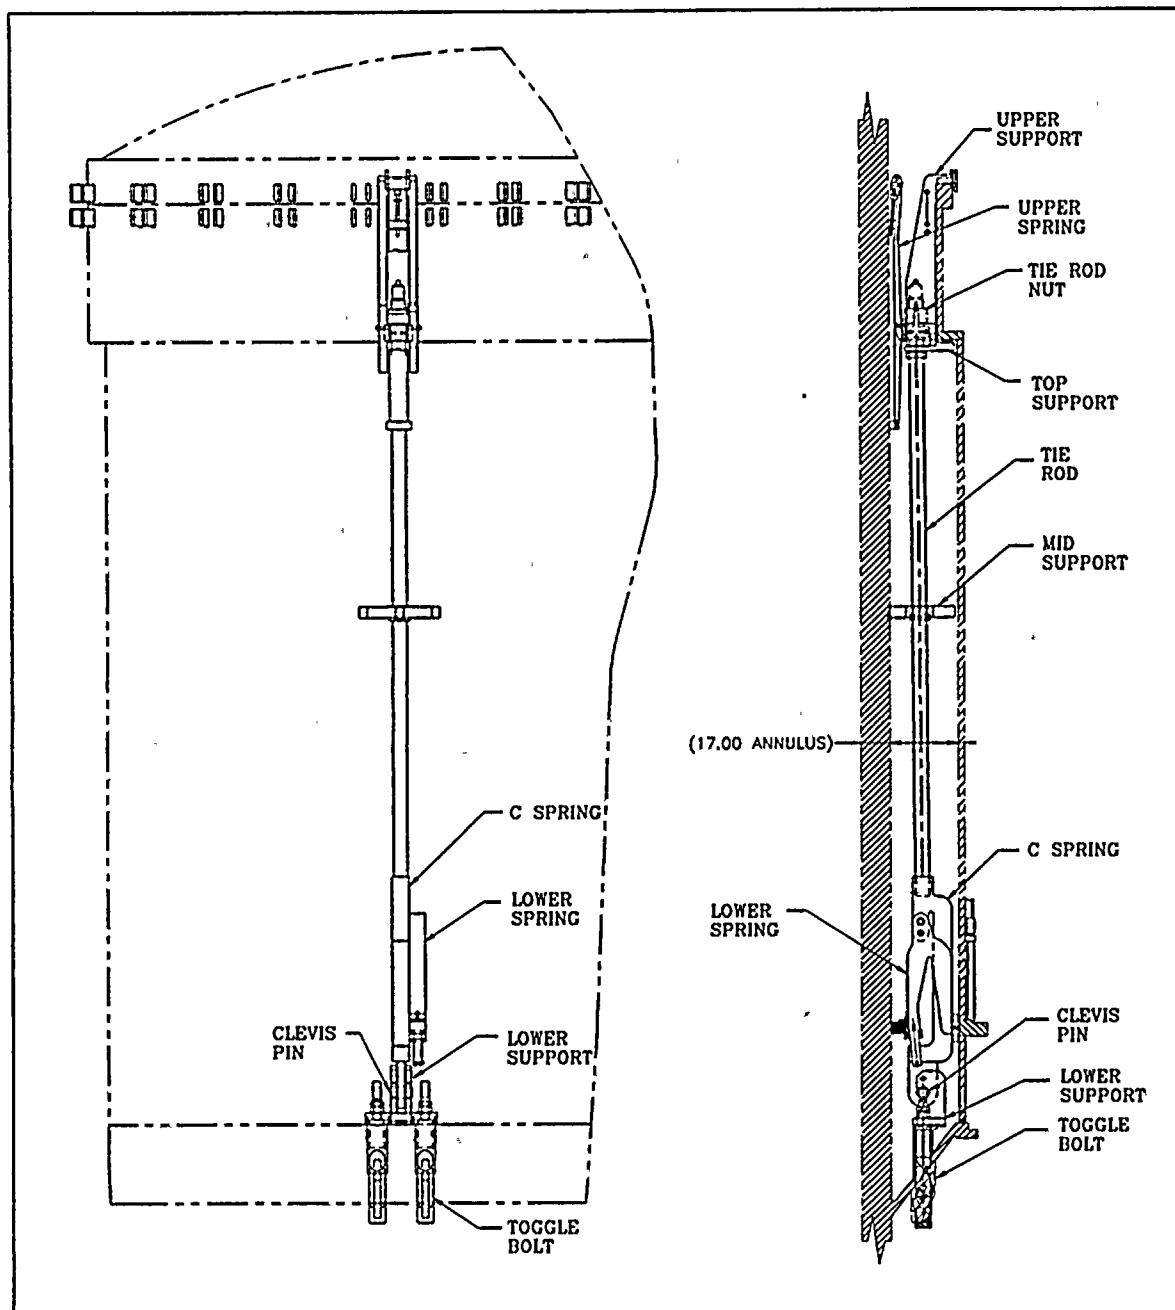
Figure 1  
Shroud Repair Assemblies

Figure 1 shows an elevation view of one set of shroud repair hardware. There are four such sets of hardware at azimuths 90, 166, 270, and 350 degrees around the core shroud. Briefly, the tie rod is the main component for reacting axial loads. The lower spring is the linear spring for supporting the shroud at the core plate elevation. The lower wedge is a component that was machined based on actual site measurement to fit between the RPV and the lower spring with a small (0.010 inch) compression of the lower spring at room temperature. The latch is a wishbone shaped piece, that is intended to prevent relative motion between the lower wedge and the lower spring. Similar latches are also used to prevent relative motion at the mid-support and at the upper spring. The lower support is an assembly that connects the shroud repair hardware to the shroud support cone. The tie rod nut is at the top of the tie rod and is used to tighten the assembly. During installation, the tie rod nut was torqued clockwise to preload the assemblies to assure minimal tightness of components. The mid-support is used to limit relative motion between the middle of the shroud and the RPV. The upper spring is a linear spring for supporting the shroud at the top guide elevation.

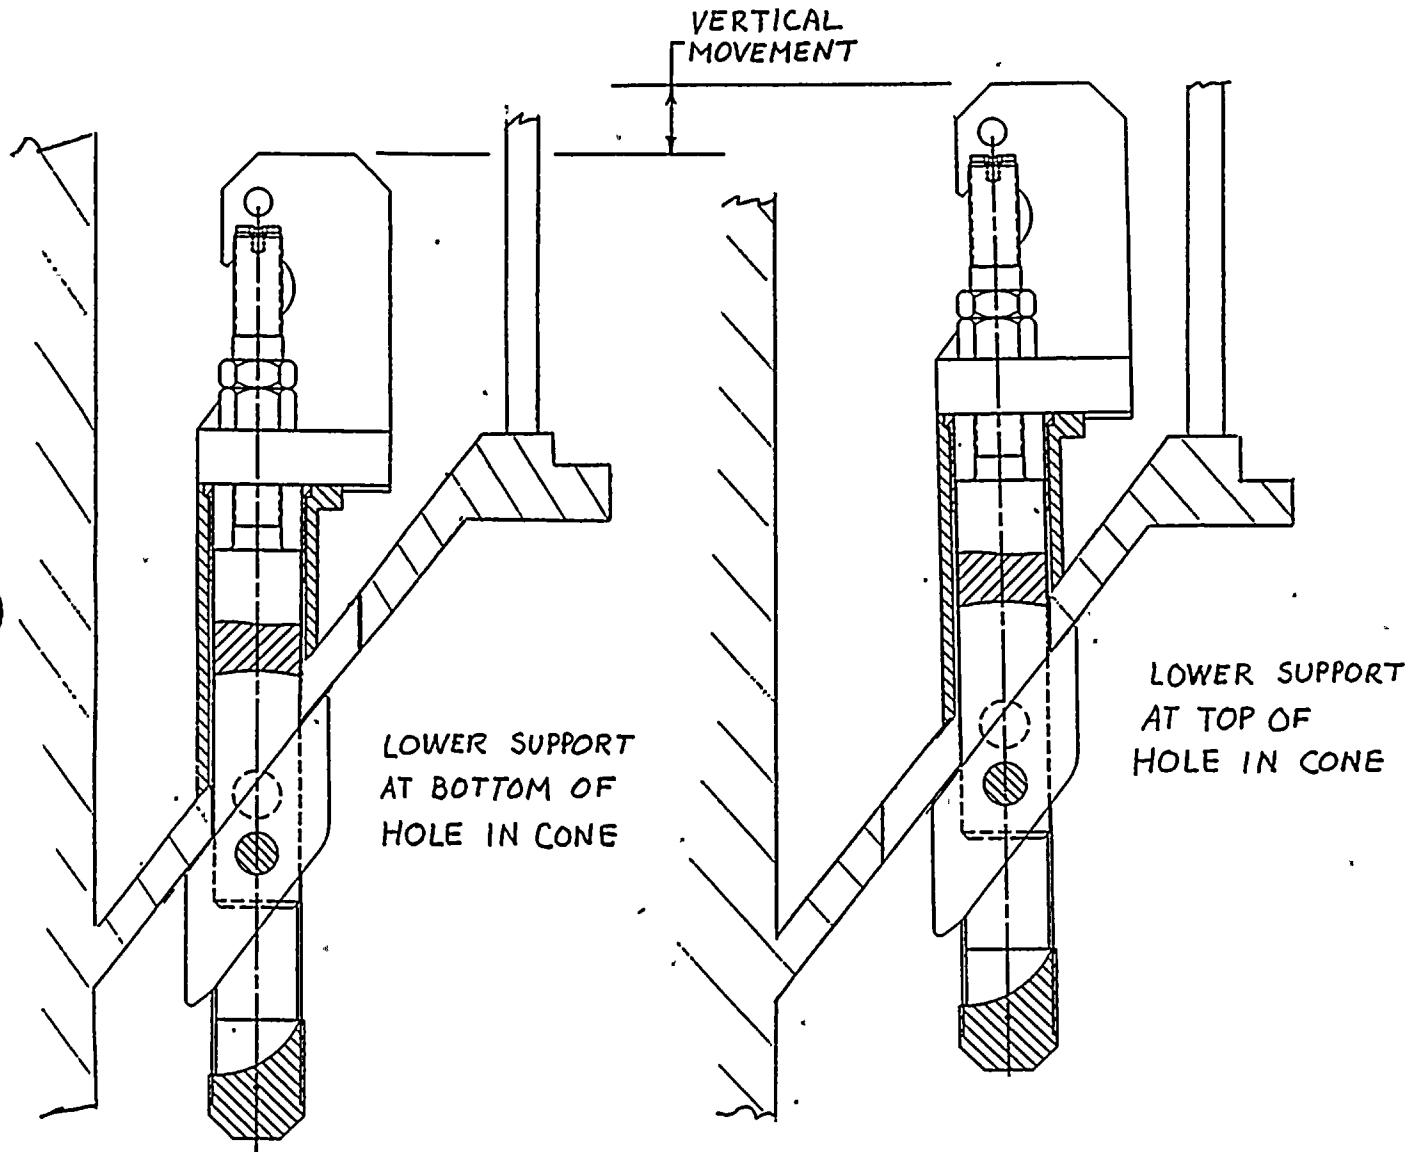
Figure 3

Therefore, the root cause of the latch failure and the tie rod looseness is related to the design assumption of sliding on vessel surface. While this appeared reasonable initially, the observed deformation on some of the latches confirms that sliding did not occur and that the original assumption of sliding was incorrect. Given that friction on the lower spring contact area can

prevent sliding, the shroud support/toggle bolt assemblies should have been installed as close to the shroud as possible, and as allowed by the holes in the shroud support cone. With the incorrect assumption, the importance of the clearance between the toggle bolts and the hole was not recognized and not incorporated into the installation engineering documentation. Therefore, all four shroud repair assemblies had an installed looseness of 0.054 to 0.151 inch. This looseness was removed by the 79,600 pound force applied by differential thermal expansion of 0.155 inch at plant operating conditions. This 0.054 to 0.151 displacement combined with the unexpected no slippage of contact displacement, overstressed the latch (assuming no slippage between the RPV and the wedge). The high stress is likely to have resulted in stress corrosion and latch separation in two years.

Toggle Bolt Movement in Shroud Support Cone

There are two corrective actions. The first is to remove the looseness between the toggle bolts and the shroud support cone. This has been, or will be, accomplished with the Reference 3.1 procedure. The second is to install new latches which are more tolerant of differential vertical displacement. The design of the new latches maintains the original design function, which is to lock the wedge to the lower spring whenever it is not supported, but modifies the latch mechanism to incorporate another spring mechanism which can tolerate vertical displacements. Therefore, the original functional requirement is accomplished while adding more flexibility in the vertical direction to accommodate the now recognized vertical displacements. The new latch is again made from X-750 material because of its high strength capabilities. Testing of X-750 has shown that it is resistant to stress corrosion cracking for stresses up to 75 ksi. In comparison, the only other high strength material with excellent corrosion resistance properties and with in-vessel experience is XM-19. However, for this material the yield strength is only 38 ksi. Likewise, the ultimate strength of X-750 is significantly higher than XM-19 (142 ksi vs. 88 ksi). Therefore, X-750 continues to be the best choice. The design of the latch will accommodate all potential vertical displacements without exceeding the ASME code limits. Under the most probable operating and sliding conditions the new latch design is expected to perform satisfactorily for the remaining life of the plant. Even for worst case postulated conditions, the latch is capable of operating without failure.
