**Metallurgical Evaluation of Failed Shroud Tie Rod
Lower Spring Contact Wedge Latches**

Nine Mile Point Unit 1, RF014

**D. E. Delwiche, Program Manager
Metallurgical Evaluations
Plant Materials Technology**

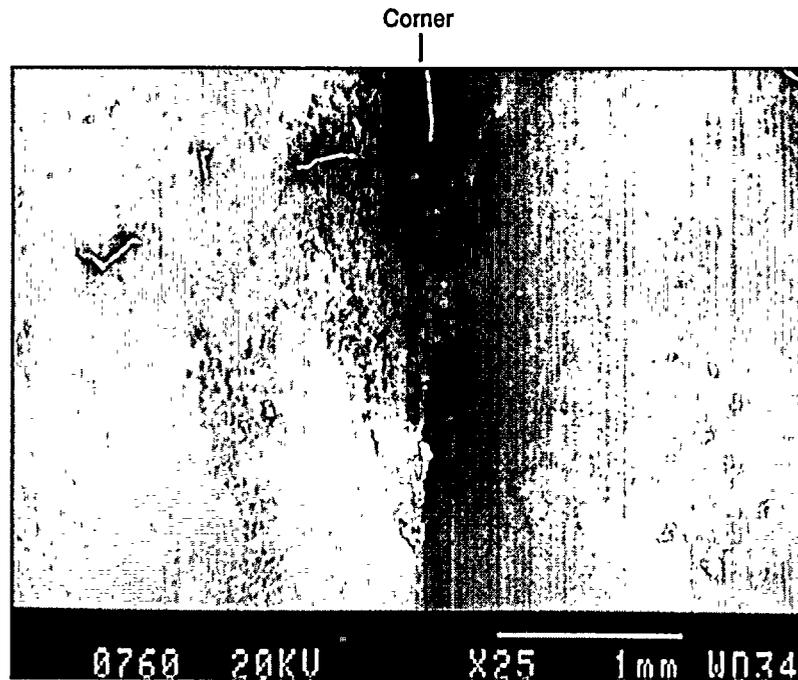
Figure 7. Typical views of “inside corner” region of 166 degree contact wedge latch by SEM imagery, performed to identify possible cracking. The method, used in place of PT (penetrant testing), revealed no cracking in area of crack initiation as found on cracked wedge latches.

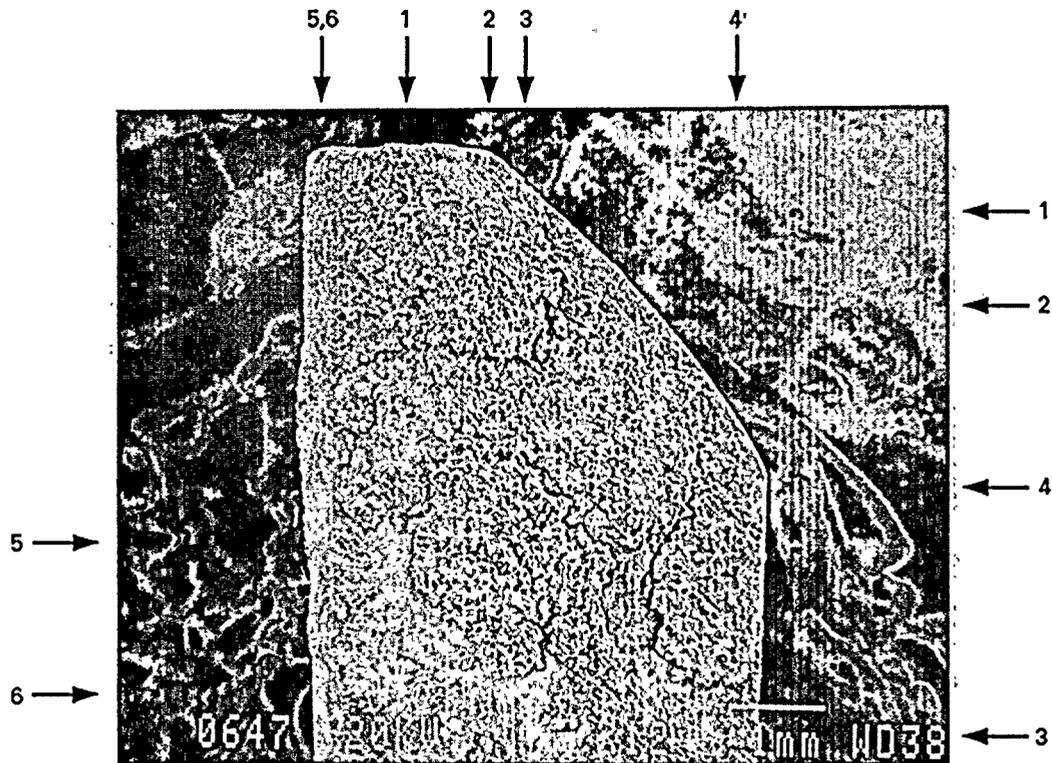
Figure 12 is an SEM view at 12 X of the fracture face of the 350 degree latch. This low magnification macroscopic view showed secondary cracking associated with the primary fracture. This is characteristic of SCC growth. This figure also provides location information for the higher magnification views of Figures 13-16.

Figure 12. SEM view (12X) fracture face of 350 degree wedge latch. This low magnification macroscopic view shows secondary cracking associated with the primary fracture. This is characteristic of SCC growth. This figure also provides location information for the higher magnification views of the following four figures. End "A" is at the left end of the left hand fracture seen in Figure 10.

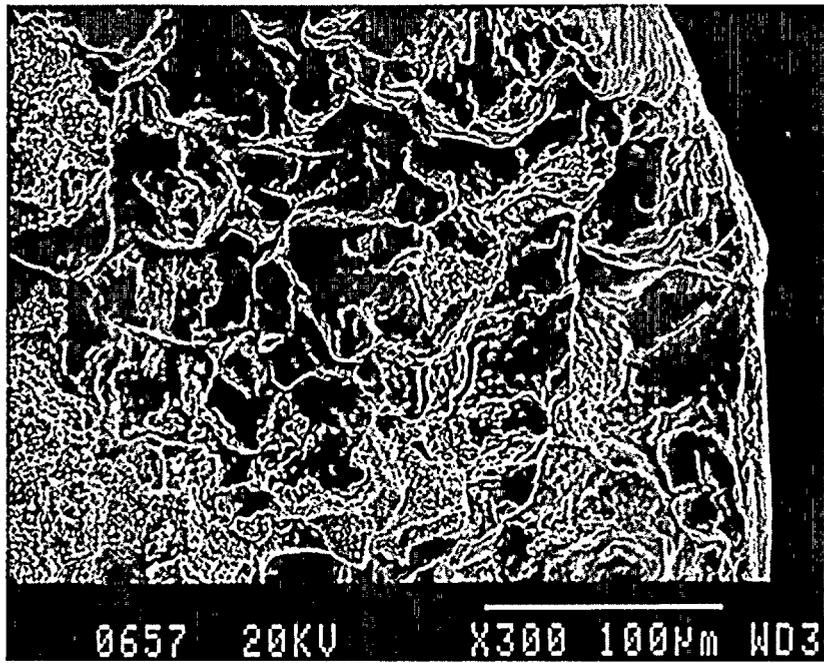
Figure 13 is a 300 X magnification view of the fracture face in the region of crack initiation. See arrow location 4 in Figure 12. Note the intergranular nature of the fracture, with minor plastic deformation and moderate oxide build-up. Figure 14 is the same fracture face at a magnification of 200 X in the mid-fracture region. Note the intergranular characteristic of the surface, with moderate oxide build-up. This is location 3 in Figure 12. Figures 15 a & b (Location 2 in Figure 12), are fracture face views taken at 200 and 300 X of the region near the crack tip. Note the slight build-up of oxide, indicating recent growth in the BWR environment. Figure 16 contains views of the fracture face (300 X and 1000 X) at location 5 in Figure 12. This is the region of ductile rupture which occurred at room temperature during latch removal.

Figure 13. Fracture face (300x) in region of crack initiation - Arrow location (4) in Figure 12. Note intergranular nature of fracture, with minor plastic deformation, and moderate oxide buildup.

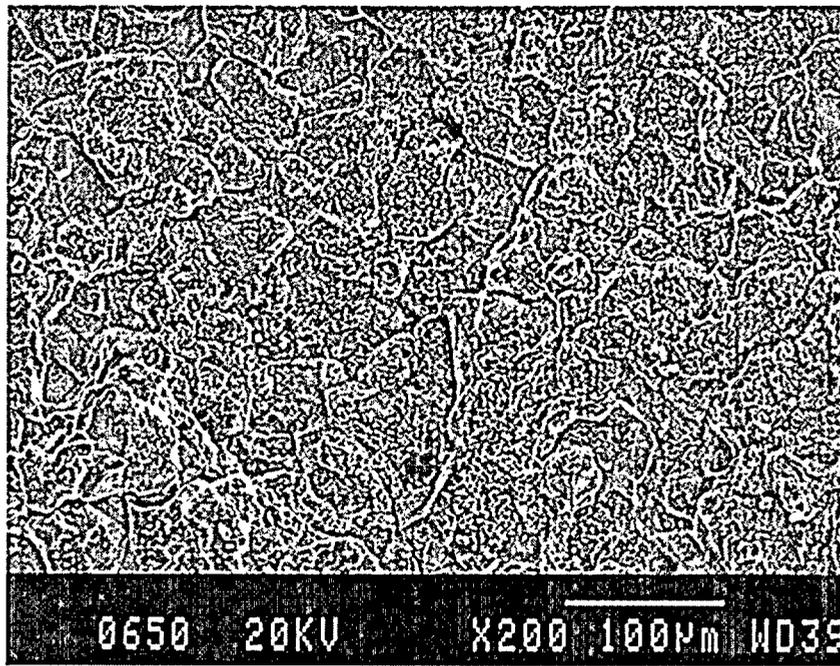
Figure 14. Fracture face (200X) in mid-fracture region of 350 degree wedge latch. Note intergranular characteristic of surface, with moderate oxide buildup. Location (3) in Figure 12.

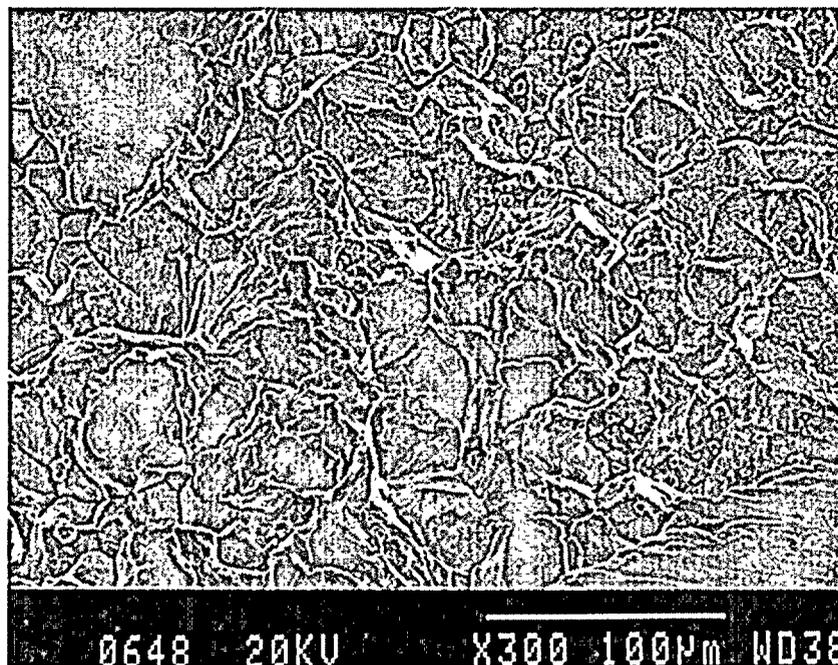
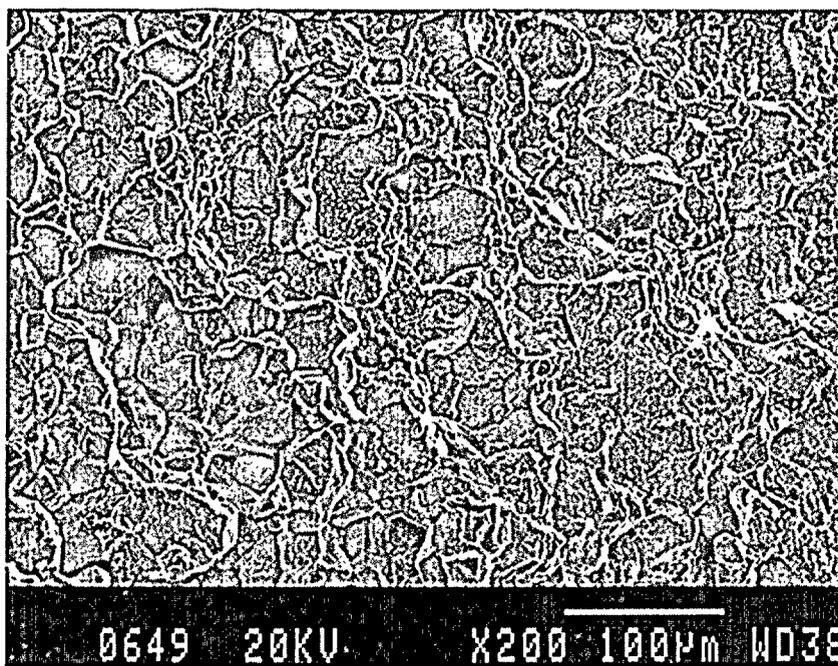
Figure 15 a & b. Fracture face views (200 and 300X) of region near crack initiation in the 350 degree wedge latch. Note slight buildup of oxide, indicating recent growth in BWR environment. (Location (2) in Figure 12.)

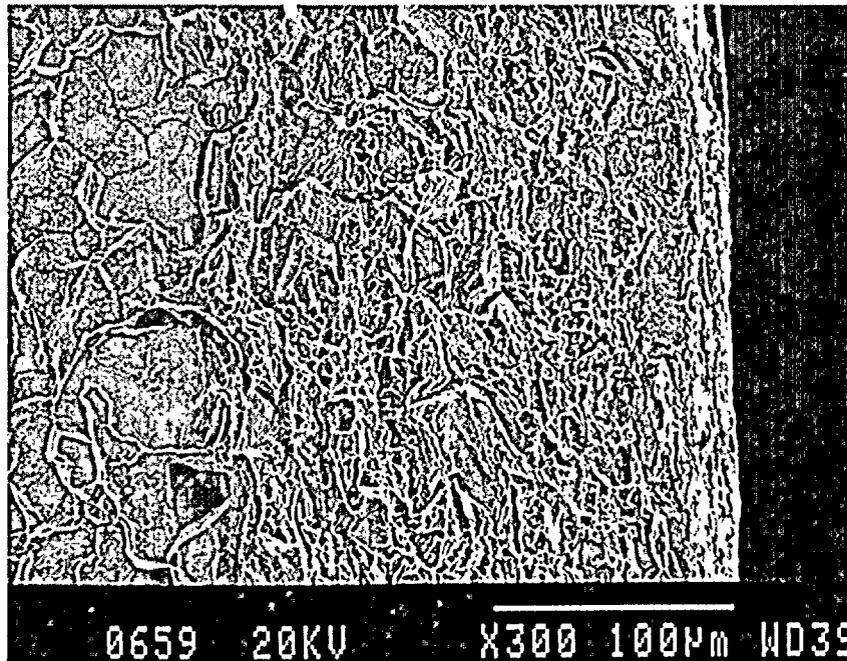
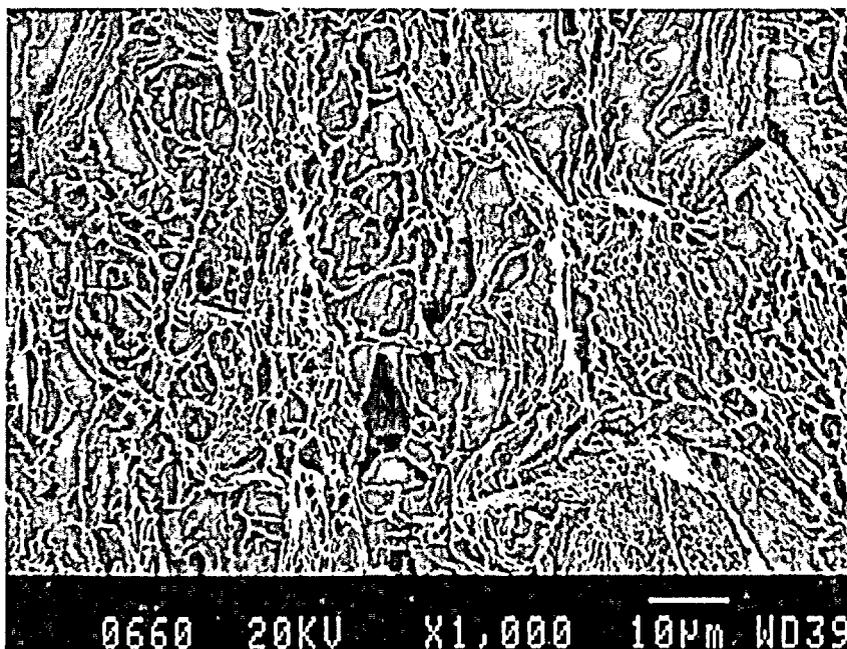
Figure 16. Views of fracture face (300 and 1000X) at location (5) in Figure 12. This is the region of ductile rupture which occurred at room temperature during the 350 degree wedge latch removal.

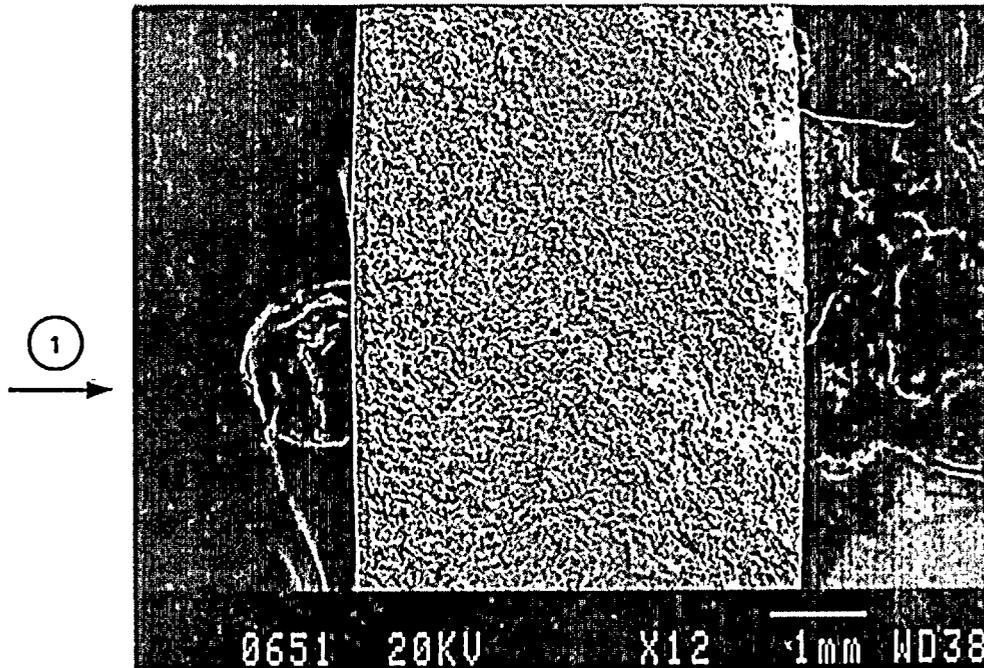
The central region of the 350 degree latch fracture face is shown in Figure 17. The left hand edge of the fracture (arrow location 1 in the Figure) was the region of low temperature fracture during latch removal. This figure provides location information for the higher magnification views of figure 18. Figure 18 contains 200 X and 300 X views of the fracture surface shown in Figure 17 at location 1. Note the IGSCC character, and the only very slight oxide. This region is near the crack tip. Location 2 has appearance the same as Figure 14.

Figure 17. SEM view (12X) of central region of fracture face of 350 degree wedge latch. The left hand edge of the fracture (arrow 1) is region of low temperature fracture during latch removal. The figure provides location information for the higher magnification views of the following figures.

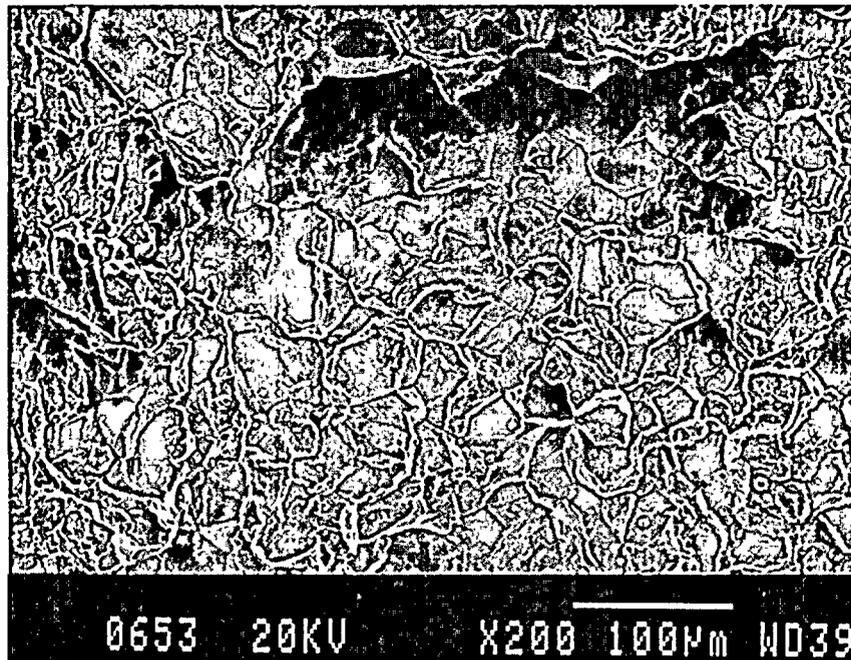
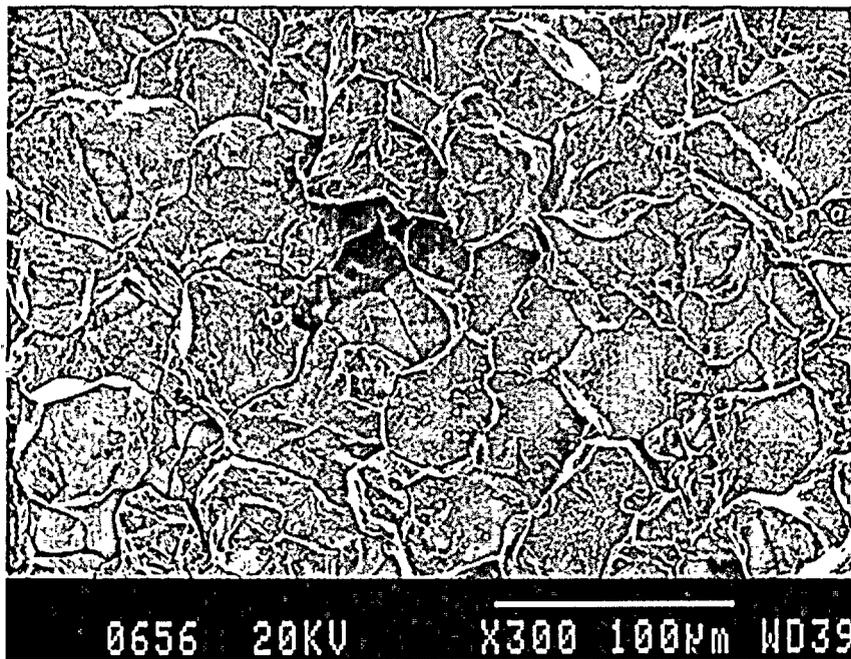
Figure 18. SEM views (200 and 300X) of fracture surface shown in Figure 17 at location (1). Note IGSCC character, and only very slight oxide, since this location is near crack tip.

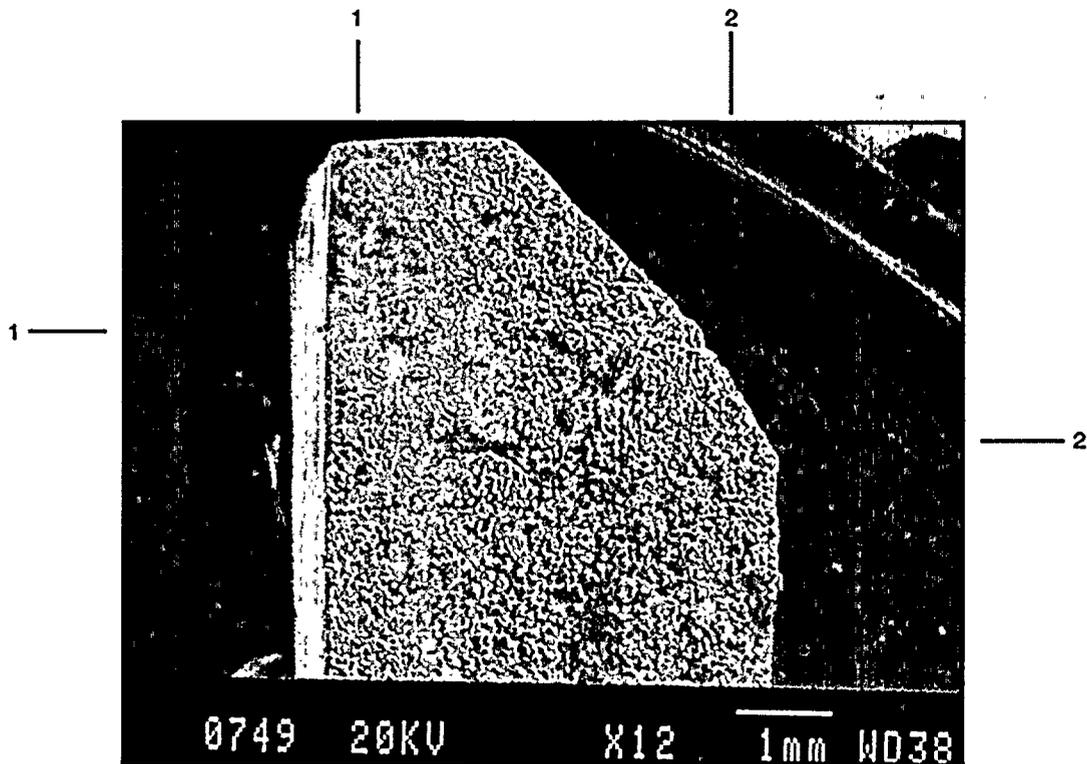
Figure 20 is a SEM view (12X) of the fracture face of the 90 degree contact wedge latch. This low magnification macroscopic view shows secondary cracking associated with the primary fracture. As was found on the 350 degree wedge latch fracture face, this is characteristic of SCC growth. This figure also provides location information for the higher magnification views of the 90 degree wedge latch fracture, Figures 21-23. Figure 21 is a 200X view of the fracture face in the area of crack initiation. The cracking is intergranular with heavy oxide buildup characteristic of IGSCC. Figure 22 is a 200X view of the region near the site of final separation of the 90 degree wedge latch. The cracking is clearly intergranular, with less oxide buildup than seen in Figure 21. Figure 23 is a 800X view of the center of fracture face of Figure 22. Note the oxide buildup and obscuring of the fracture face detail.

Figure 20. SEM view (12X) of the fracture face of 90 degree contact wedge latch. This low magnification macroscopic view shows secondary cracking associated with the primary fracture. As was found on the 350 degree wedge latch fracture face, this is characteristic of SCC growth. This figure also provides location information for the higher magnification views of the following 90 degree wedge latch fracture figures.

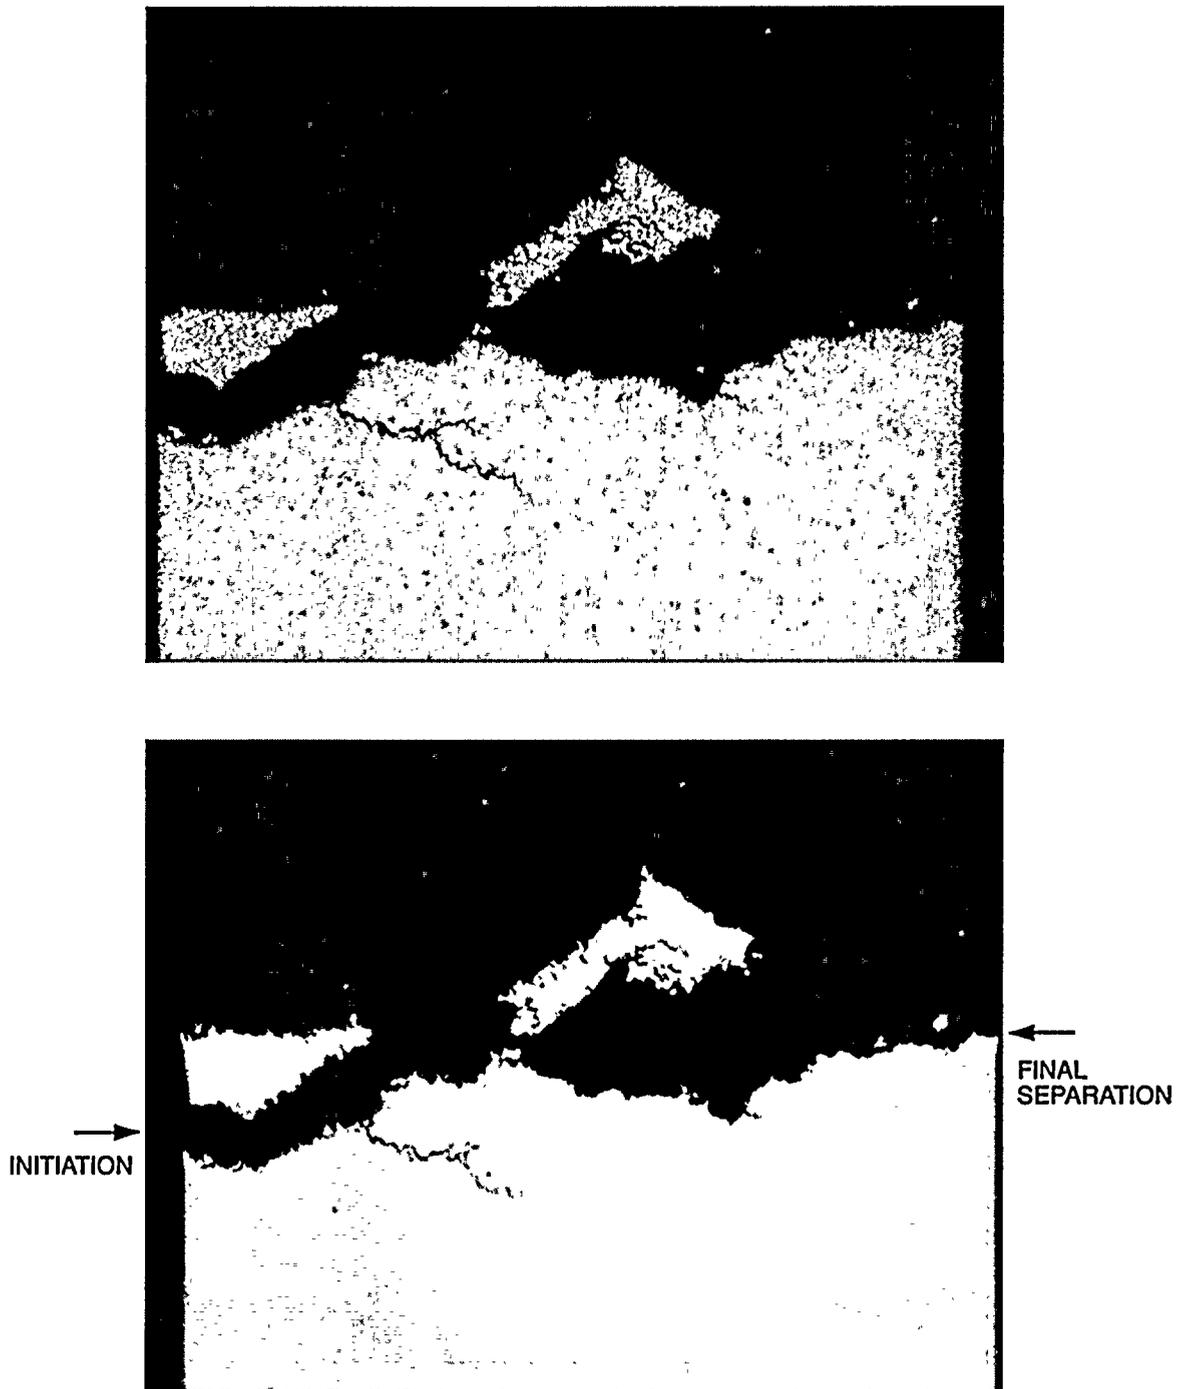
Figure 25. As-polished and etched views (20X) of 350 degree latch section. Plane of polish is perpendicular to fracture face at location indicated in Figure 24.

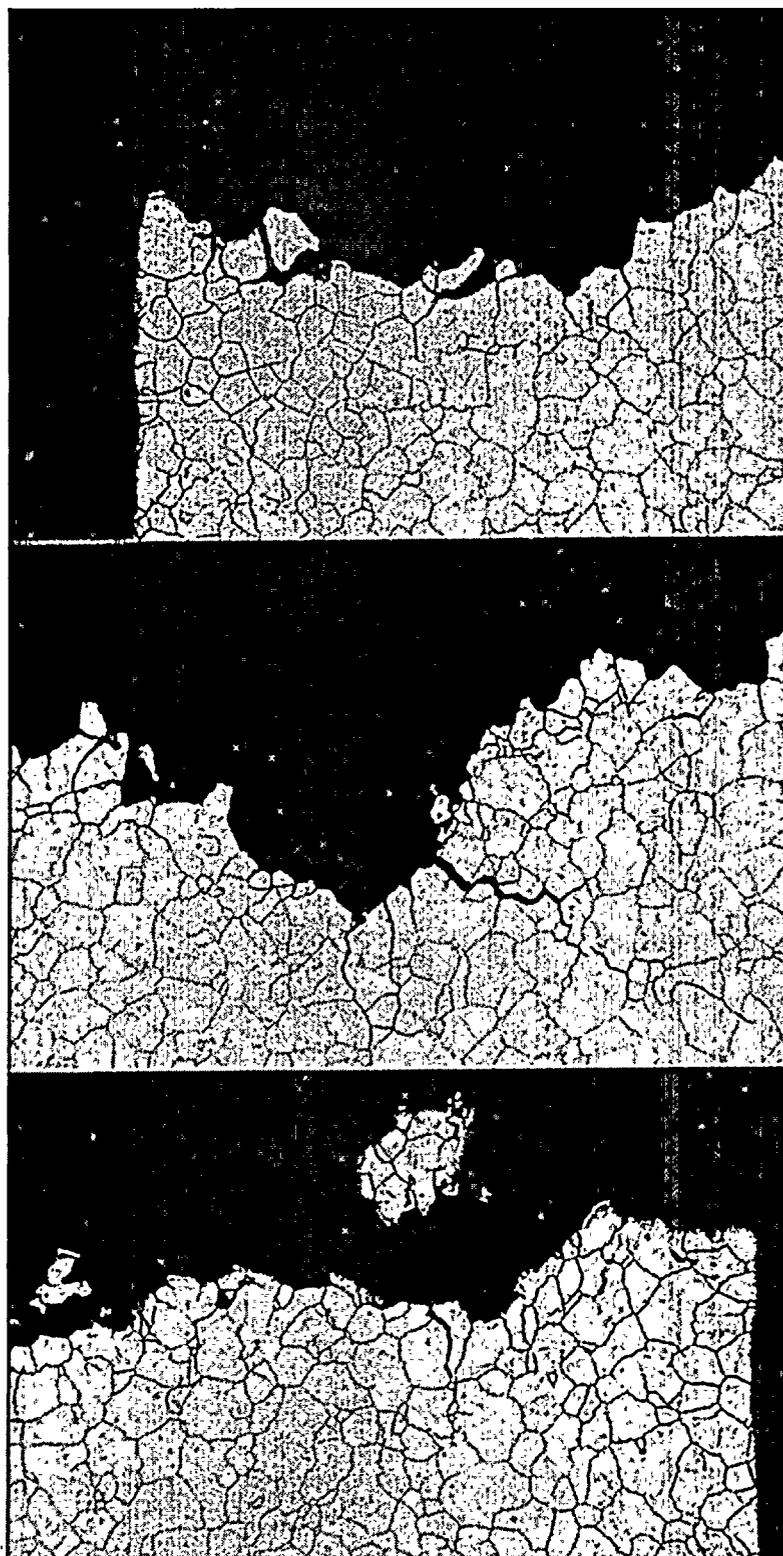
Figure 26 contains optical microscopic views of the latch failure. Photo a. is the region of the crack mouth (initiation). Photo b. is the mid-fracture region, and c. is the region of final separation characterized by transgranular ductile rupture. The upper left photograph in Figure 27 shows secondary cracking characteristic of IGSCC. Magnified views of the crack

a. REGION OF CRACK MOUTH
(INITIATION) 128X

b. MID FRACTURE REGION - NOTE
SECONDARY IGSCC CRACKS.
128X

c. REGION OF FINAL SEPARATION
TRANSGRANULAR DUCTILE
RUPTURE. 128X

Figure 26. Views of fracture by optical microscopy - 350 degree wedge latch.

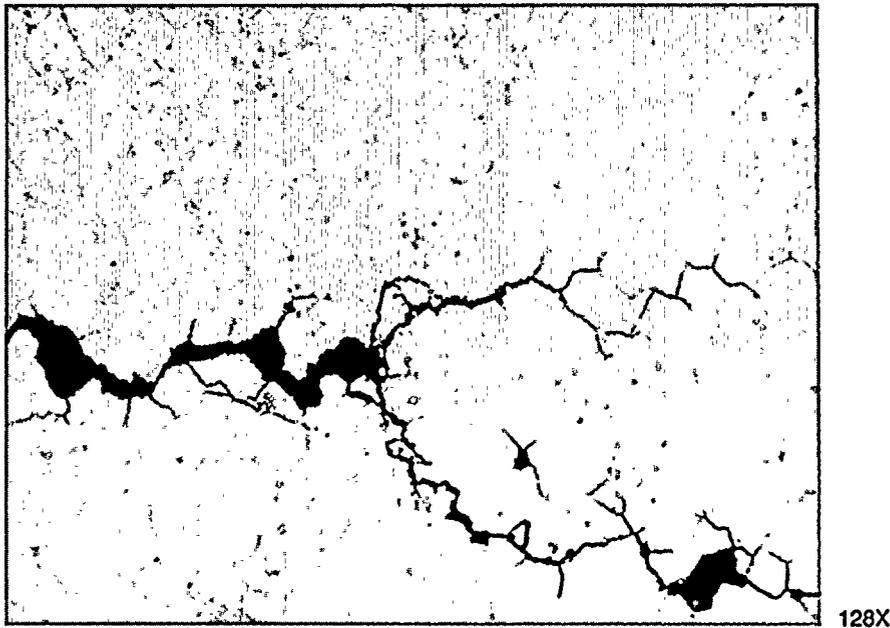
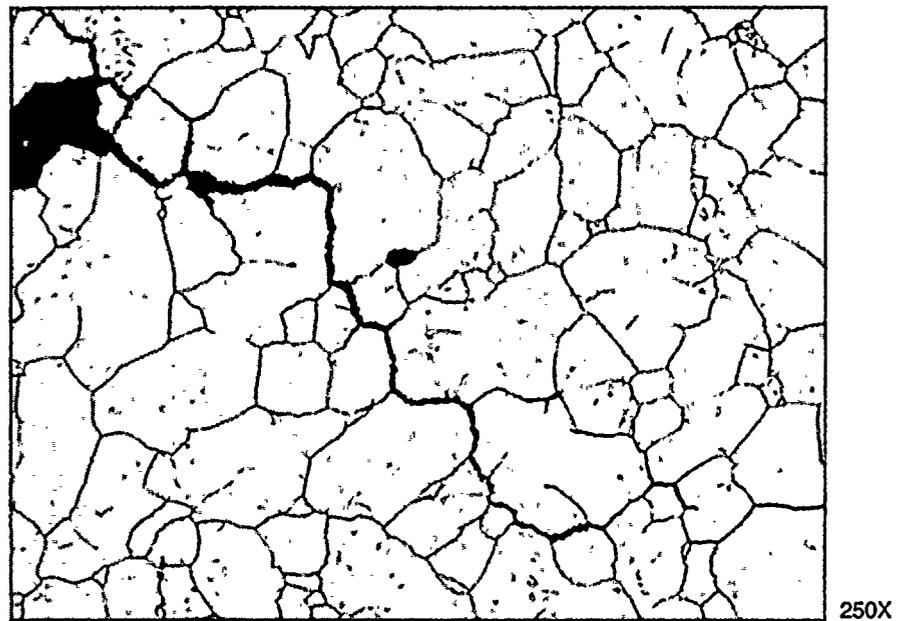
are noted in the lower photo of Figure 27. This crack morphology is characteristic of IGSCC. Figure 28 is a high (250X) view of the fracture in the region of the crack initiation. Evidence of minor cold work was observed. Figure 29 is a high magnification (250X) view of the mid-fracture region of the 350 degree wedge latch, clearly showing the IGSCC nature. Figure 30 shows high magnification (250X) view of latch fracture face in region of final separation. The final separation occurred by ductile rupture, and has an associated plastic deformation. The observation is fully consistent with the results of SEM fractography, as seen in the views of Figure 16.

Figure 27. Secondary cracking - IGSCC. Magnified views of crack noted in Figure 25 (upper photo). This crack morphology is characteristic of IGSCC.

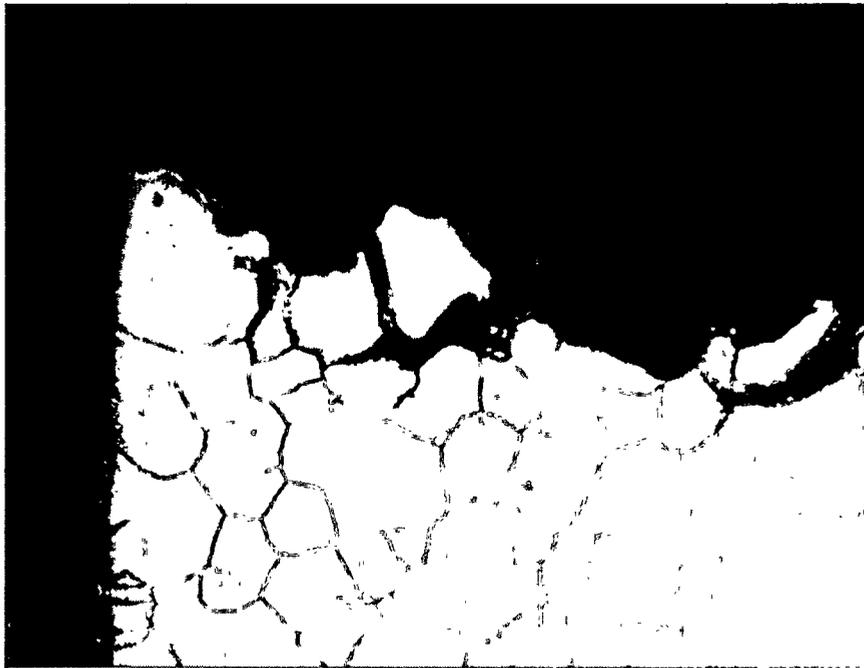
Figure 28. High magnification (250X) view of fracture in region of crack initiation – 350 degree wedge latch. Note evidence of minor cold work.

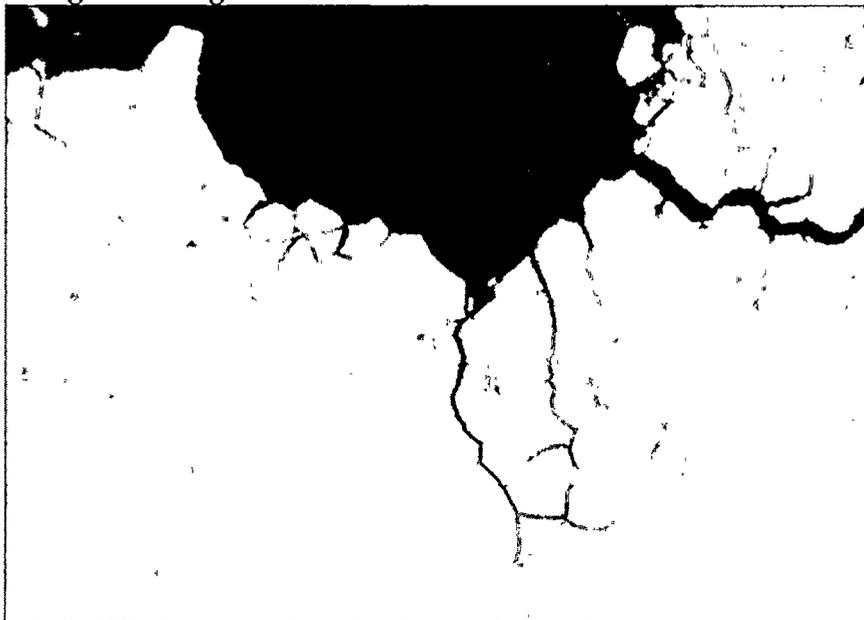
Figure 29. High magnification (250X) views of mid fracture region of 350 degree wedge latch, clearly shows IGSCC nature.

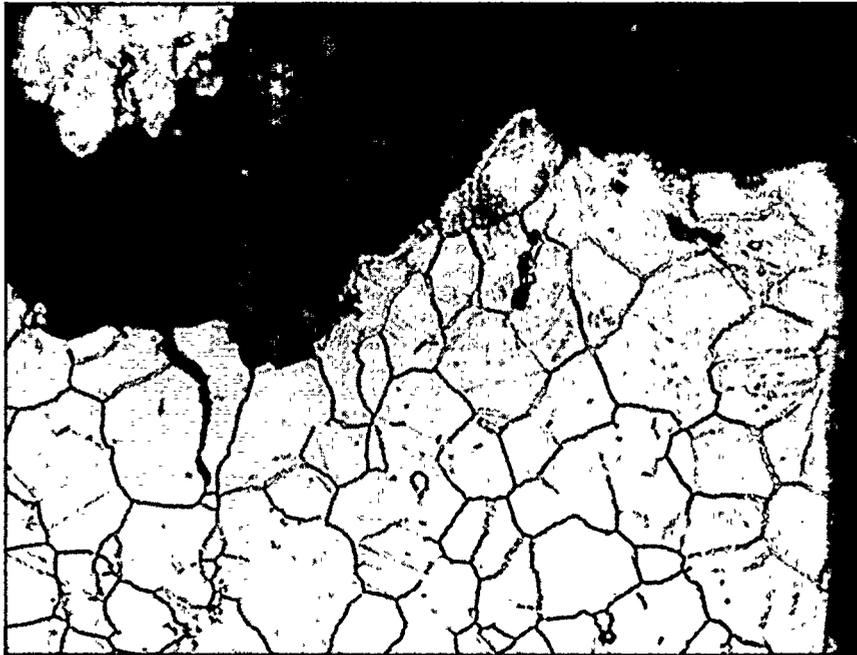
Figure 30. High magnification (250X) view of 350 degree latch fracture edge in region of final separation. The final separation occurred by ductile rupture, and has an associated plastic deformation. The observation is fully consistent with the results of SEM fractography, as especially seen in the views of Figure 16.

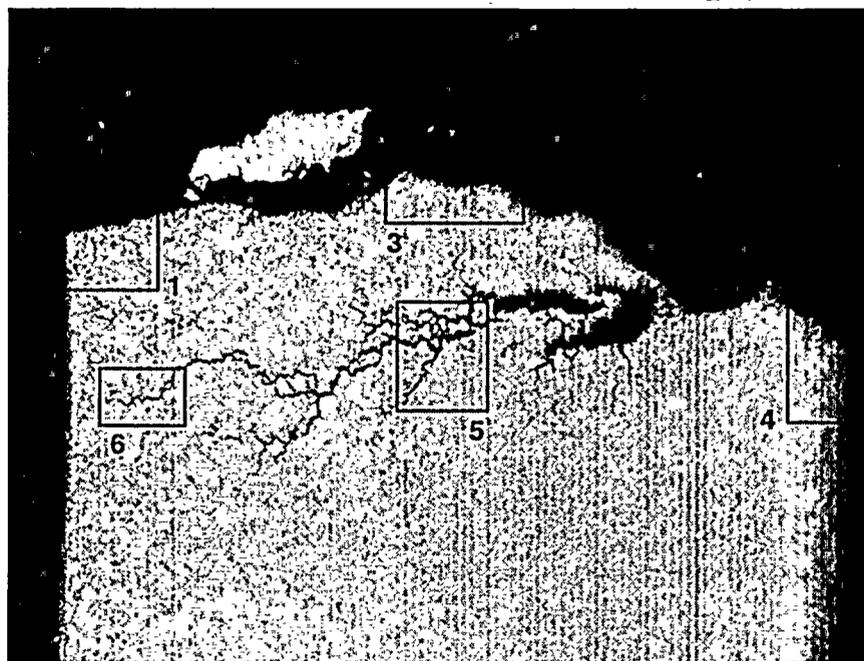
Figure 31. Etched view (20X) of 90 degree contact wedge latch section. Plane of polish is perpendicular to fracture face indicated in Figure 20. Note secondary branch cracking, and compare with view of 350 degree latch section of Figure 25.

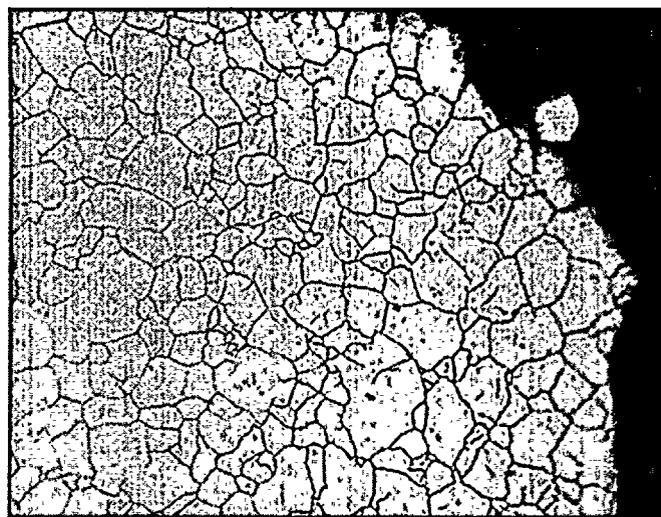
Figure 32 contains optical microscopic views of the latch failure. Photo a. is the region of the crack mouth (initiation). Photo b. is the mid-fracture region, and c. is the region of final separation. There was no transgranular ductile rupture associated with this latch fracture. Figure 33 shows secondary cracking characteristic of IGSCC. Figure 34 is a high (250X) view of the fracture in the region of the crack initiation. Note evidence of minor cold work, similar to that found on the 350 degree latch. Figure 35 is a high magnification (250X) view of the mid-fracture region of the 90 degree wedge latch, clearly showing the IGSCC nature. Figure 36 is a view of a portion of the secondary cracking near the mouth of the secondary crack, with significant oxide buildup. This buildup is characteristic of a crack surface exposed to the BWR environment for some time. By comparison, the 350 degree latch was a more "recent" failure.

a. REGION OF CRACK MOUTH
(INITIATION) 128 X

Figure 32. View of fracture by optical microscopy – 90 degree wedge latch. 128X

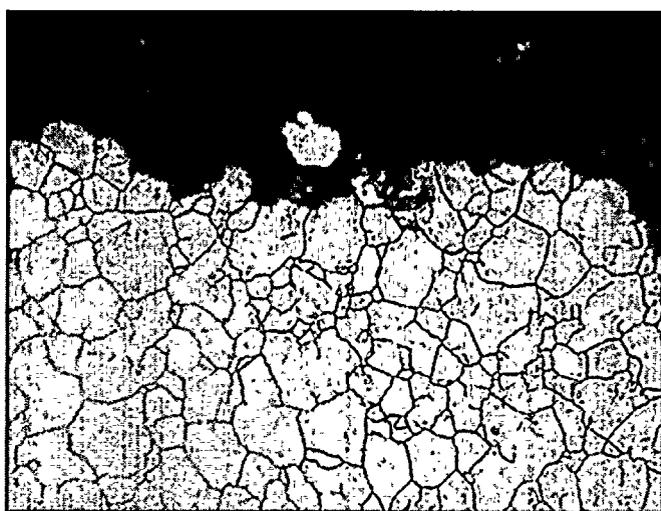
b. MID-FRACTURE REGION-
NOTE SECONDARY IGSC
CRACKS. 128 X

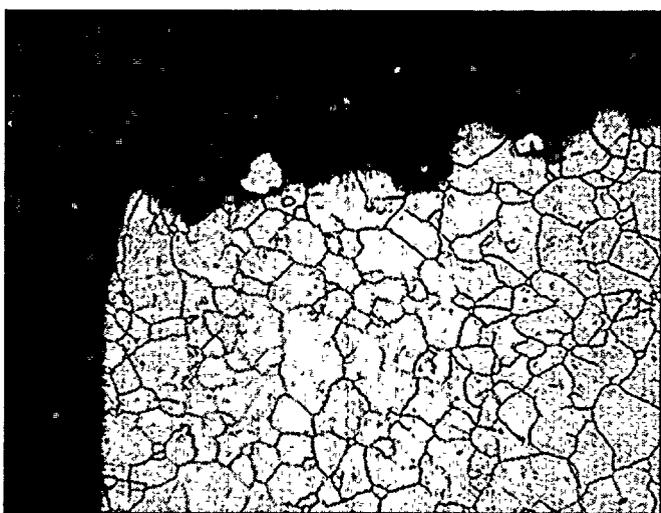
c. REGION OF FINAL SEPARATION-
IGSC, WITHOUT DUCTILE
RUPTURE. 128 X

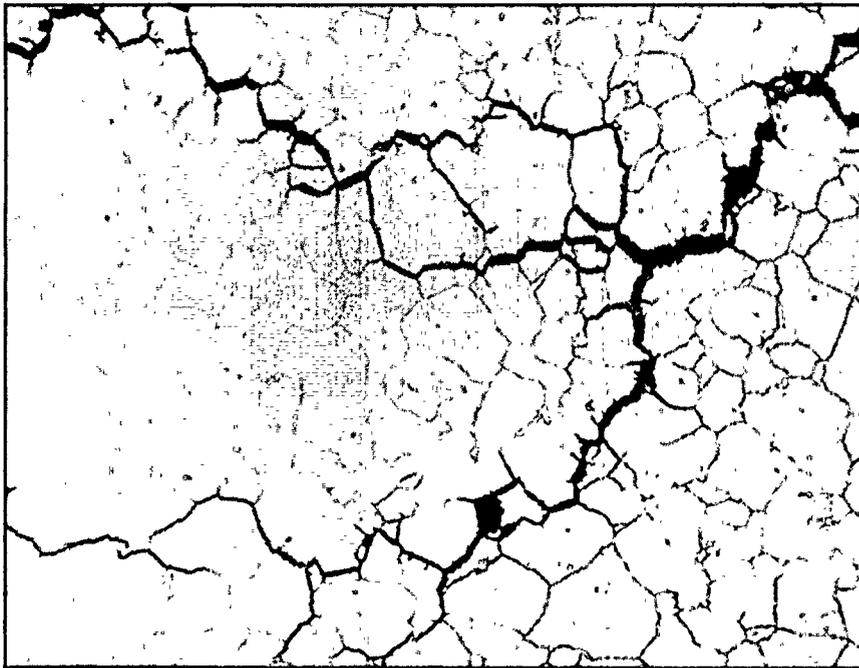
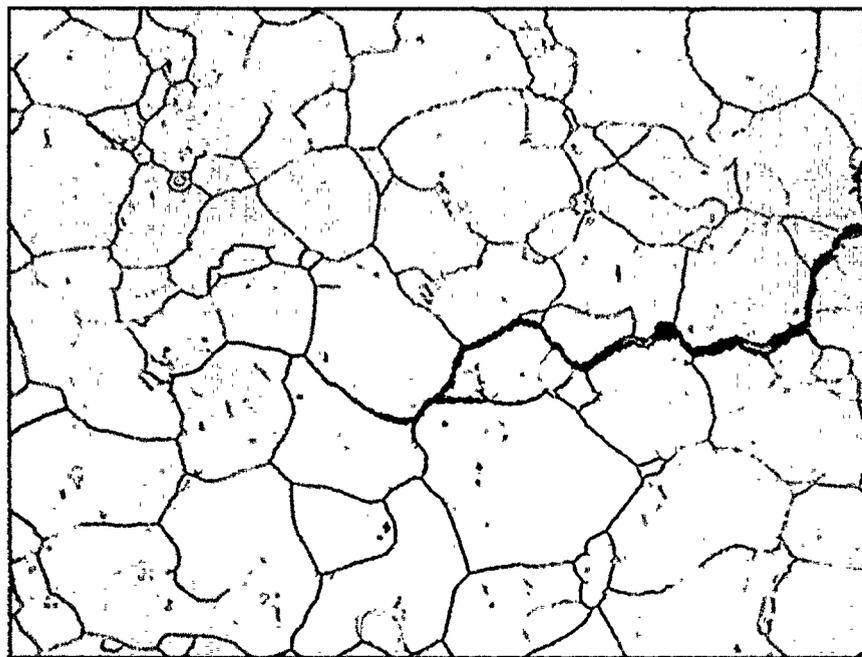
Figure 33. Secondary cracking in fracture of 90 degree contact wedge latch – IGSCC nature is same as that observed in 350 degree latch. Compare with Figure 27.

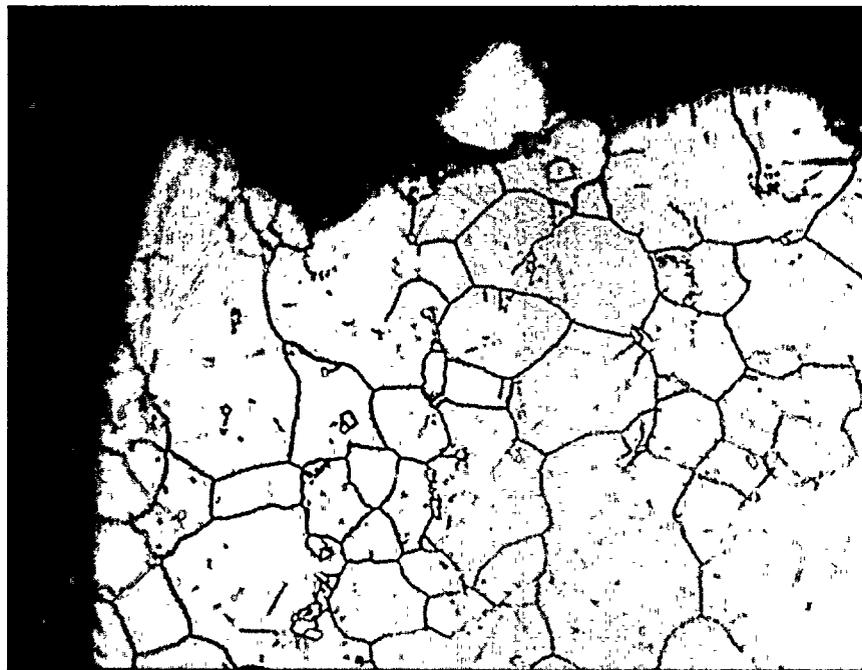
Figure 34. High magnification view (250X) of fracture in region of crack initiation of 90 degree wedge latch. Note evidence of minor cold work.

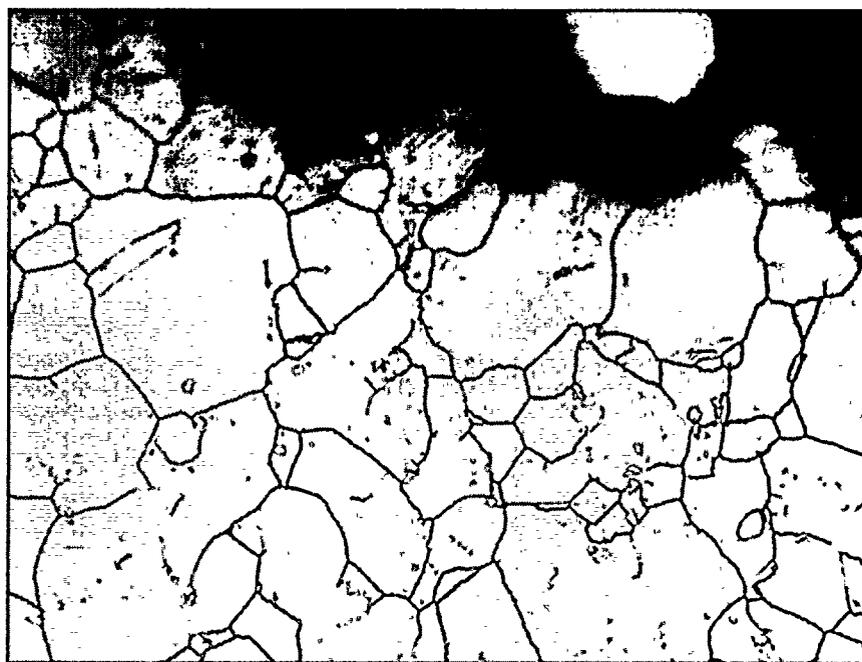
Figure 35. High magnification (250X) view of mid-fracture region, clearly showing IGSCC nature.

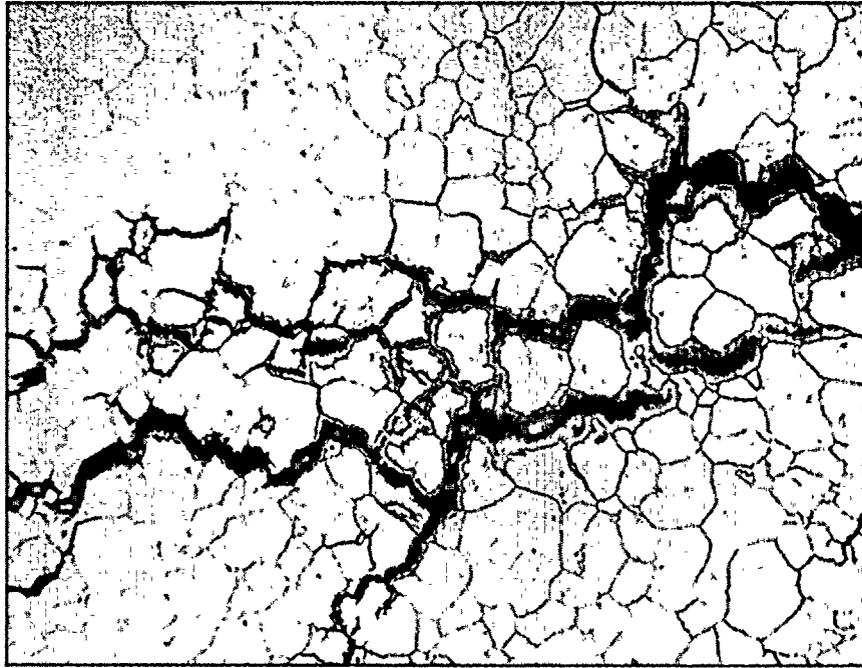
Figure 36. Secondary cracking in region 5 of Figure 31, with oxide buildup, characteristic of exposure to the BWR environment.

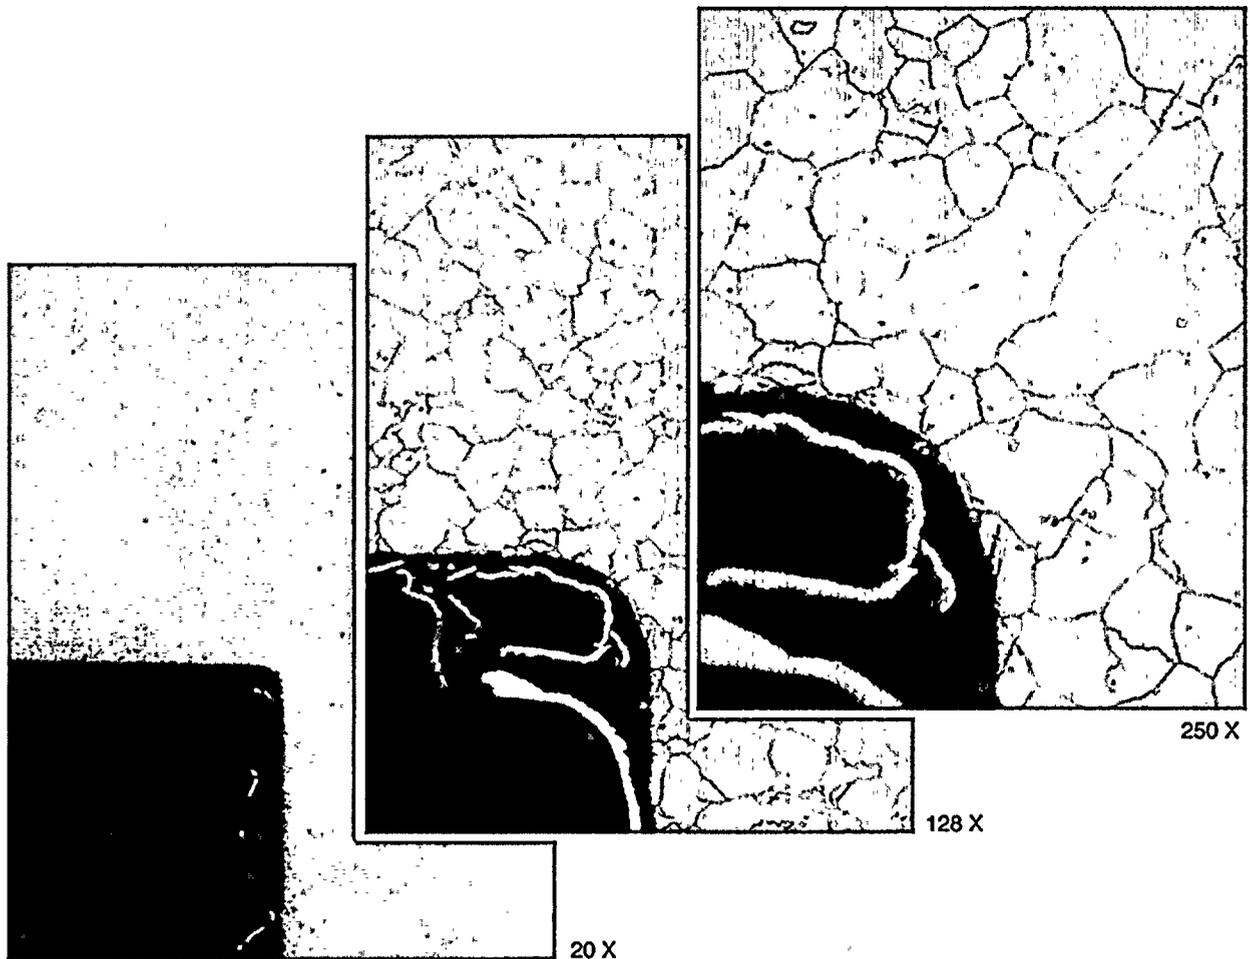
Figure 37 has cross-sectional views of the uncracked 166 degree wedge latch. Note the lack of incipient cracking or plastic deformation in the area of crack initiation on the 90 and 350 degree latches.

Figure 37. Cross-sectional views of uncracked 166 degree wedge latch. Note lack of incipient cracking or plastic deformation in area of crack initiation on the 90 degree and 350 degree latches.

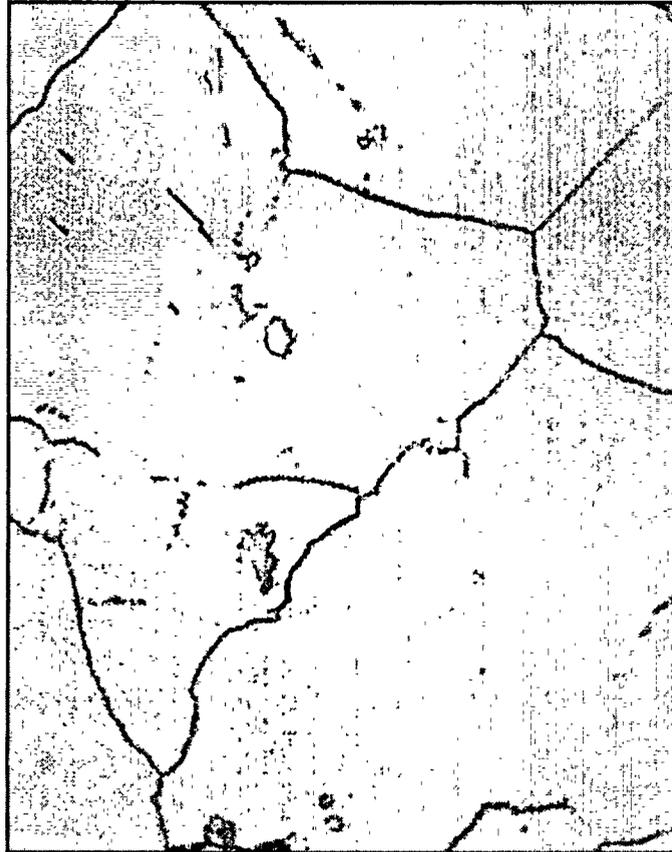
Figure 41. High magnification (1000X) view of 90° (broken) wedge latch microstructure. The structure is typical of a correctly heat treated X750 wedge latch material.

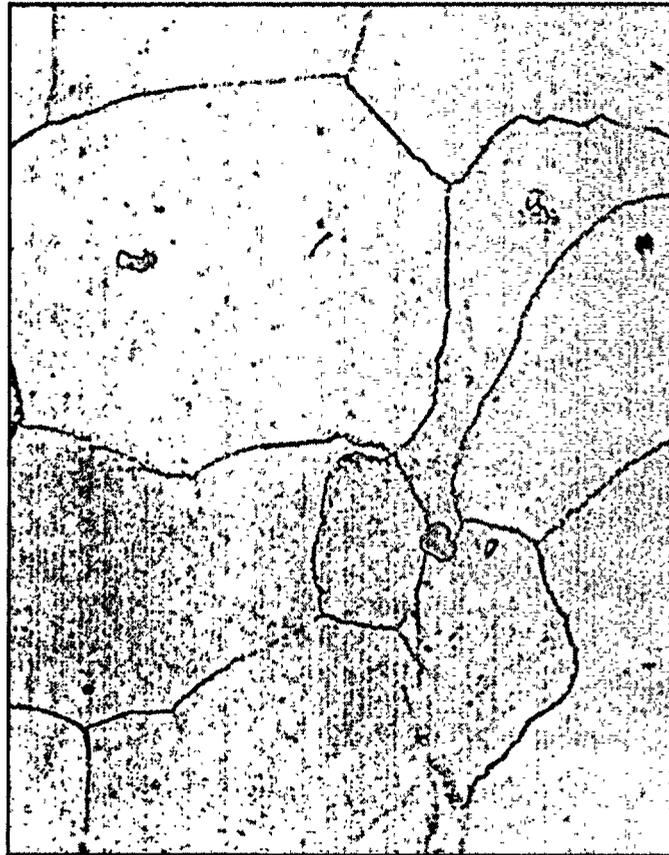
Figure 42. High magnification optical microscopic view of uncracked 166 degree wedge latch.
