U.S. NUCLEAR REGULATORY COMMISSION

Docket/Report Nos.: 50-220/97-12
50-410/97-12

Facility: Nine Mile Point, Units 1 and 2

Dates: November 9, 1997 - January 3, 1998

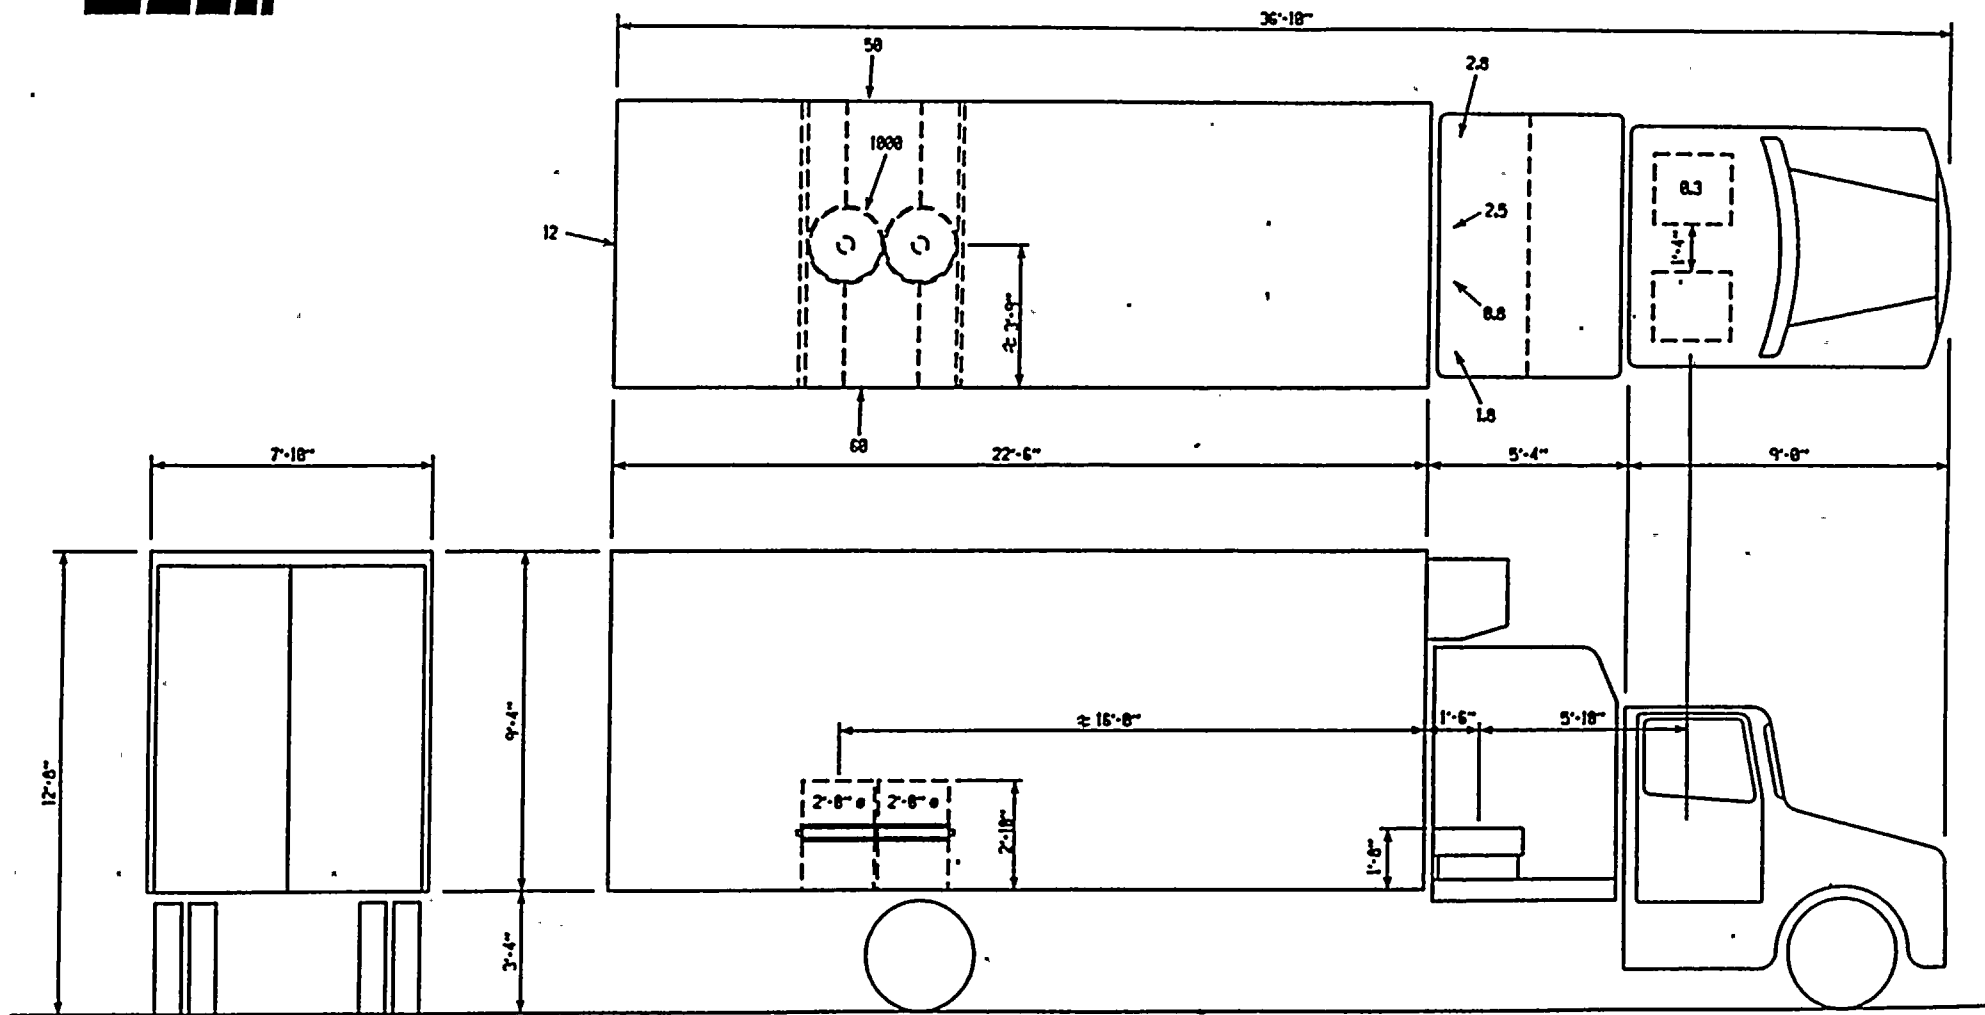
TRUCK SURVEY AT BWX
(mr/hr)

“On July 24, 1997, the licensee shipped two metal samples from the core shroud to BWX Technologies, Inc. Upon receipt, it was noted by BWX that radiation levels in an occupied portion of the vehicle were 2.8 milliRem per hour (mRem/hr), in excess of the regulatory limit of 2 mRem/hr, as specified in 49 CFR 173.441; this is an apparent violation.”

- Radiation Protection Manager review
- Tailboard meetings with technicians
- Radiation Protection continuing training
- Personnel counseling and disciplinary action
- Radiation survey procedures are being revised.
