CORE SHROUD BOAT SAMPLE
TESTING SUMMARY

*Interpretive Metallurgical Report on
Core Shroud Vertical Weld Boat Samples
from Nine Mile Point Unit 1*

**Technical Report No. 97181-TR-02
Revision 0
Volume 1 of 1**

Niagara Mohawk Power Corporation
Nine Mile Point Unit 1

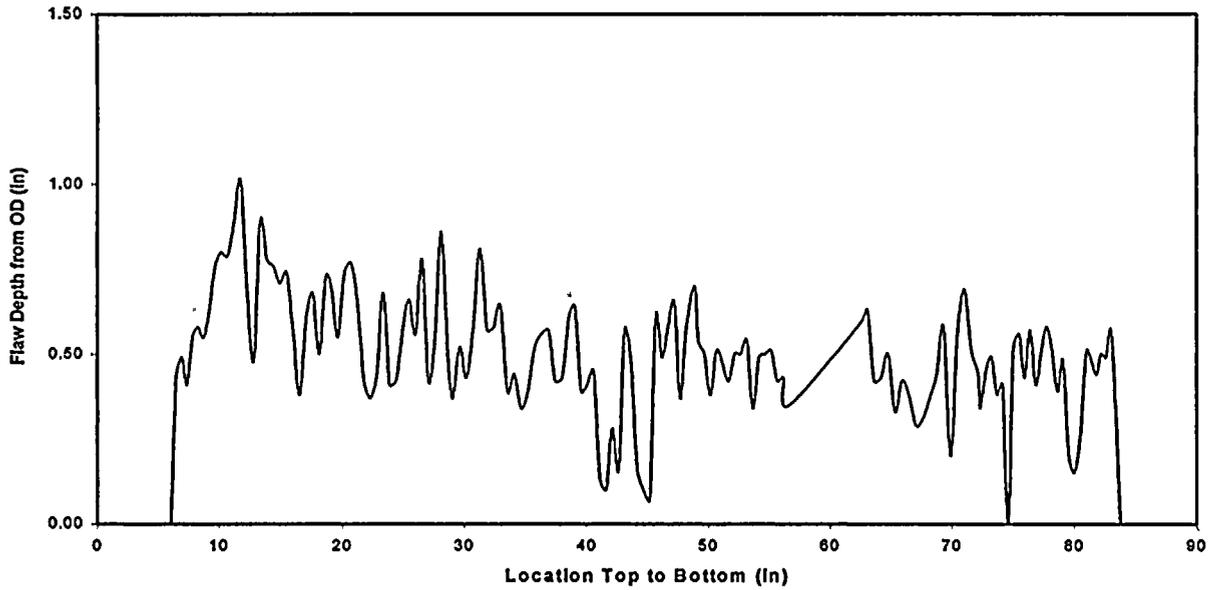
Figure 1 - Crack depth profile for right side of vertical weld V-10

The cracks on the right side of weld V-10 (viewed with the shroud oriented vertically) are reasonably represented by a single continuous crack indication running parallel to the weld. The cracks are essentially bounded within a volume of material adjacent to the weld fusion interface known as the weld heat affected zone (HAZ). Cracking is restricted to the outer surface at this weld. Crack depths typically were measured from 0.4 to 0.7 inches, although several specific locations along the length of this weld were deeper. Figure 1 presents a profile of the depths of cracking along the length of the V-10 weld. In general the cracking was slightly deeper towards the top and shallower towards the bottom. Actual data are discrete measurements plotted as if they were continuous. No cracking was seen immediately adjacent to the horizontal welds bounding the top and bottom of the shell course. Eight short crack segments (parallel to the weld) were seen on the outer surface to the left side of weld V-10 as shown in Figure 2.

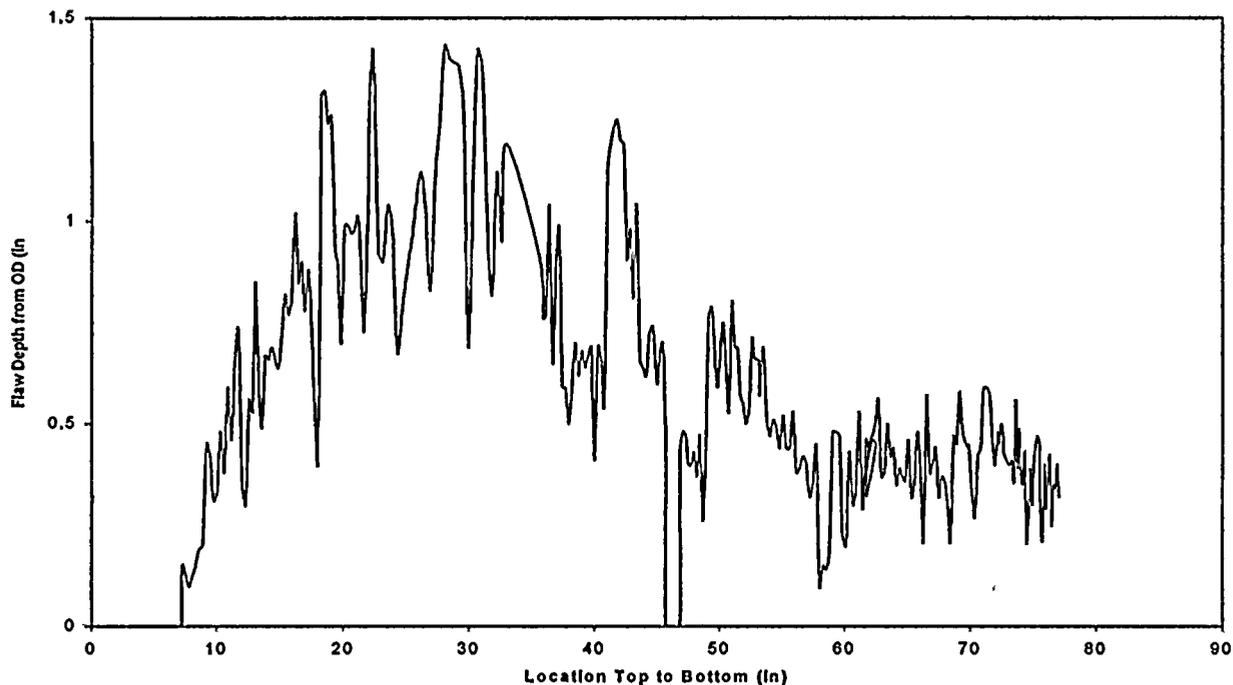
Figure 3 - Crack depth profile for left side of vertical weld V-9

Cracking patterns are similar on the outer surface of weld V-9 except that cracking was predominantly on the left side of the weld. Figure 3 presents the depth profile of cracking measured along the length of weld V-9. The maximum depth of cracking associated with the left outer surface of weld V-9 is greater than the maximum depth of cracking associated with weld V-10. It should be noted that the left side of V-9 and the right side of V-10 are the same plate of material. [Note: There were two short crack segments on the right side originating at the inner surface, and these were the only inner surface cracks associated with either of the vertical welds, V-9 and V-10.]

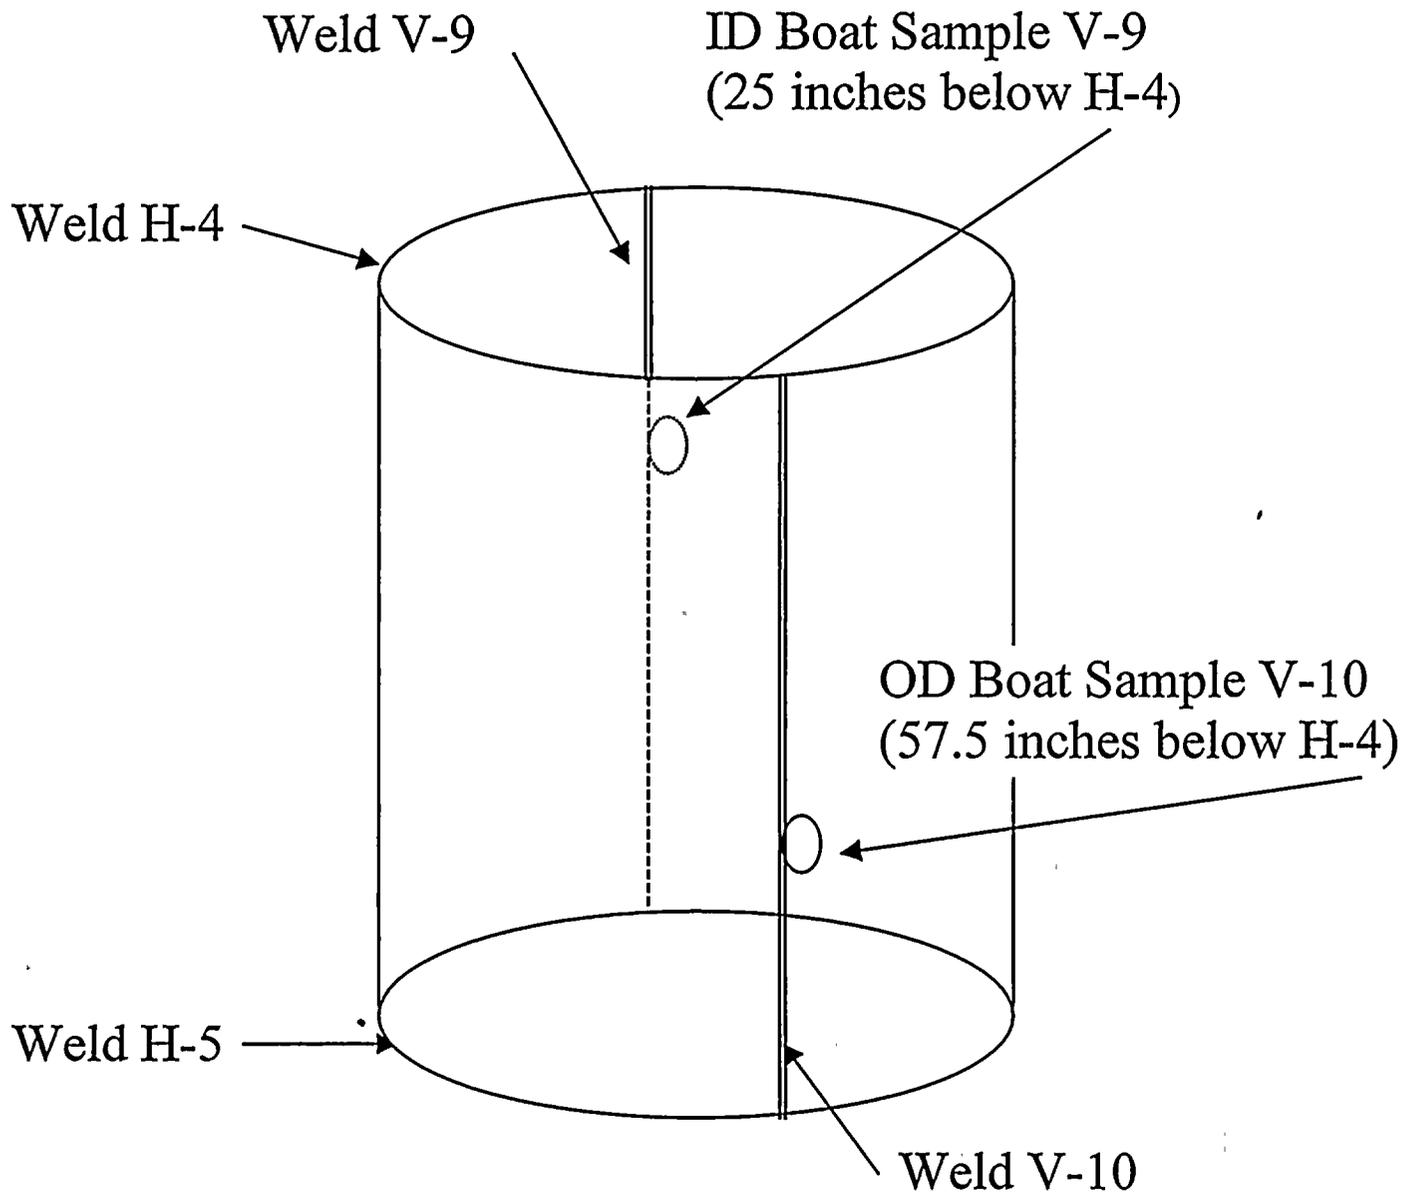
Figure 4 - Sketch of the locations for boat samples V-9 & V-10

The metallurgical evaluation examined two boat samples taken from the welds designated as V-9 and V-10 that join the plates forming the central-mid-cylinder shell course. This cylinder is located approximately at the core mid-plane. Boat sample V-10 was removed from the outer surface and was positioned such that it contained a sample of the crack having a depth that could be captured within the volume of the boat sample. The EDM sampling cutter was positioned on the outer surface such that the edge of the weld would be located to the left side of the boat sample, and should contain the edge of the weld deposit. The vertical location was approximately 57.5 inches below the upper horizontal weld, H-4. Sample V-10 was used primarily to document representative metallurgical features associated with cracking of the vertical welds. Boat sample V-9 was not cracked, and was removed from the inner surface of the shroud. It was located to the right of weld V-9 at an elevation approximately 25 inches below the upper horizontal weld, H-4. This latter sample represented a high fluence location and was used to determine if the accumulated fluence resulted in measurable materials effects such as degree of sensitization or radiation hardening. The sampling device was positioned in a manner similar to V-10 so that the edge of the weld could be captured. Figure 4 is a sketch that shows the locations from which the boat samples were removed.

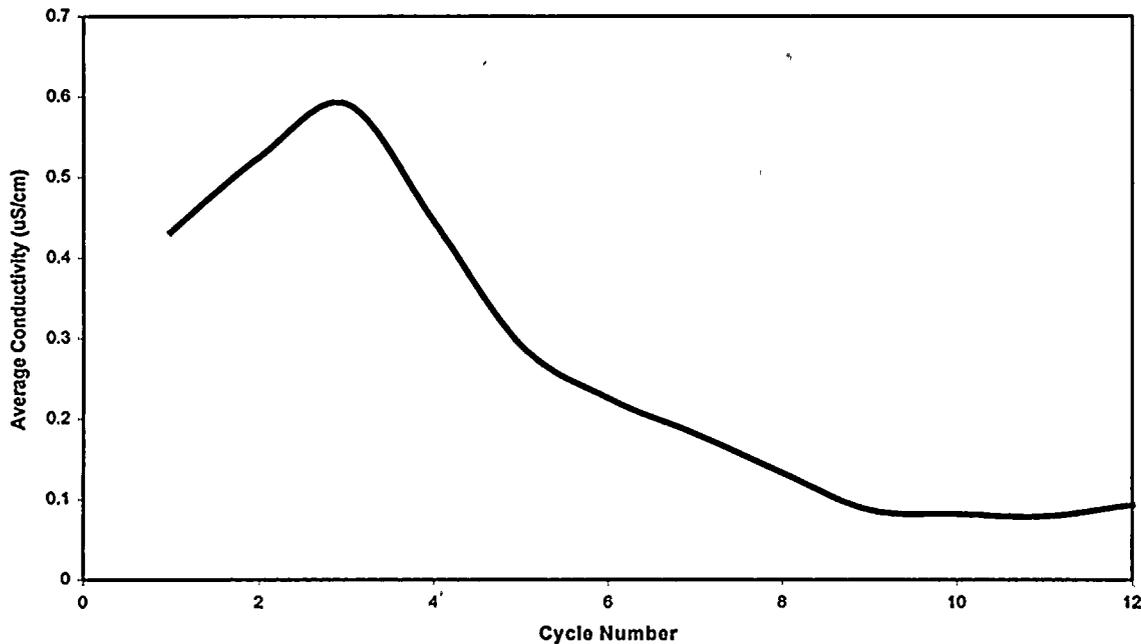
Figure 5 - Average conductivity for the first 12 cycles at NMP-1

The observed characteristics are consistent with the NMP1 operating history in that during the initial 5 fuel cycles the operating conductivity was typically above 0.3 $\mu\text{S}/\text{cm}$. Figure 5 describes the average conductivity for the plant operating history. Figure 6 plots the average chloride content for the operating history. It can be seen that chloride was a major source of increased conductivity in the early years. Both average conductivity and anion content have been tightly controlled in recent years (cycle 9 to the present time) to levels consistent with the recommendations of the BWROG/EPRI Water Chemistry Guidelines, Reference 6. The pattern of significantly improved water chemistry is typical of other BWRs and signals a significantly reduced tendency for corrosion to be supported. In other words, the susceptibility to corrosion would have been much greater in the early years than it is today. Likewise crack growth rates in the recent times will be slower due to the excellent water chemistry.
