SUBJECT: Responds to comments to UCS re util request to extend core
shroud inspection interval for NMPNS Unit 1.

Subject: *Response to Comments by the Union of Concerned Scientists Regarding the Request by Niagara Mohawk Power Corporation to Extend Core Shroud Inspection Interval for Nine Mile Point Unit 1*

ATTACHMENT 1
RESPONSE TO UNION OF CONCERNED SCIENTISTS QUESTION RELATIVE TO
NIAGARA MOHAWK POWER CORPORATION'S REQUEST TO EXTEND THE
NINE MILE POINT UNIT 1 CORE SHROUD INSPECTION INTERVAL

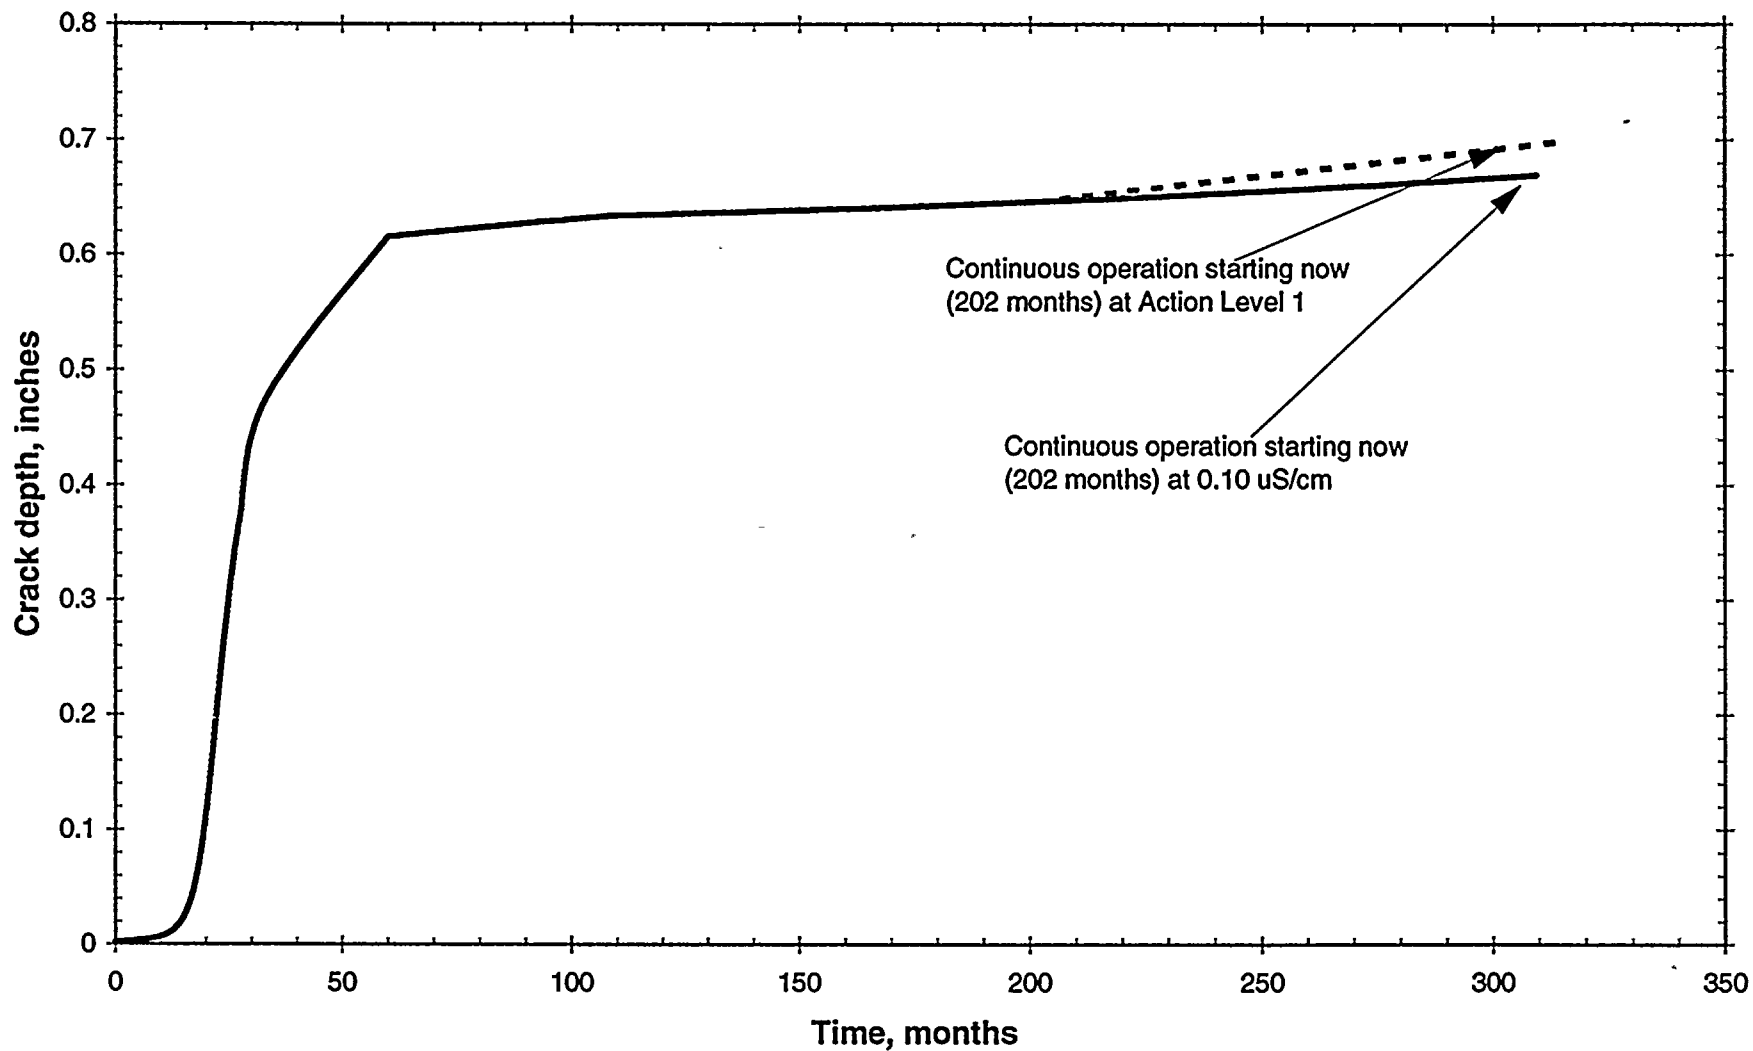
NMPC has concluded that the appropriate EPR estimates were applied in the GE PLEDGE analysis since the EPR estimates were based upon cross-calibration of the McDermott Laboratories measurement techniques, and independent metallurgic assessment based upon GE expertise.

Subsequently, on June 8, 1998, the NRC has issued a Safety Evaluation Report approving the Boiling Water Reactor Vessel Internals Project (BWRVIP) Report Number BWRVIP-14, which addresses crack growth rate for 304SS material in the BWR environment. It should be noted that the BWRVIP-14 equation for crack growth rate does not include a term for degree of sensitization. The BWRVIP-14 crack growth rate of $2.2E^{-5}$ in/hr applies to core shroud 304SS independent of the degree of sensitization (i.e., EPR).

**Figure 3: Crack Depth vs. Time: NMP-1 Shroud Vertical Weld Cracks
(Parameters Selected for Consistency with Current Depth of Cracking)**
