SUBJECT: Forwards core shroud & shroud support repair assemblies
 reinspection plan for RFO15, including insp methods to be
 used & provisions for sample expansion, re GL 94-03,
 "Intergranular Stress Corrosion Cracking of Core...."

Subject: *Generic Letter 94-03, "Intergranular Stress Corrosion Cracking of Core Shrouds in Boiling Water Reactors"*

NINE MILE POINT NUCLEAR STATION UNIT 1 CORE SHROUD, CORE SHROUD REPAIR ASSEMBLIES & CORE SHROUD SUPPORT WELDS AUGMENTED INSERVICE INSPECTION (ISI)

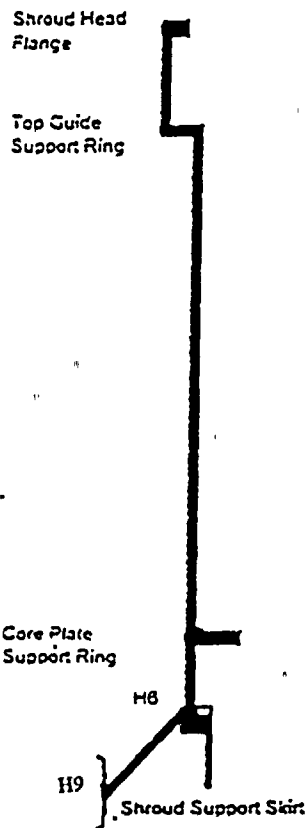
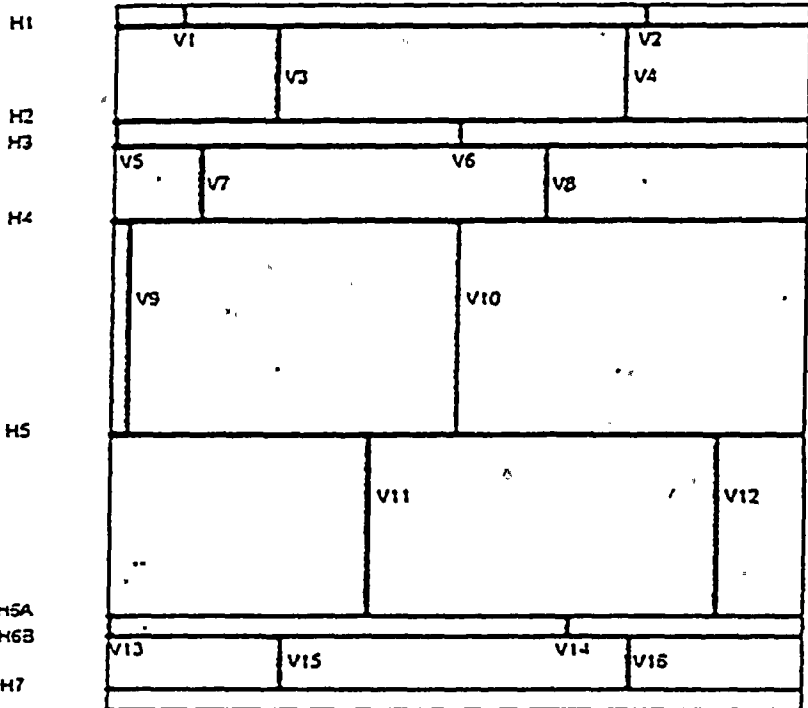
Figure 1. Nine Mile Point Unit 1 Shroud Configuration

A 100% inspection of all accessible portions of all of the shroud vertical welds will be performed by ultrasonic testing (UT) methods or a combination of UT and enhanced visual techniques (EVT-1). The vertical welds are designated as V3, V4, V7, V8, V9, V10, V11, V12, V15, and V16 as shown in Figure 1 (attached). The planned coverage is expected to duplicate and/or exceed that coverage obtained during Refueling Outage No. 14 (RFO14).

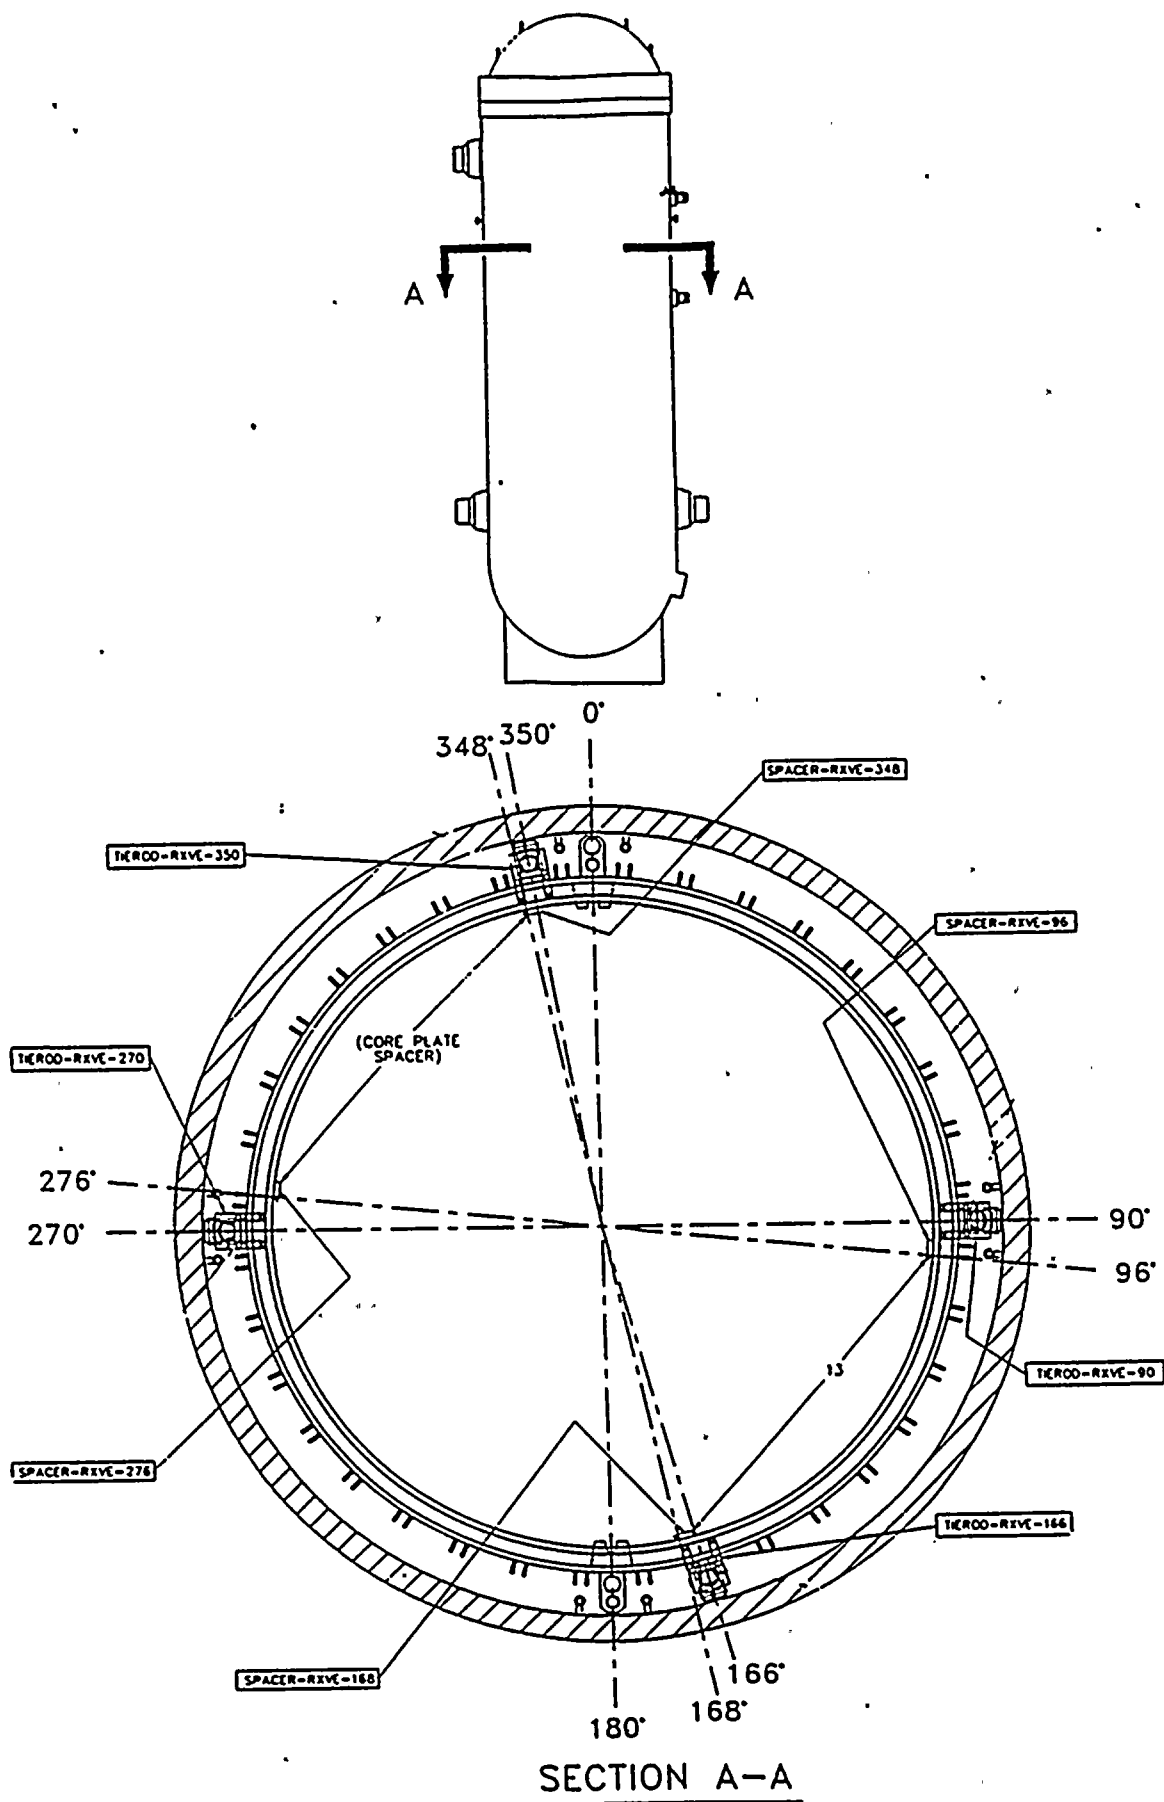
Figure 2: Tie Rod & Core Plate Spacer Locations

The tie rod inspections will include a combination of VT-3, EVT-1 and tie rod nut torquing to confirm the structural integrity and tightness of the assemblies. Figures 2, 2a, and 2b (attached) provide an illustration of the tie rod assemblies. Prior to performing the VT-3 and EVT-1 inspections and the torque procedure described below, a visual inspection of both sides of each of the four entire tie rod assemblies will be performed and recorded. This inspection is intended to be an overall visual scan from a distance back far enough from the tie rods to look for any obvious anomalies and to confirm proper arrangement of the assemblies.

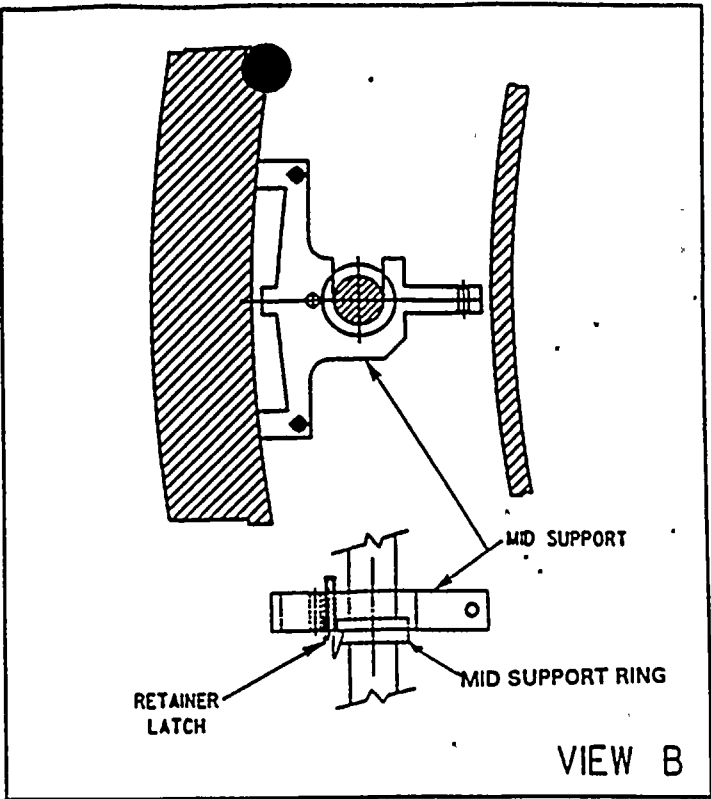
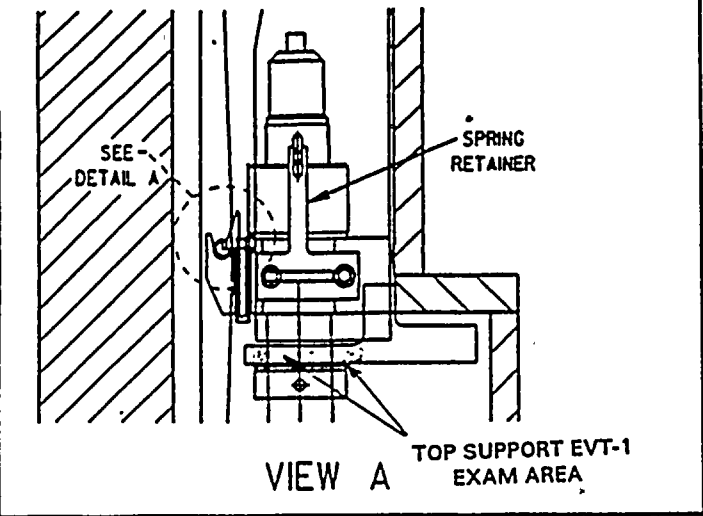
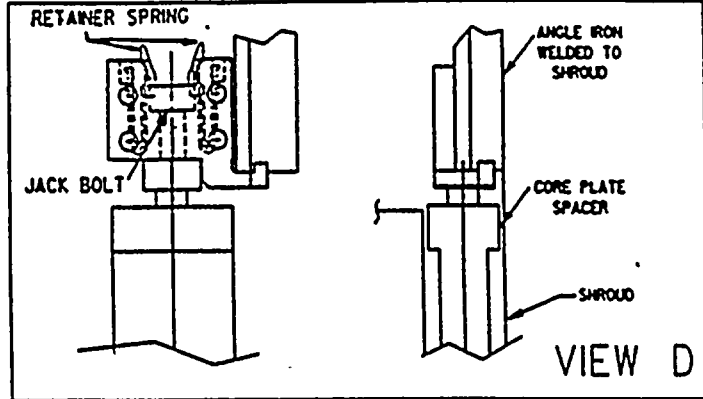
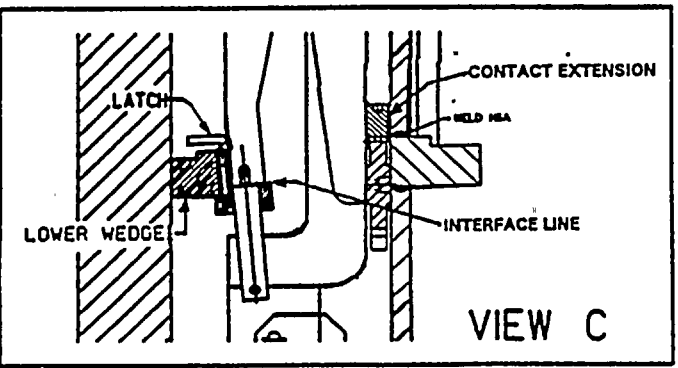
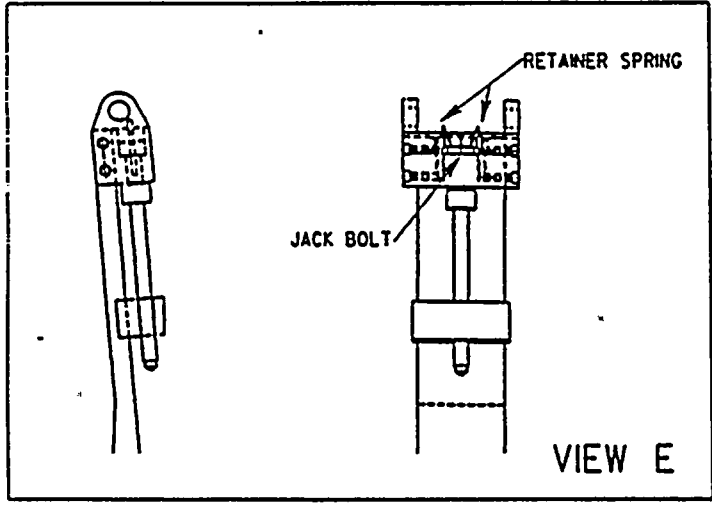
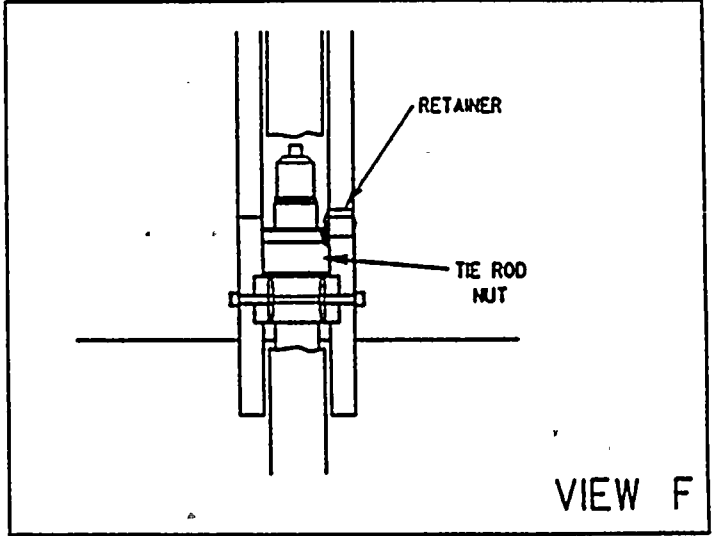
FIGURE 2b

- Verify the core plate spacer assemblies located inside the shroud remain in position as installed.
- Verify all retainer devices have remained in position.
