SUBJECT: Part 21 rept re potential mfg problem with certain pumps & amplifiers used in ASCO general controls hydramotor actuators. Review of pin/clevis dimension showed that class of fit between two parts could be either slip-fit.

**SUBJECT: Potential Manufacturing Problem With Certain Pumps and Amplifiers
Used in ASCO General Controls Hydramotor® Actuators.**

**POTENTIAL MANUFACTURING PROBLEMS WITH CERTAIN PUMPS AND
AMPLIFIERS USED IN ASCO GENERAL CONTROLS
HYDRAMOTOR® ACTUATORS**

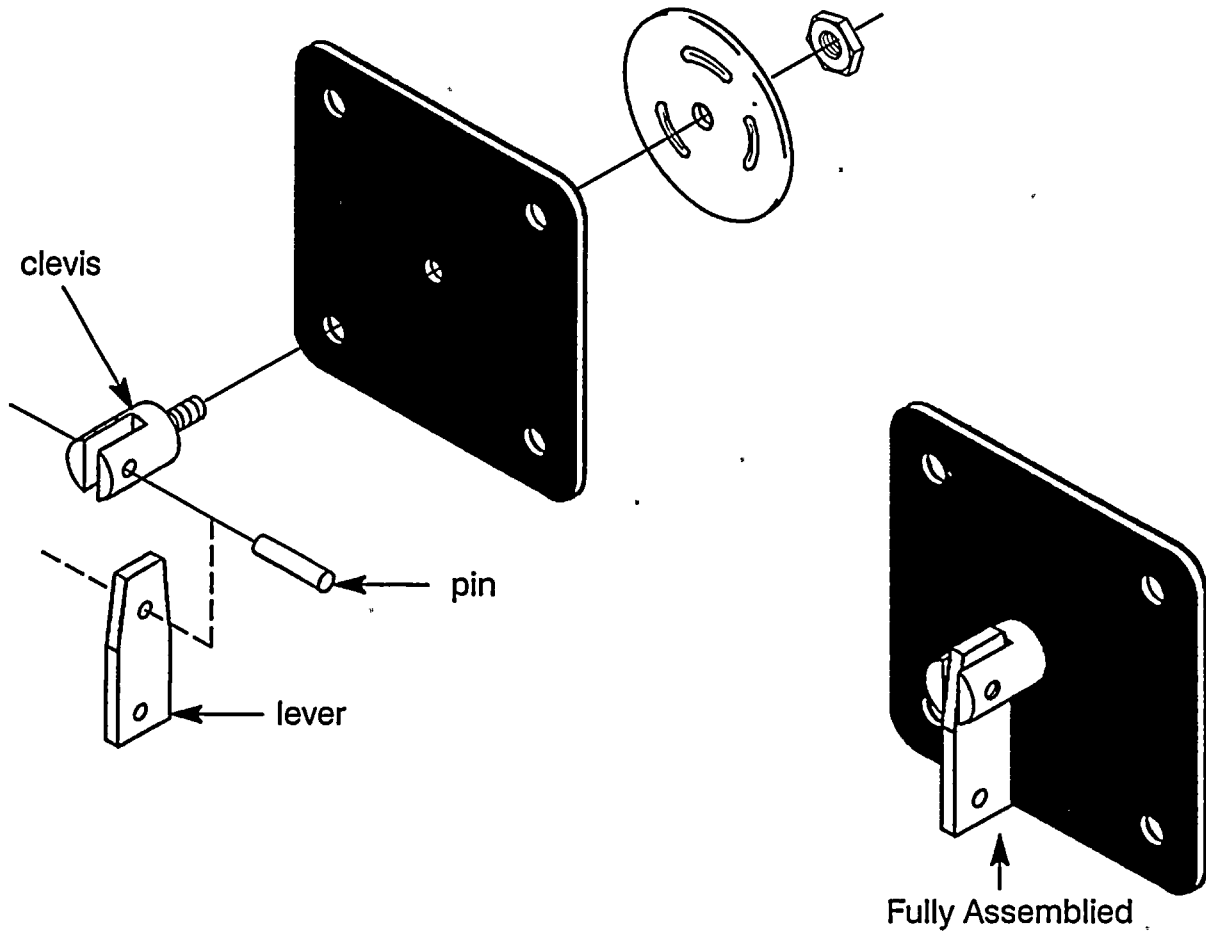
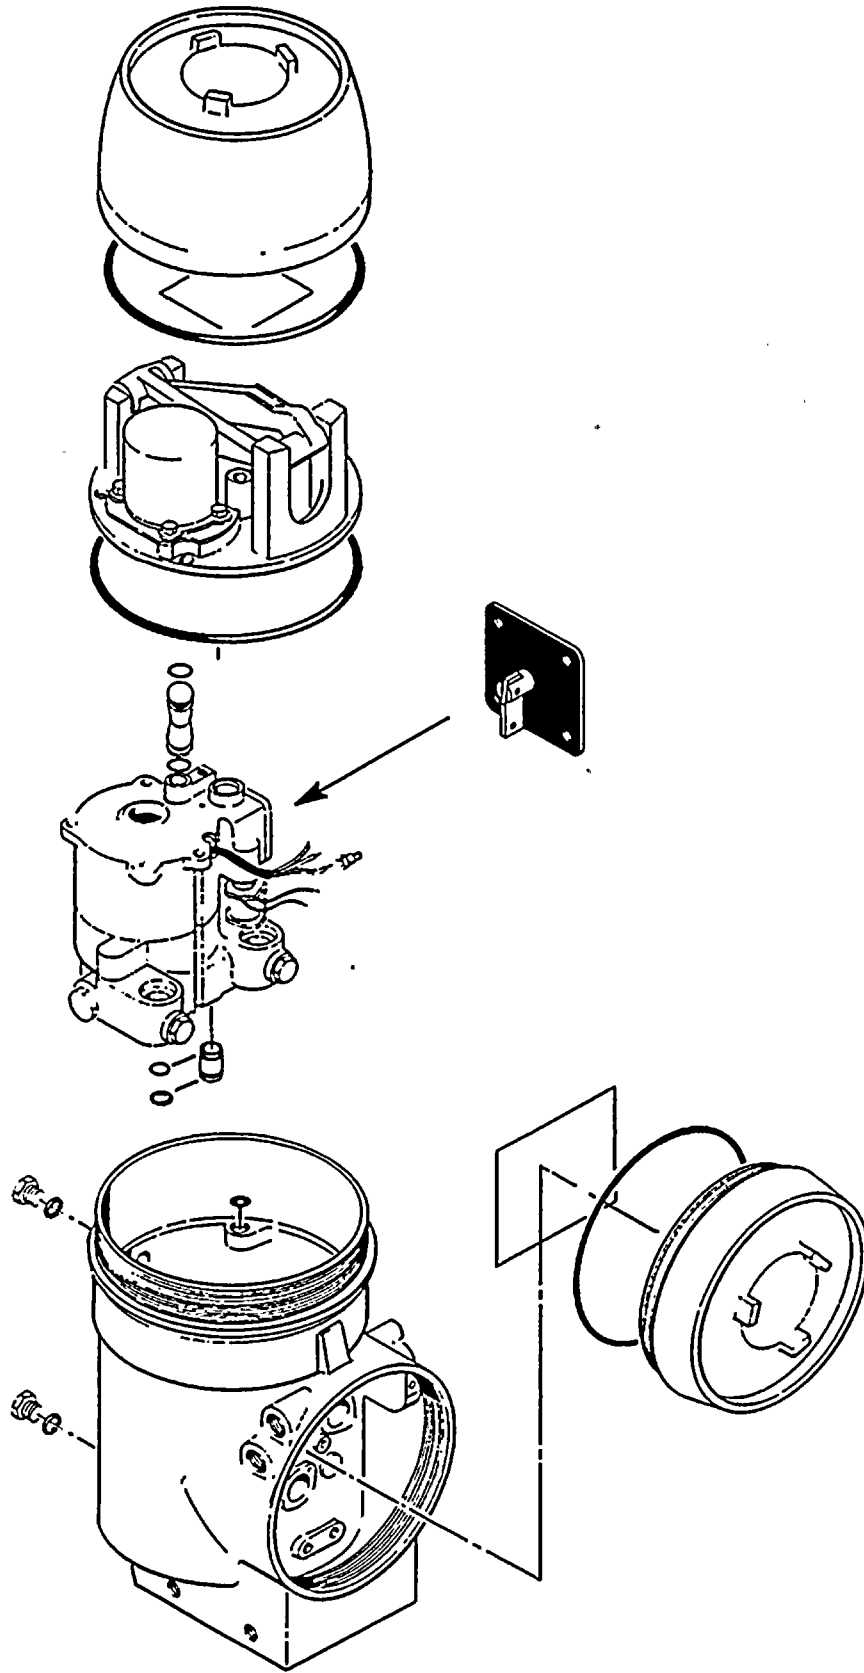
Diaphragm Assembly

pins to prevent their movement. We believe that this procedure, although not documented in any assembly procedure, was followed regularly by assembly personnel. We base this belief not only on a thorough review with assemblers of assembly methods, but on the fact that this failure occurred during post installation testing. This is the only incidence of this nature reported in almost 3 years of ASCO's production of this product, and inspection of ASCO's stock of finished pump assemblies showed all pins were staked.

The potential failure described above may result in the actuator not maintaining the piston in the retracted position although the pump is running. We believe that in most, if not all, cases the return of the piston to the extended position is considered the fail safe condition for the Hydramotor® actuator. As such, the described failure of the pin/clevis assembly would result in the unit moving to the fail safe condition. Depending on the nature of the application, the utility should determine what the fail safe mode of the Hydramotor® is.

Analysis of the returned unit confirmed that the actuator was not maintaining the piston in the retracted position although the pump was running. Further analysis revealed that the diaphragm assembly located in the amplifier of the pump unit had disengaged from the lever. The diaphragm was no longer acting on the lever, allowing pressure to build up inside the amplifier assembly and ultimately ruptured the diaphragm. Inspection of the clevis/lever assembly revealed that the pin holding the clevis and lever together had become dislodged. Refer to enclosed illustration.

A review of the pin/clevis dimension showed that the class of fit between the two parts could be either a slip-fit or press-fit, depending on the tolerance of the parts.

Interviews with assembly people involved with assembling the pump units revealed that the pins typically slip into place. In order to secure the pins, they have been instructed to stake the pins by use of a center punch, thus deforming the end of the

ASCO will notify all purchasers of affected product of the potential problem. If the affected product is not in service, ASCO will offer to rework it at our factory at no charge. If the product is in service ASCO will work out with the utility the appropriate inspection and corrective action, if necessary. ASCO has revised its written assembly procedure to specify that the pin holding the clevis and lever together be staked, and provided training to ensure proper and effective assembly of the clevis/lever assembly.
