UNITED STATES  
NUCLEAR REGULATORY COMMISSION  
WASHINGTON, D.C. 20555-0001

SAFETY EVALUATION BY THE OFFICE OF NUCLEAR REACTOR REGULATION  
RELATED TO ALTERNATIVE REPAIR OF THE CORE SHROUD VERTICAL WELDS  
NINE MILE POINT NUCLEAR STATION, UNIT NO. 1

DOCKET NO. 50-220

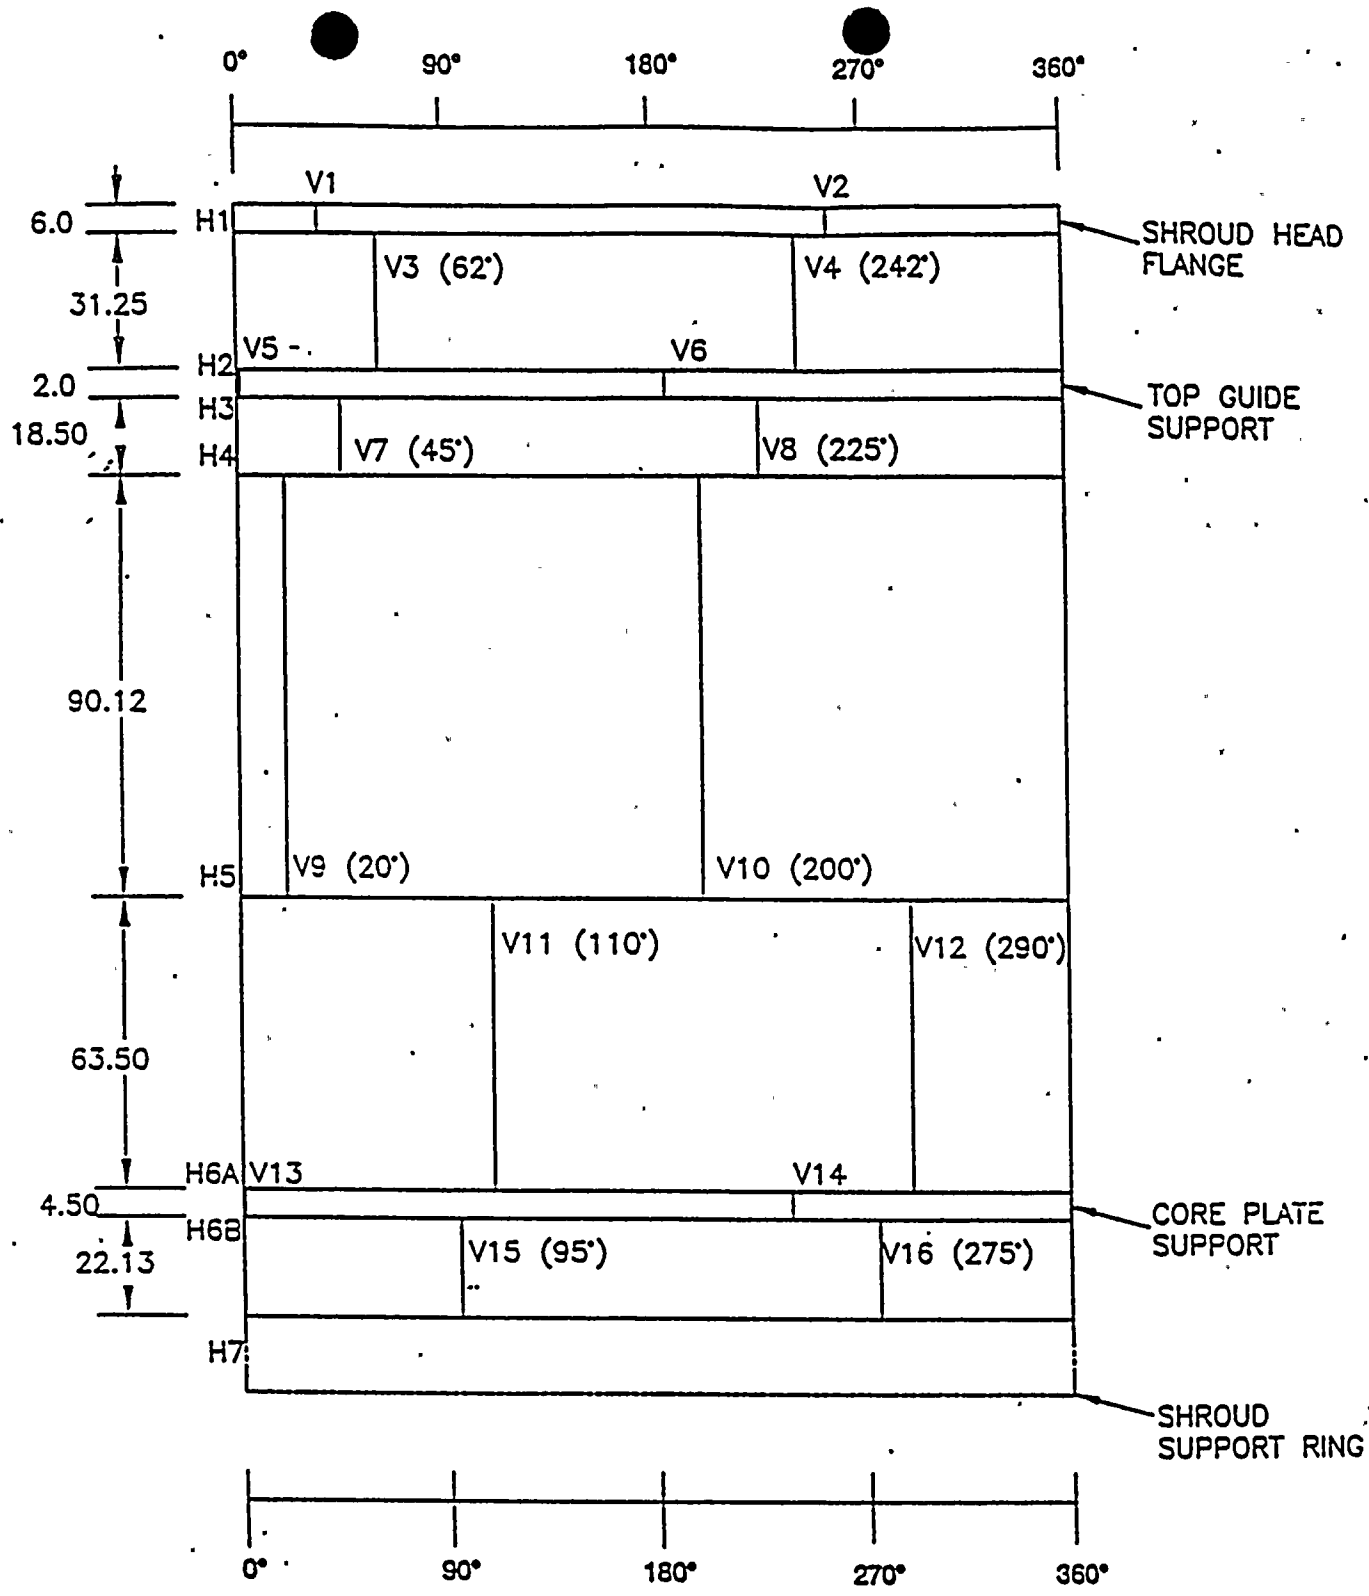
Figure 1-1. Nine Mile Point - Unit 1  
NMP-1 Core Shroud Welds

The repair clamp design and installation drawings are provided in NMPC's application. Some of these drawings are extracted and attached to this SE. Attached Figure 1-1 shows the locations of the NMP1 core shroud welds. The NMP1 repair plan addresses vertical welds V4, V9, and V10, and the repair clamps can be installed on each weld independently; i.e., depending upon shroud inspection results, any one, two, or three welds may be repaired with these repair clamps. Attached Figure 1-3 shows the vertical weld clamp assembly installed across vertical weld V4. Attached Figure 1-4 is an exploded view of the vertical weld clamp assembly before installation across vertical weld V9 or V10.
