From: Anchondo, Isaac
To: [Collins, Jay](#)
Cc: [Werner, Greg](#); [Proulx, David](#); [Kopriva, Ron](#); [Alley, David](#)
Subject: Leak Location
Date: Thursday, October 13, 2016 1:39:00 PM
Attachments: [leak location.pdf](#)

4. Reason for Request

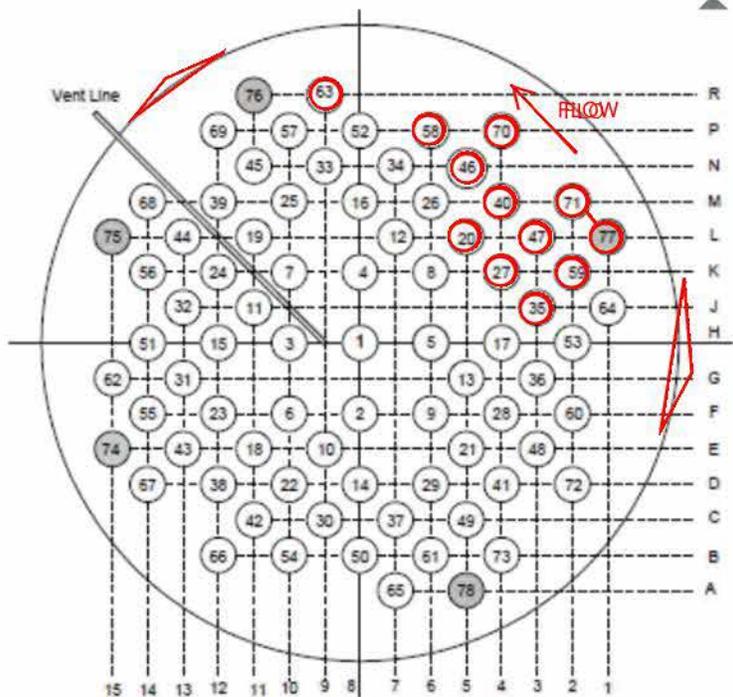
Based on visual examination (VE), deposits resulting from leakage in the canopy seal weld on penetration 77 are on the Reactor Vessel Closure Head. These deposits are dispersed on the reactor head in such a way that it is evident they resulted from the spray pattern, or spray deflection, from the canopy seal weld leak. Other observations noted were: 1) the condition of the head which only had surface rust present rather than wastage; 2) the color and location of these deposits were consistent with spray following the crud burst that was then oxidized by exposure to the atmosphere; 3) there was a layer of white boric acid on top of the deposits in a similar pattern indicating that clean borated water had followed the same path; and 4) no penetrations other than those in the path of the spray/deflection show any abnormal indications.

With this evidence indicating the condition resulted from the canopy seal weld leak above the head the deposits still obscure the head and prevent the required VE from being performed on the affected penetrations. WCNOG will perform supplemental examinations of the affected penetrations.

Twelve penetrations require supplemental examination in accordance with code requirements. Per paragraph -3200(b) of N-729-1 these supplemental examinations "...shall include volumetric examination of the nozzle tube and surface examination of the partial-penetration weld,...".

WCNOG does not have the internal resources to conduct the volumetric and surface examinations as required by Code Case N-729-1 – 3200(b). A third party vendor has been contracted to perform the examinations. The options for the surface examination of the
