Subject: Duke Energy Carolinas, LLC (Duke Energy)
McGuire Nuclear Station, Unit 2
Docket No. 50-370
Relief Request 17-MN-001
Alternative for Repair of Class 1 Piping

**Duke Energy Carolinas, LLC
McGuire Nuclear Station, Unit 2
Relief Request Serial #17-MN-001**

**Relief Requested in Accordance with 10 CFR 50.55a(z)(2) for Weld Overlay Repair of
Class 1 Piping**

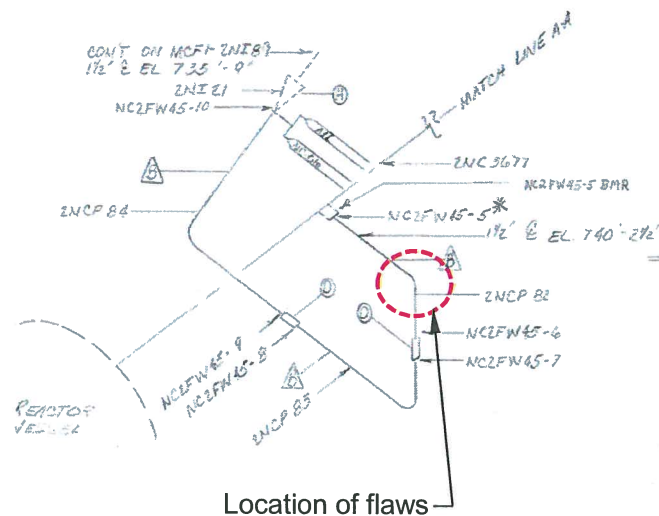
ASME Class 1 Piping, NPS 1-1/2 Schedule 160 5D bend (in piping subassembly 2NCP82) in the Boron Injection Line to 2D Reactor Coolant System Cold Leg.

The specific location of the piping subassembly is shown in the following excerpt from drawing MCFI-2NC45:

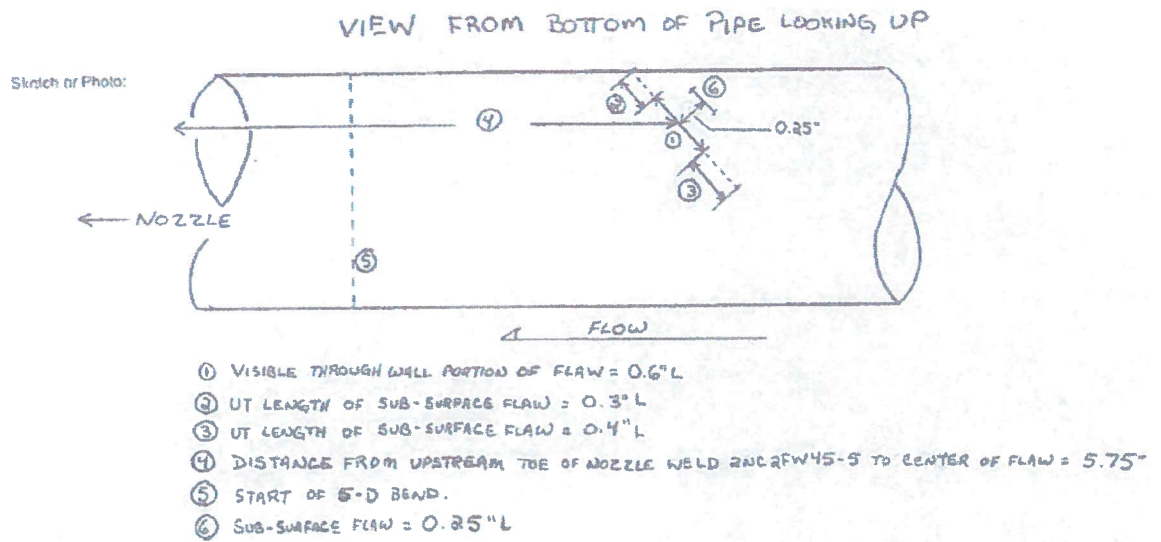
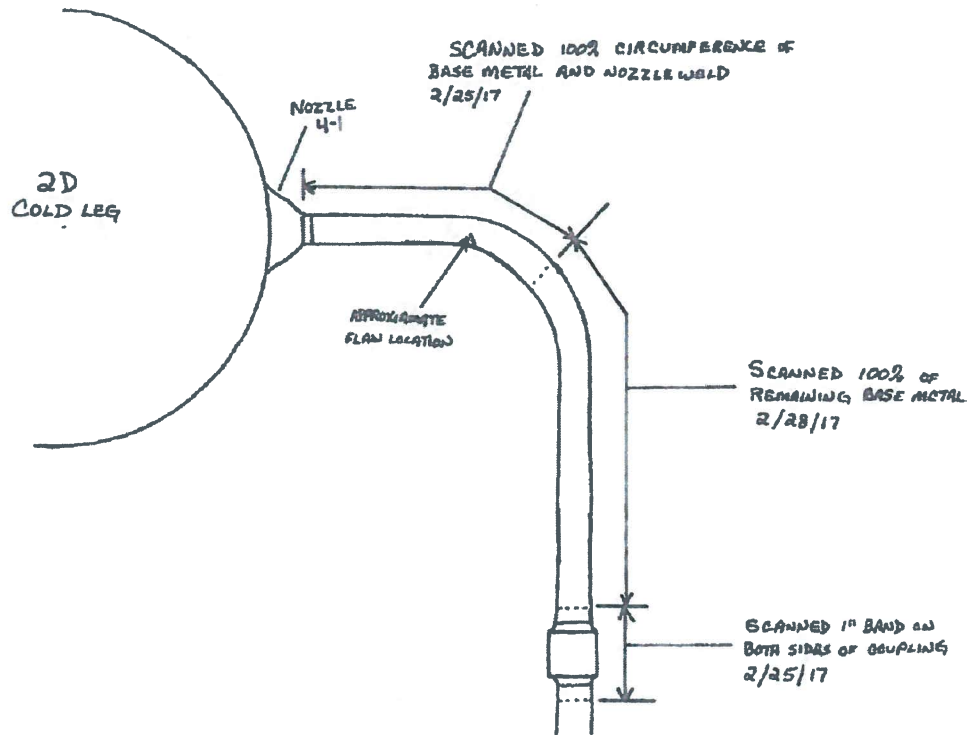
Elevation View

- 4.1 An unisolable pressure boundary leak in the boron injection line to 2D Reactor Coolant System Cold Leg was detected during plant operation on February 23, 2017, requiring a unit shutdown to perform a repair/replacement activity. The flawed area of piping is located approximately 5.75" from the pipe to nozzle weld 2NC2FW45-5, on the intrados of the 5D elbow bend. The flaw was located approximately 45 degrees between the bottom and side of the piping circumference at a skew of approximately 45 degrees to the piping axis. Reference Attachment 1 for information on the location and orientation of the identified flaws.

The flaw was observed to be open to the surface for a dimension of approximately 0.6" of length. The flaw was ultrasonically length sized with a combined surface and subsurface length of approximately 1.3". The flaw was further characterized as an off-axis axial flaw. Adjacent to the surface breaking flaw, two additional low amplitude indications were observed at approximately 0.1" to 0.15" below the leaking flaw and another indication of significant amplitude was observed, approximately 0.25" above the leaking flaw, with a length of approximately 0.25". A total of 4 off-axis flaws were observed.

Nondestructive Examination Data for the NPS 1-1/2 Schedule 160 5D Bend in the Boron Injection Line to 2D Reactor Coolant System Cold Leg

- 4.3 To repair this defect, Duke Energy proposes to perform a temporary weld overlay repair using ASME Code, Section XI, Nonmandatory Appendix Q, as modified in this request. Compliance with the requirement of ASME IWA-4420 to remove the defect and perform a repair in accordance with IWA-4000 will require draining of the reactor coolant system (RCS) loops below the level necessary for operability of the Residual Heat Removal (RHR) System. This requires the reactor to be defueled. Duke Energy believes that compliance with the requirement of IWA-4420 would result in hardship or unusual difficulty without a compensating increase in the level of quality and safety.
