# Status Report: Intergranular Stress Corrosion Cracking of BWR Core Shrouds and Other Internal Components

**U.S. Nuclear Regulatory Commission**

**Office of Nuclear Reactor Regulation**

Manuscript Completed: March 1996  
Date Published: March 1996

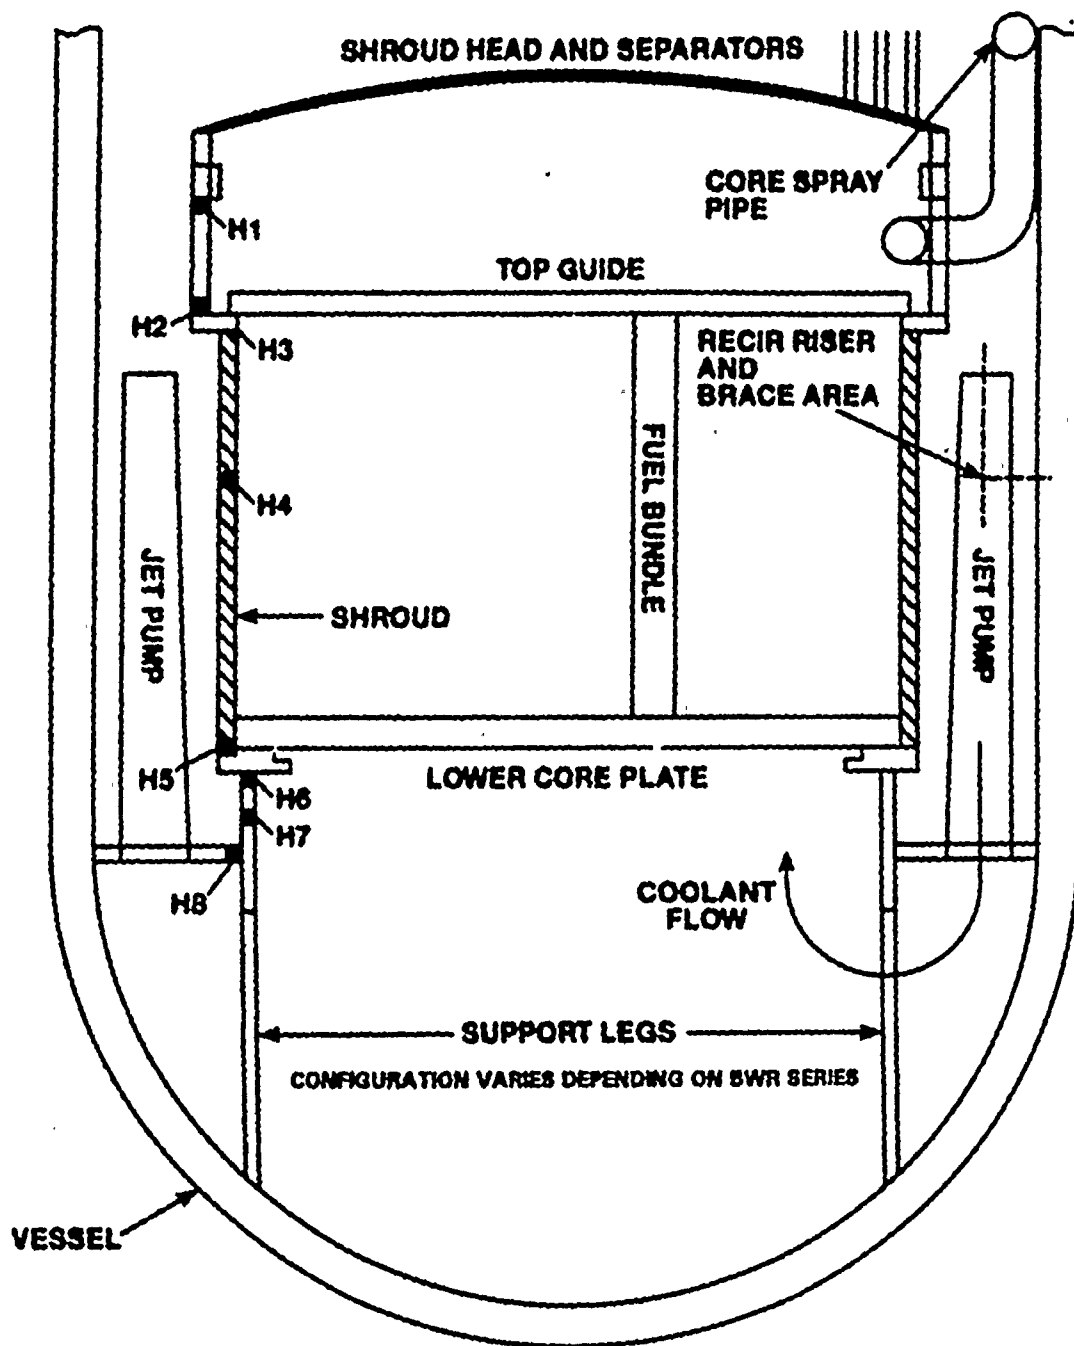
Figure 2.2-2 Core Shroud Weld Locations Typical of GE BWR-3, BWR-4, BWR-5, and BWR-6 Core Shroud Designs

The most extensive flaw indication in the BR-1 shroud was located on the inside shroud surface of the H3 weld. CP&L determined that the crack was located in the HAZ

of the weld. This circumferential weld joins the top guide support ring to the middle shroud shell. Using conservative assumptions, CP&L hypothesized that the crack could extend nearly 360° around the circumference of the weld. Boat samples taken from the H3 weld identified IGSCC as the cracking mechanism, and indicated that the H3 flaws could be more than 0.036 m (1.4 in) deep. The VT-1 examinations also revealed circumferential cracking along significant portions of welds H1 and H2 (using conservative assumption, up to 74% and 68% of the weld circumferences, respectively). In addition, CP&L reported minor cracking associated with the HAZs of circumferential welds H4, H5, H6a, and H6b.

refueling outage. GPU's examinations of the OCNGS core shroud included UT inspections of accessible areas on shroud welds H1, H2, H4, H5, and H6a, and enhanced visual examinations of welds H3, H6b, and H9. The results of the shroud examinations indicated significant cracking at the H4 weld. This weld joins the upper mid-shroud shell to the lower mid-shroud shell, and is in the vicinity of the reactor beltline region. The results of the OCNGS shroud examinations also indicated some minor cracking at the H2 and H3 welds.
