Subject: Duke Energy Carolinas, LLC (Duke Energy)  
McGuire Nuclear Station, Unit 2  
Docket No. 50-370  
Relief Request 17-MN-001  
Alternative for Repair of Class 1 Piping

**Duke Energy Carolinas, LLC  
McGuire Nuclear Station, Unit 2  
Relief Request Serial #17-MN-001**

**Relief Requested in Accordance with 10 CFR 50.55a(z)(2) for Weld Overlay Repair of  
Class 1 Piping**

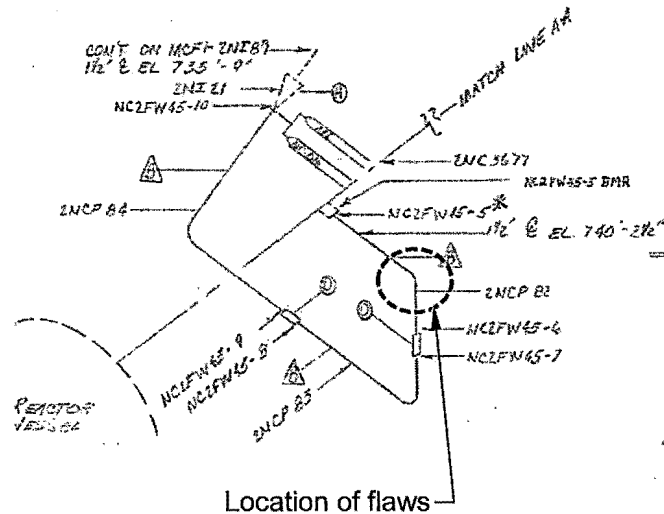
ASME Class 1 Piping, NPS 1-1/2 Schedule 160 5D bend (in piping subassembly 2NCP82) in the Boron Injection Line to 2D Reactor Coolant System Cold Leg.

The specific location of the piping subassembly is shown in the following excerpt from drawing MCFI-2NC45:

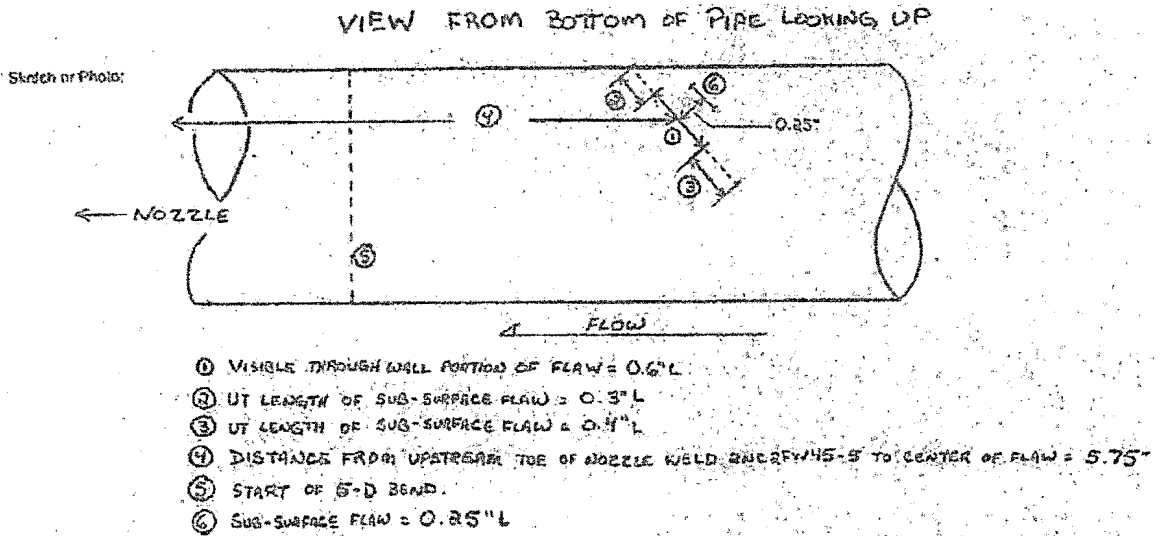
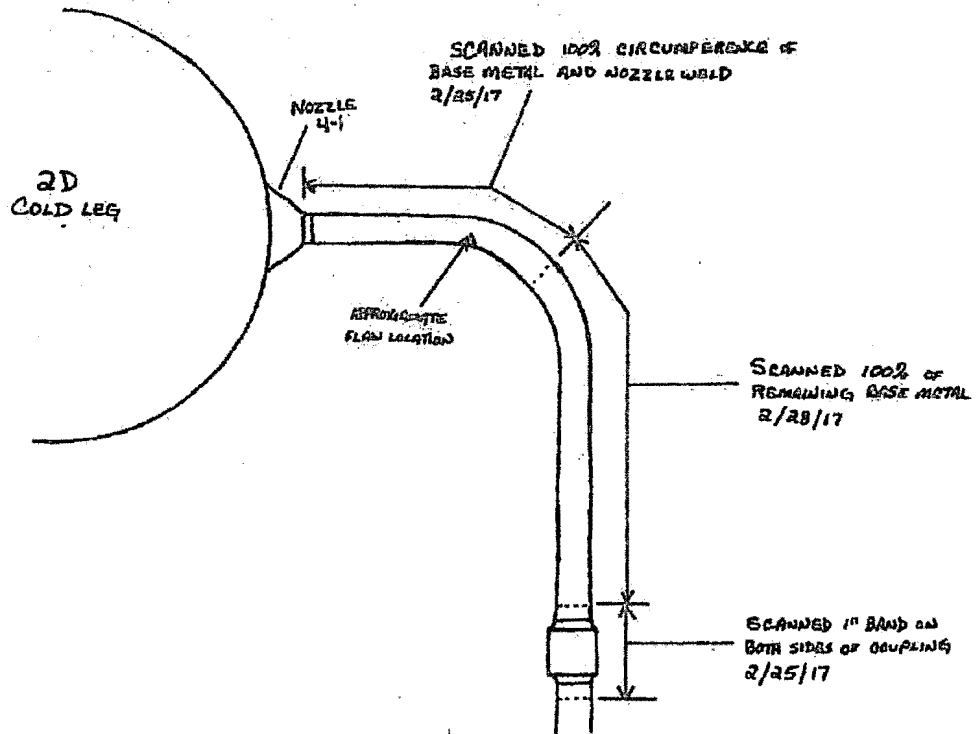
Elevation View

- 4.1 An unisolable pressure boundary leak in the boron injection line to 2D Reactor Coolant System Cold Leg was detected during plant operation on February 23, 2017, requiring a unit shutdown to perform a repair/replacement activity. The flawed area of piping is located approximately 5.75" from the pipe to nozzle weld 2NC2FW45-5, on the intrados of the 5D elbow bend. The flaw was located approximately 45 degrees between the bottom and side of the piping circumference at a skew of approximately 45 degrees to the piping axis. Reference Attachment 1 for information on the location and orientation of the identified flaws.

The flaw was observed to be open to the surface for a dimension of approximately 0.6" of length. The flaw was ultrasonically length sized with a combined surface and subsurface length of approximately 1.3". The flaw was further characterized as an off-axis axial flaw. Adjacent to the surface breaking flaw, two additional low amplitude indications were observed at approximately 0.1" to 0.15" below the leaking flaw and another indication of significant amplitude was observed, approximately 0.25" above the leaking flaw, with a length of approximately 0.25". A total of 4 off-axis flaws were observed.

- 5.3.1 Cracking is likely being influenced by residual stress from forming the 5D bend, applied torsional stress, or both.
  - 5.3.2 Axial cracking near the intrados (in the "cheeks") of a pipe bend is a common location for ID-initiated axial cracks due to the residual stress patterns formed in cold-formed pipe bends. The straightness of the cracking implies a fatigue mechanism, which could be caused by either thermal and/or mechanical fatigue. The 5D bend was fabricated by a vendor using piping material supplied by Duke Energy and was installed during the 2014 refueling outage 2EOC22. The PT conducted on the 5D pipe bend prior to installation at receipt inspection did not indicate flaws.

Nondestructive Examination Data for the NPS 1-1/2 Schedule 160 5D Bend in the Boron Injection Line to 2D Reactor Coolant System Cold Leg

- 4.3 To repair this defect, Duke Energy proposes to perform a temporary weld overlay repair using ASME Code, Section XI, Nonmandatory Appendix Q, as modified in this request. Compliance with the requirement of ASME IWA-4420 to remove the defect and perform a repair in accordance with IWA-4000 will require draining of the reactor coolant system (RCS) loops below the level necessary for operability of the Residual Heat Removal (RHR) System. This requires the reactor to be defueled. Duke Energy believes that compliance with the requirement of IWA-4420 would result in hardship or unusual difficulty without a compensating increase in the level of quality and safety.
