JAFP-17-0024
March 22, 2017

Subject: LER: 2017-002, Residual Heat Removal to Reactor Water Recirculation
Loop A Weld Flaw Indication

James A. FitzPatrick Nuclear Power Plant
Docket No. 50-333
License No. DPR-59

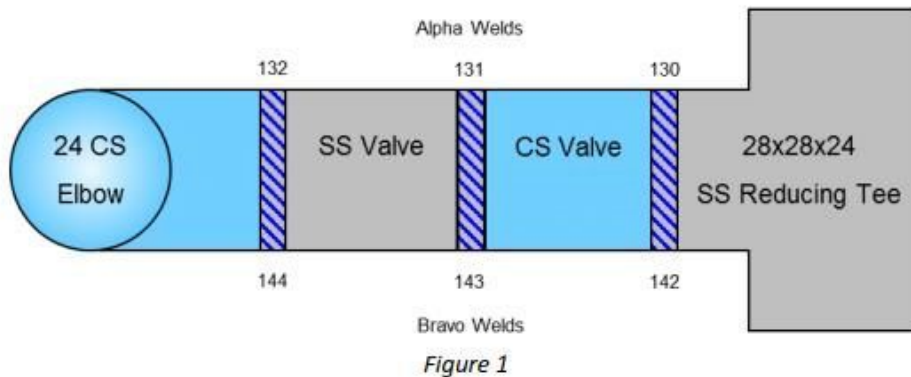
The A Loop of RHR system connects to the RWR Loop A at the dissimilar metal weld between the 24” nominal pipe size locked open carbon steel (CS) manual isolation valve 10RHR-81A and the 24” side of the stainless steel (SS) 28” x 28” x 24” Tee of the RCS A Loop. The dissimilar metal weld joins the carbon steel valve and the stainless steel Tee using Inconel 82/182 as the weld materials. See Figure 1.

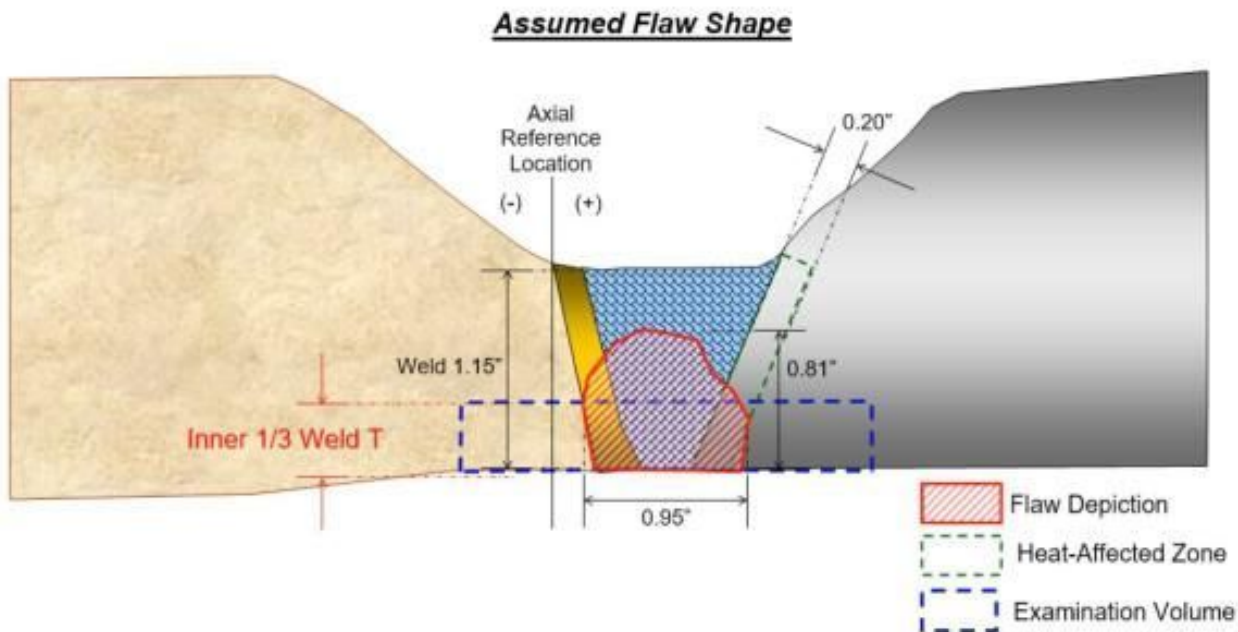
Figure 2

A planned inspection of the A RHR LPCI to A RWR loop dissimilar metal weld 24-10-130 took place during R22 in January 2017. The inspection consisted of an ultrasonic testing (UT) examination of the dissimilar metal weld between the 24” nominal pipe size carbon steel valve 10RHR-81A and the 28” x 28” x 24” stainless steel Tee of the A RWR Loop. The examination showed an inner diameter axial flaw indication (oriented parallel to the axis of the piping run) with a length approximately 0.95” long with a maximum wall depth of 0.81” with a remaining ligament (sound metal above the flaw tip) of 0.34”. See Figure 2.

This flaw did not meet IWB-3514-2 allowable standards and was reported to the NRC per 10 CFR 50.72(b)(3)(ii)(A) as ENS 52503 and this License Event Report (LER) is submitted per 10 CFR 50.73(a)(2)(ii)(A) as a condition of the nuclear plant, including its principle safety barriers, being seriously degraded.

The flaw indication, in the dissimilar metal weld between the A RHR LPCI connection to the A RWR Loop, 24-10-130, is consistent with Inter-granular Stress Corrosion Cracking (IGSCC).

Review of weld record history for weld 24-10-130 identified that in 1973 the original weldment underwent a repair from the inner surface of the weld root to address a rejectable linear indication. The indication was successfully repaired based upon later weld acceptance. The 1973 repaired area and this 2017 flaw indication are located at the same azimuthal location. A repair from the inside diameter can generate high tensile residual stresses associated with the repair process. A tensile stress condition provides a driving force for IGSCC.

The safety significance of this event is considered minimal. The axially – oriented weld flaw in the valve to tee dissimilar metal weld was approximately 0.95” long with a maximum wall depth of 0.81” with a remaining ligament (sound metal above the flaw tip) of 0.34”.

The weld flaw at 24-10-130 was corrected by implementation of a full structural weld overlay using ASME Code Cases N-504-4 and N-638-4. This repair method was submitted as ISI Relief Request RR-21 and authorized by the NRC. The weld overlay repair involved the deposition of Alloy 52M weld metal on the outside surface of the dissimilar metal weld and adjacent base material. The repair method reduces the potential for IGSCC by the use of weld filler materials that are resistant to this mechanism.

- Performed UT of final weld overlay at 24-10-130. Detected indications associated with the final weld overlay were evaluated using the acceptance standards of ASME Section XI IWB-3514-2 and determined to be acceptable.
- Performed UT examinations of six RWR to RPV nozzle to safe end N2 dissimilar metal welds. Results of these examinations were acceptable.
