SUBJECT: Forwards response to NRC 810309 request for info re breakwaters. Breakwater damage would not result in configuration for which intake facility safety features are not qualified. Written confirmation requested.

Re: Docket No. 50-275
Docket No. 50-323
Diablo Canyon Units 1 & 2

SAFETY IMPLICATIONS OF DAMAGED BREAKWATERS

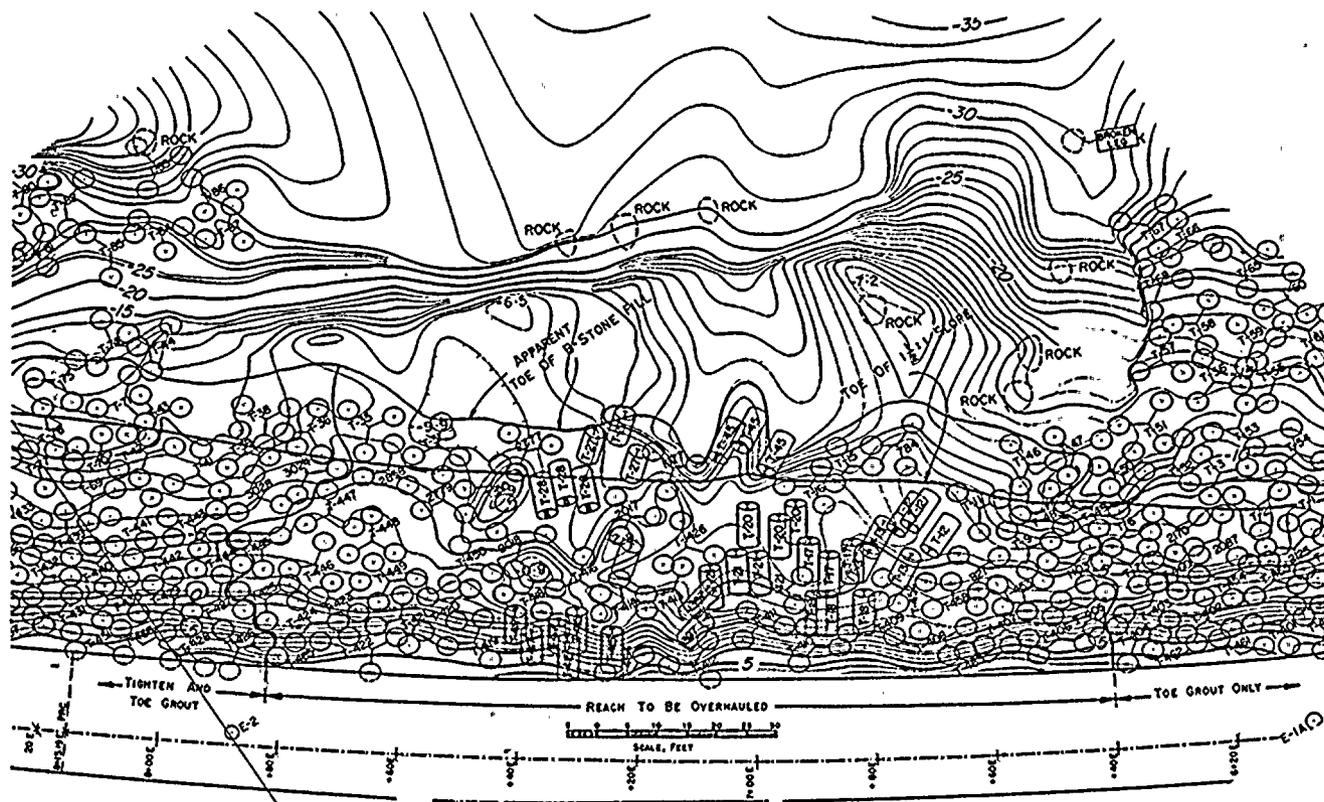
Fig. 19 Surveyed Positions of Individual Tribars, January 1975

the unprotected mound at that time by waves, before "B" stone could be laid over the core to hold it. It was suspected the nine "B" stones that were mapped on the basin floor were also of that earlier origin, not the product of the recent episode.

Diagnosis.—The abruptness of drop of the sea floor just basinward of the armor's toe of slope had not been delineated by the surveys shown on Figs. 3 and 5. At that time it was hazardous, virtually all of the time, to operate a sounding boat at that location, and interest was in fact concentrated at the niche sites that were in mind for the pump stations. Cross-sections taken during construction did discover the abruptness of the escarpments, but they were not compiled into a contour map. They had shown, however, that there was not enough ledge left to keep a dike of "B" stone over the basinward toe of the Tribar armor, and none was placed. The terrain features along the damaged area were probably critically involved in the situation.

Nine "B" stones were found on the basin floor but no Tribars had rolled there, in spite of the fact 10 to 15 foot high escarpments dropped off into deeper water just past the toe of the breakwater. There was apparent core material, pieces of rock 4 to 6 inches nominal diameter, on the basin floor, but marine life on that material suggested it had been there since construction was under way, presumably washed off
