SUBJECT: Responds to Board Notification 84-071 issues re draft investigation/insp rept discussed at 840328 & 0402 meetings. Cross ref between issues & util responses encl. Encl info also forwards to ACRS for presentation on 840406.

Re: Docket No. 50-275 OL-DPR-76
Diablo Canyon Unit 1
Response to Board Notification 84-071

CROSS REFERENCE LIST (INSPECTION ITEM VS PGandE RESPONSE)

TABLE OF CONTENTS TO PGandE RESPONSES

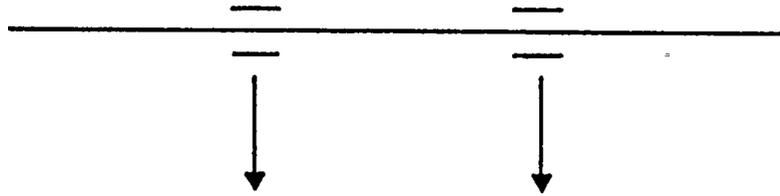
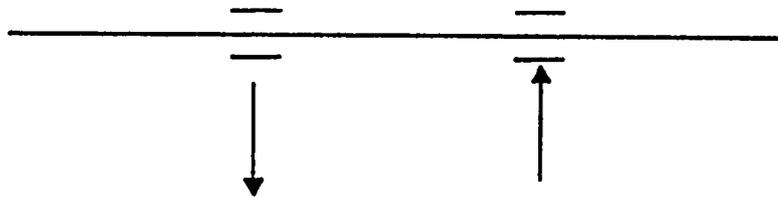
Figure 1

With regard to rigids located in close proximity to rigids, the concern is that if two closely spaced rigid supports (spaced supports with standard construction tolerances of 1/16 to 3/16 inch) have different clearances, then the support with the smaller clearances will have to carry load previously assigned to the support with the larger clearances.

The actual contributions of the two mechanisms to the support design loads are dependent on specific piping and support configurations. PGandE has examined all of the large bore stress isometrics and identified approximately 140

instances of close proximity rigid supports. From this group, a representative sample has been selected and is being analyzed with consideration of the actual clearances. These analyses will help quantify the actual support load changes.
