U.S. NUCLEAR REGULATORY COMMISSION

AUGMENTED INSPECTION TEAM (AIT) REPORT

Report No. 50-275/91-09
License No. DPR-80
Docket No. 50-275

Facility Name: Diablo Canyon Nuclear Power Plant, Unit No. 1

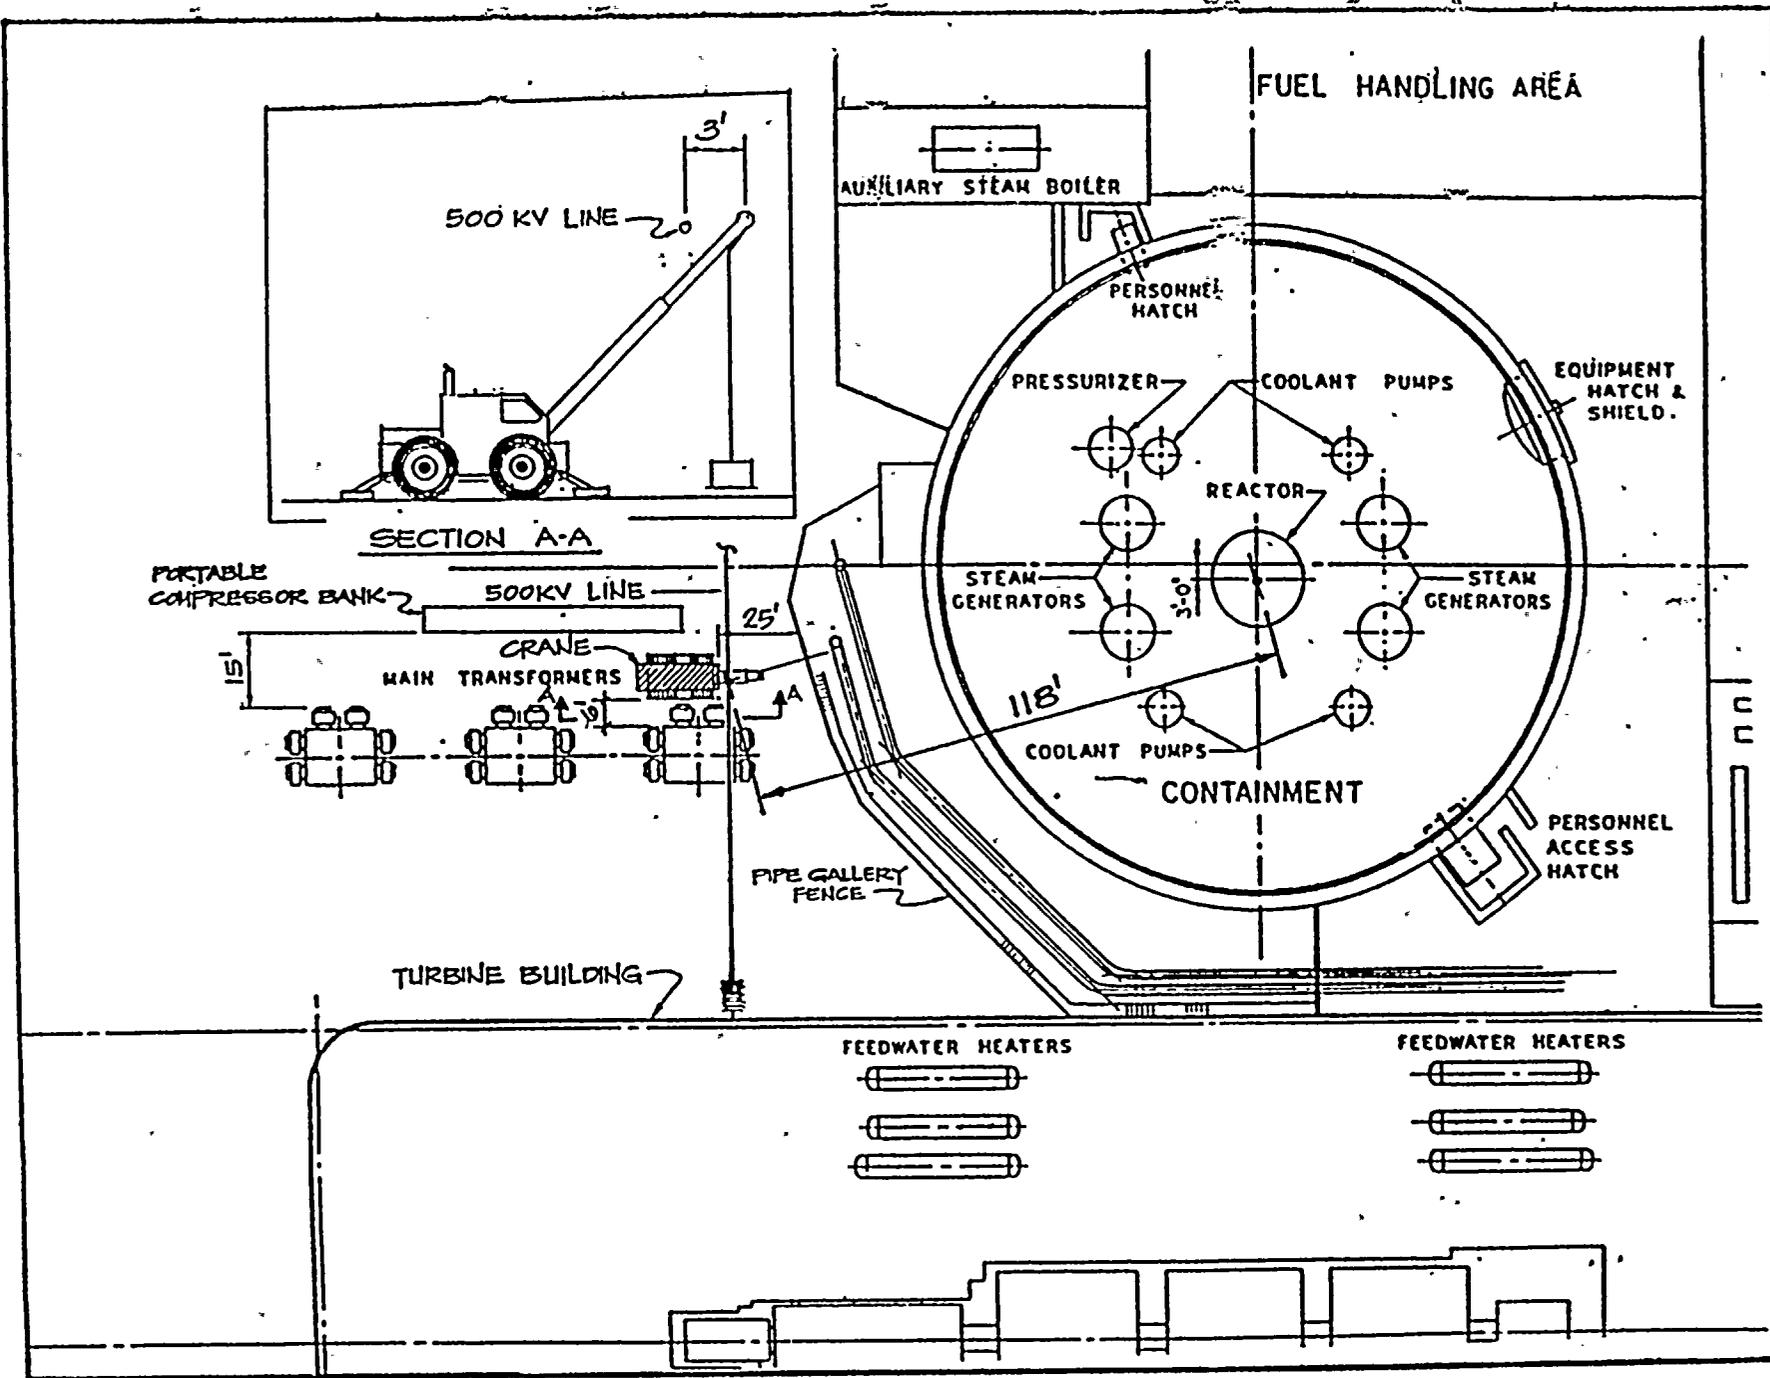
FIGURE C-1
LOSS OF OFF-SITE POWER EVENT

On the day of the event, the space used by the cranes on previous occasions was occupied by compressors to be used for the containment integrated leak rate test. The crane operator placed his crane in the location shown on Figure C-1 of Appendix C.

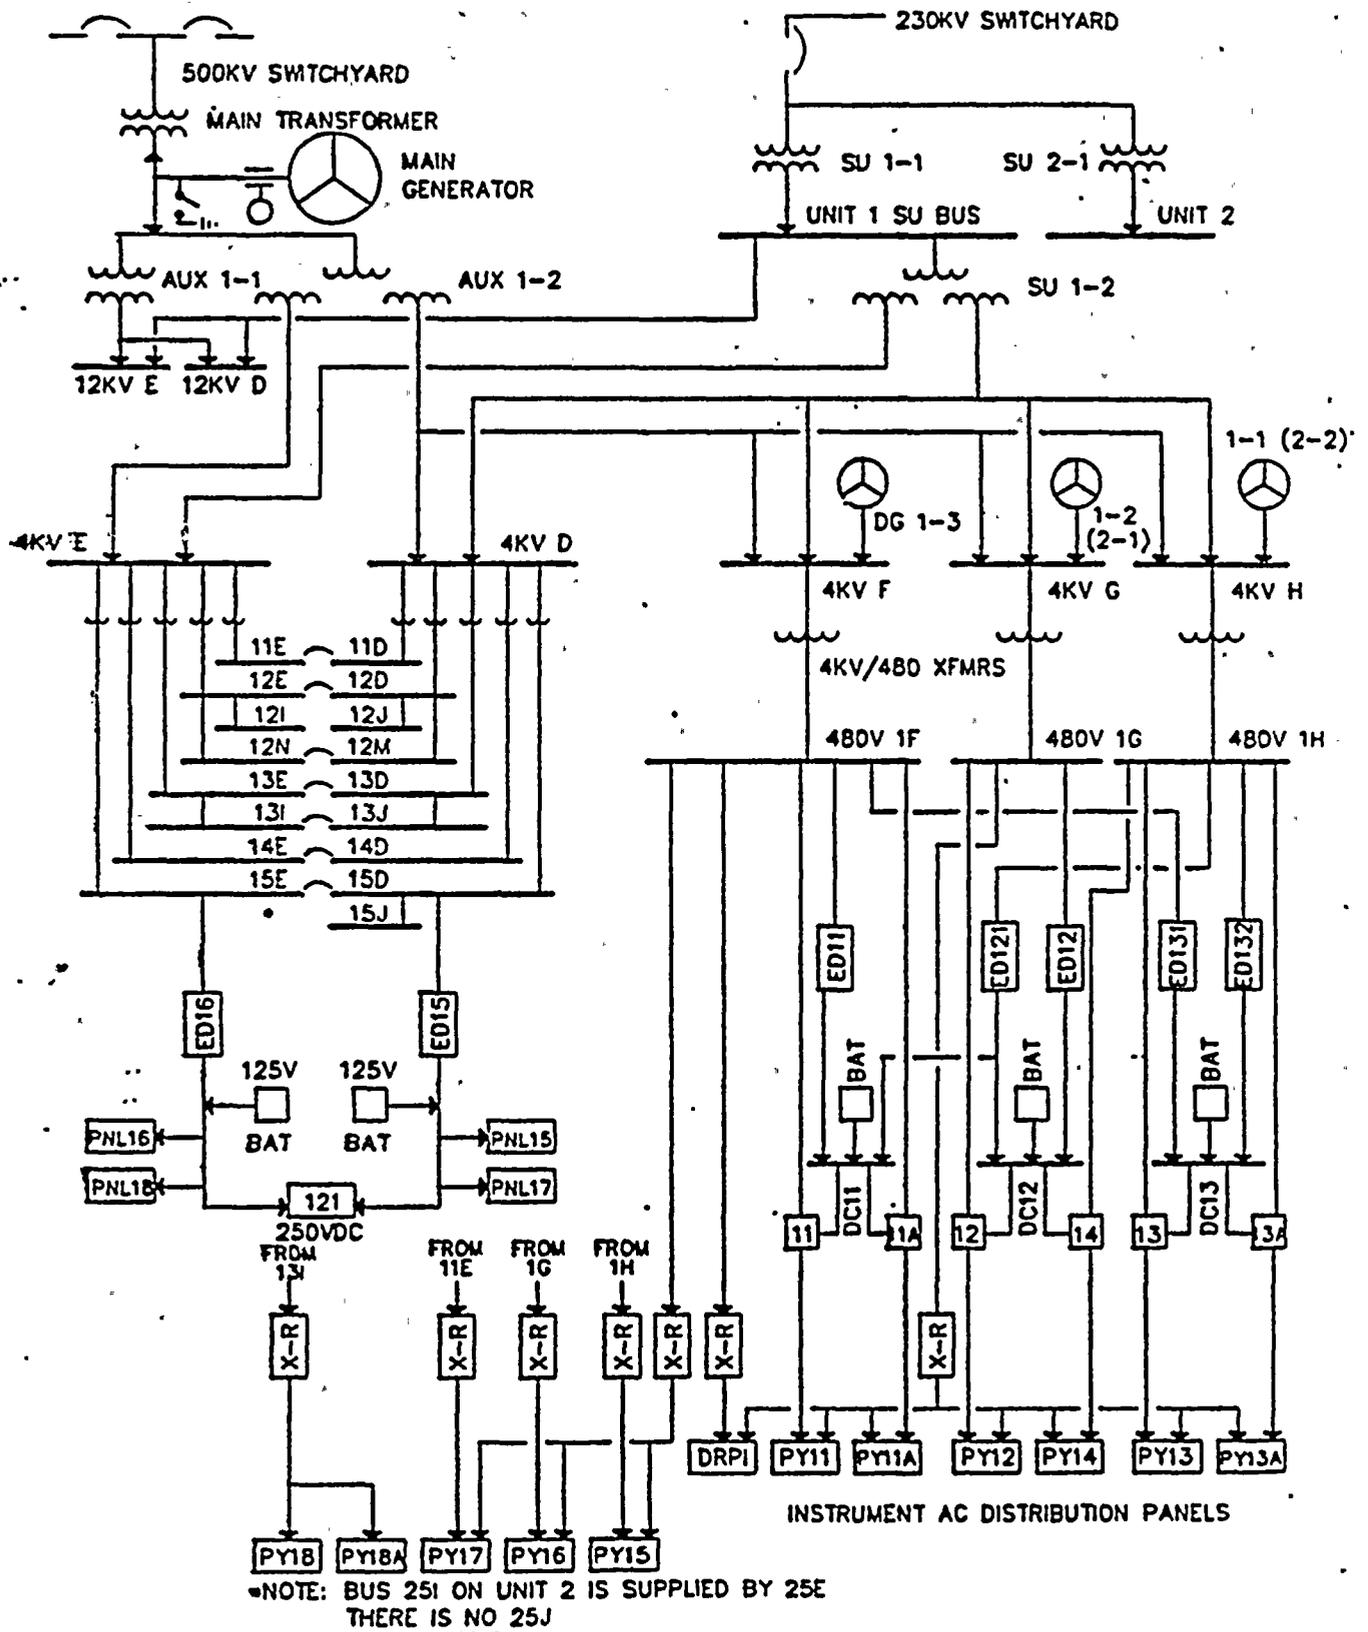
FIGURE C-4

Diablo Canyon is a two unit plant. Figures C-4 and C-5 of Appendix C depict the plant electrical single line diagram. Each unit has one 25 kV main generator feeding three single phase 500 kV/25 kV transformers (A; B, & C) which together comprise the main transformer. Each main generator also feeds two auxiliary transformers; one for reactor coolant pumps and large loads (12 kV) and the other (4 kV) for all other plant loads. There is a motor-operated disconnect switch between the generator and the main transformer to allow disconnecting the generator from the 25 kV bus. This allows backfeeding of power from the 500 kV system through the main and auxiliary transformers. There are also two 230 kV/12 kV three phase standby startup transformers, Nos. 1-1 and 2-1 feeding, respectively, one 12 kV standby startup bus for each unit. The Unit 1 and Unit 2 standby startup busses can be cross connected through a 12 kV tie breaker. Each unit's 12 kV standby startup bus feeds the unit's 4 kV engineered safety busses (F,G, and H) and 4 kV auxiliary busses (D and E) through a 12 kV/4 kV three phase standby startup transformer (No. 1-2 for Unit 1 and No. 2-2 for Unit 2). Each unit is provided with two emergency 4 kV diesel generators. A fifth
