LICENSEE: Pacific Gas and Electric Company (PG&E)
FACILITY: Diablo Canyon Nuclear Power Plant, Unit 1
SUBJECT: SUMMARY OF OCTOBER 20, 1992 PUBLIC MEETING TO DISCUSS STEAM
GENERATOR FEEDWATER NOZZLE CRACKING

STEAM GENERATOR FEEDWATER NOZZLE CRACKS

AT DIABLO CANYON UNIT 1

**PACIFIC GAS AND ELECTRIC COMPANY
DIABLO CANYON POWER PLANT
PRESENTATION ON FEEDWATER NOZZLE ISSUES**

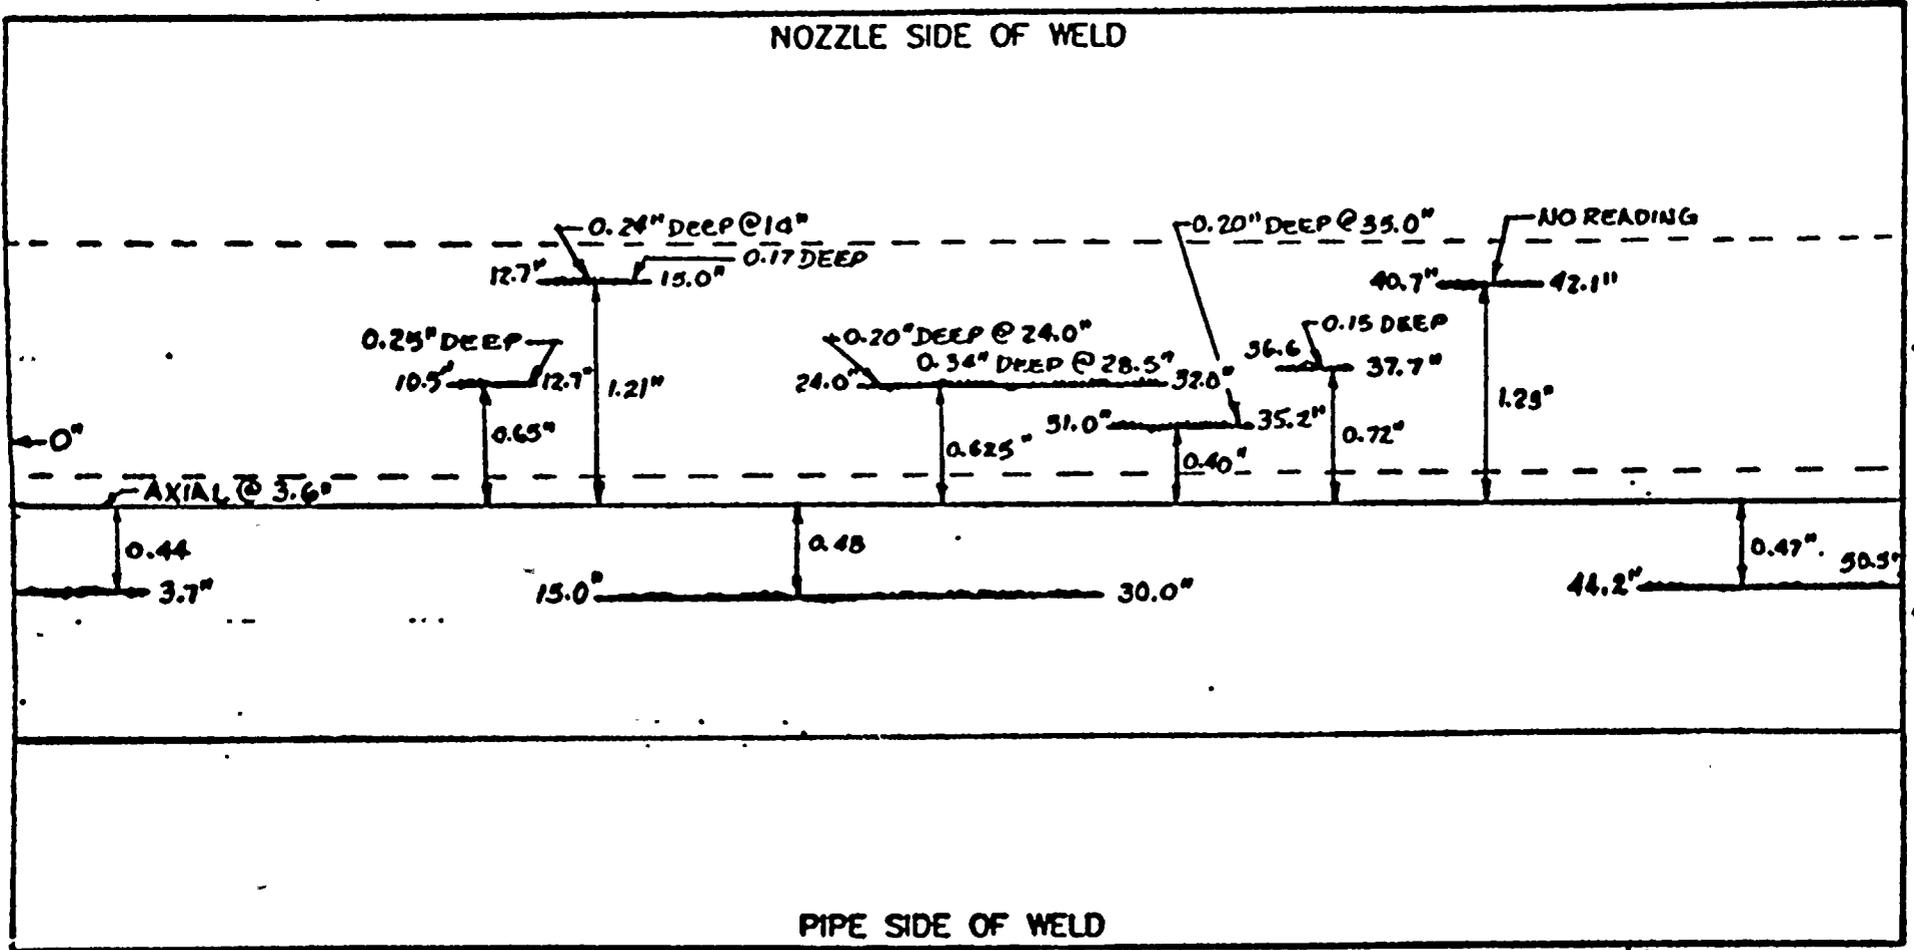
STEAM GENERATOR: 1-1
 WELD NO. WICG 101A1-1
 INSPECTOR NAME: HECHT/HOLLOW
 DATE: 9/24/92
 SCALE: NONE

RESULTS OF ULTRASONIC INSPECTION

DCPP UNIT 1 - 1R5, FEEDWATER PIPE TO SG NOZZLE WELDS

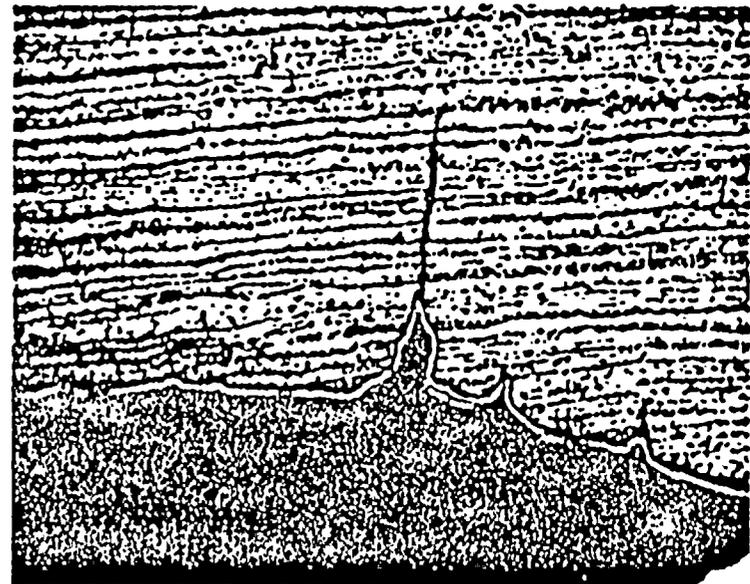
FW Nozzle 1-3: 8 3/8" CCW from TDC. Cracks in A106 spool attached to nozzle. Deepest crack is 0.035".

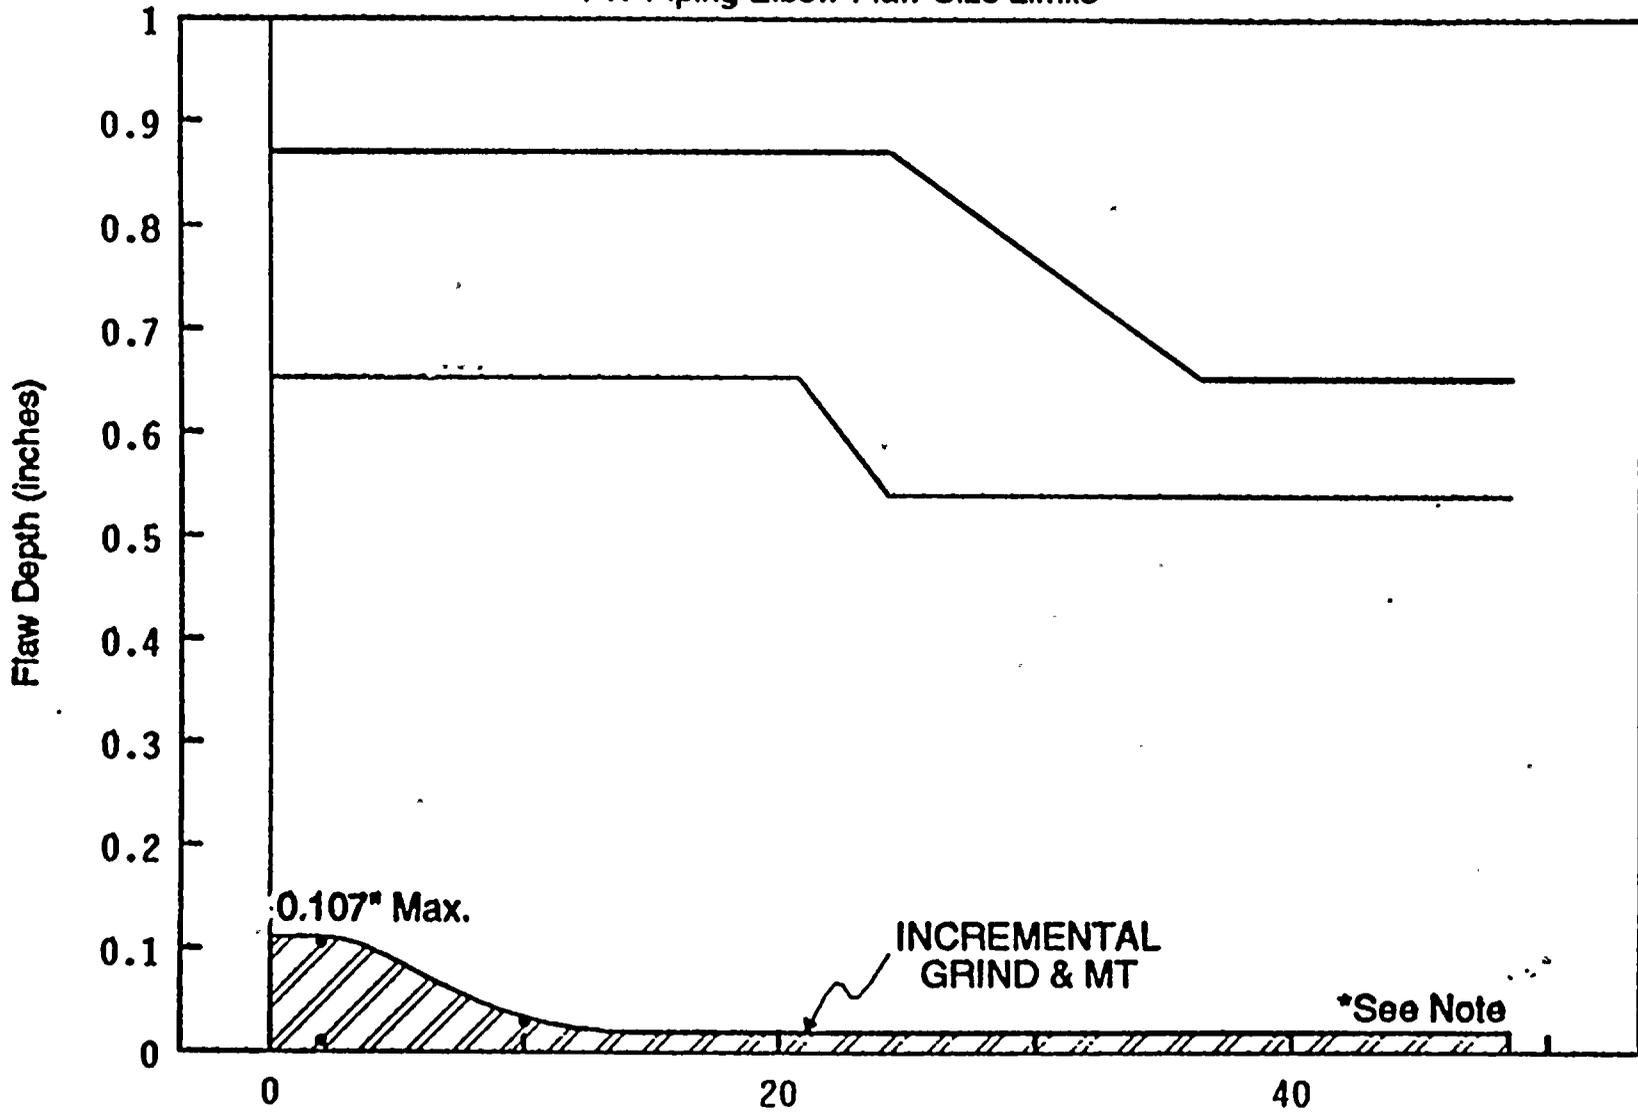
FW Piping Elbow Flaw Size Limits

*0.020" General Cleanup

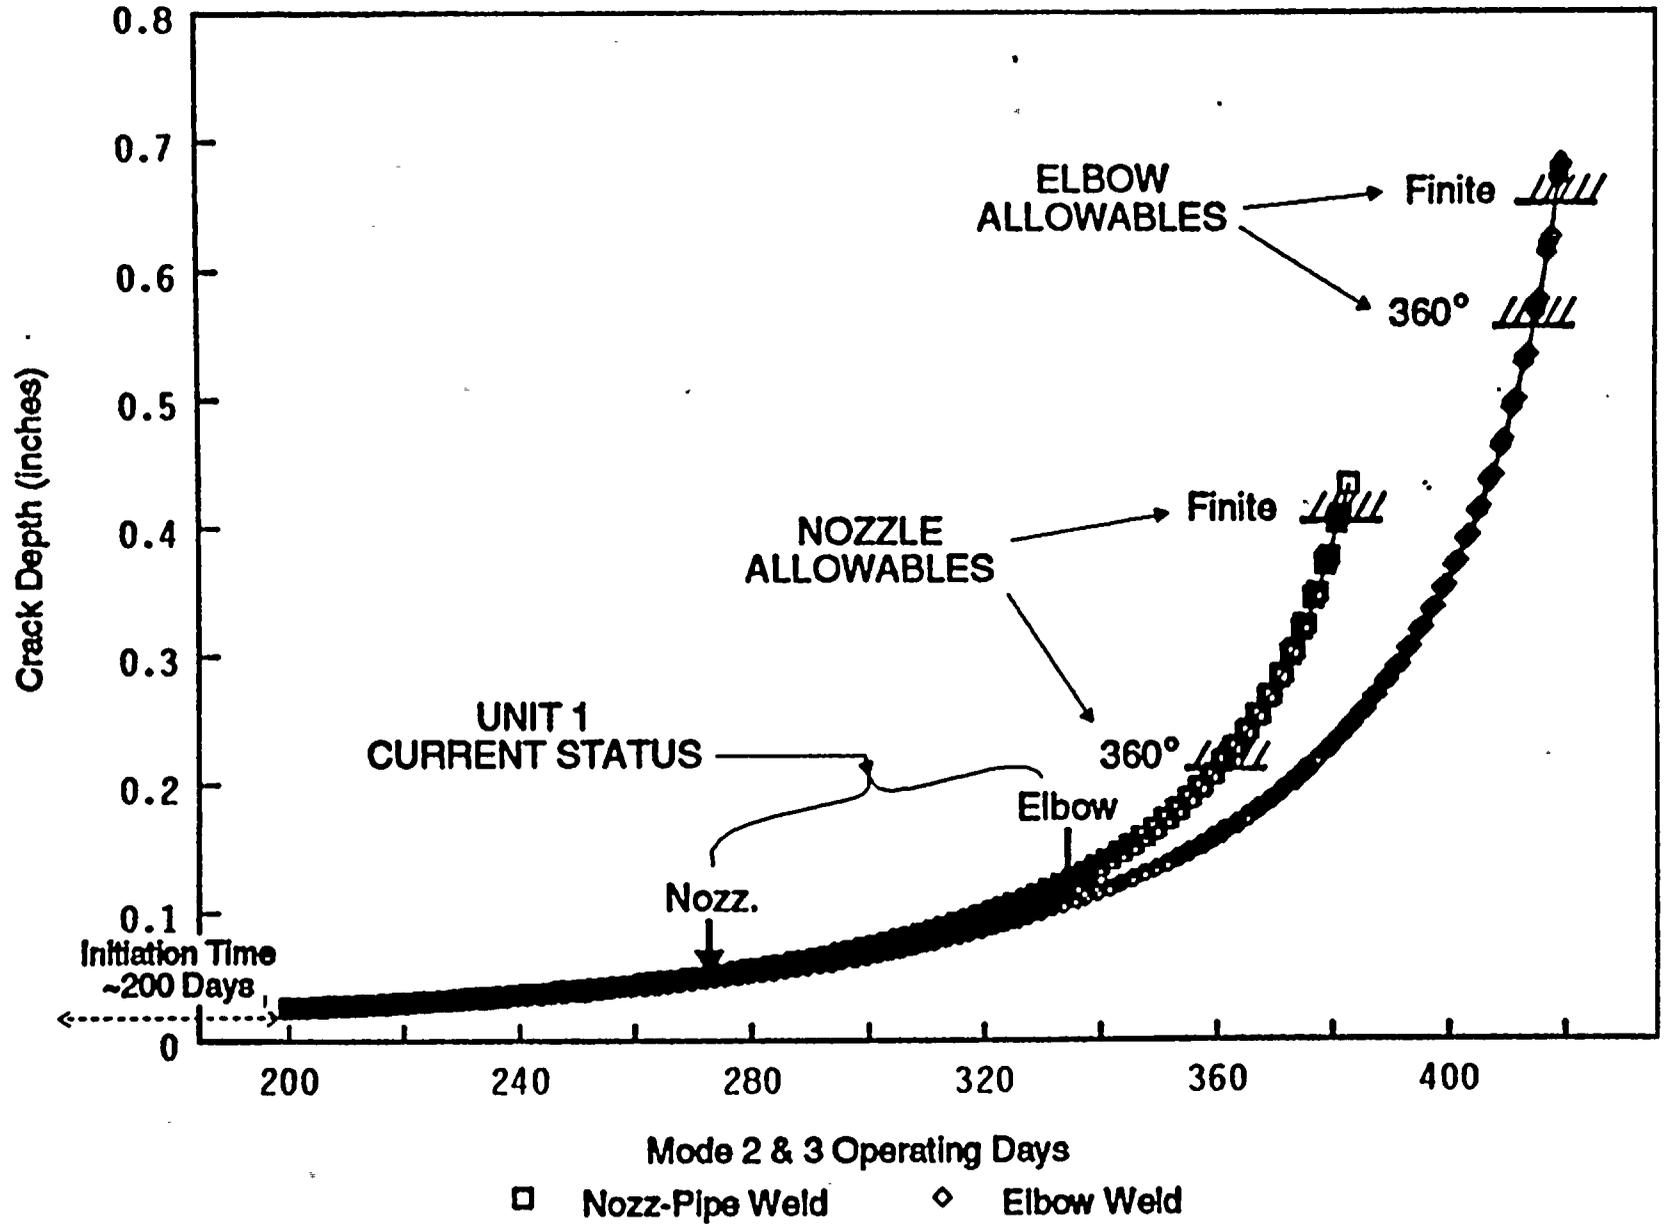
NOZZLE-PIPE CRACK GROWTH PROJECTIONS

- **Observed Cracking in Unit 1:**
 - **Significantly Below Code Allowables**
 - **Consistent with Industry Experience (IEB-79-13)**
 - **Consistent with DCPD AFW Flow/Stratification Cycles**
 - **Would Not Have Grown to Unacceptable Depth for Several Subsequent Fuel Cycles**

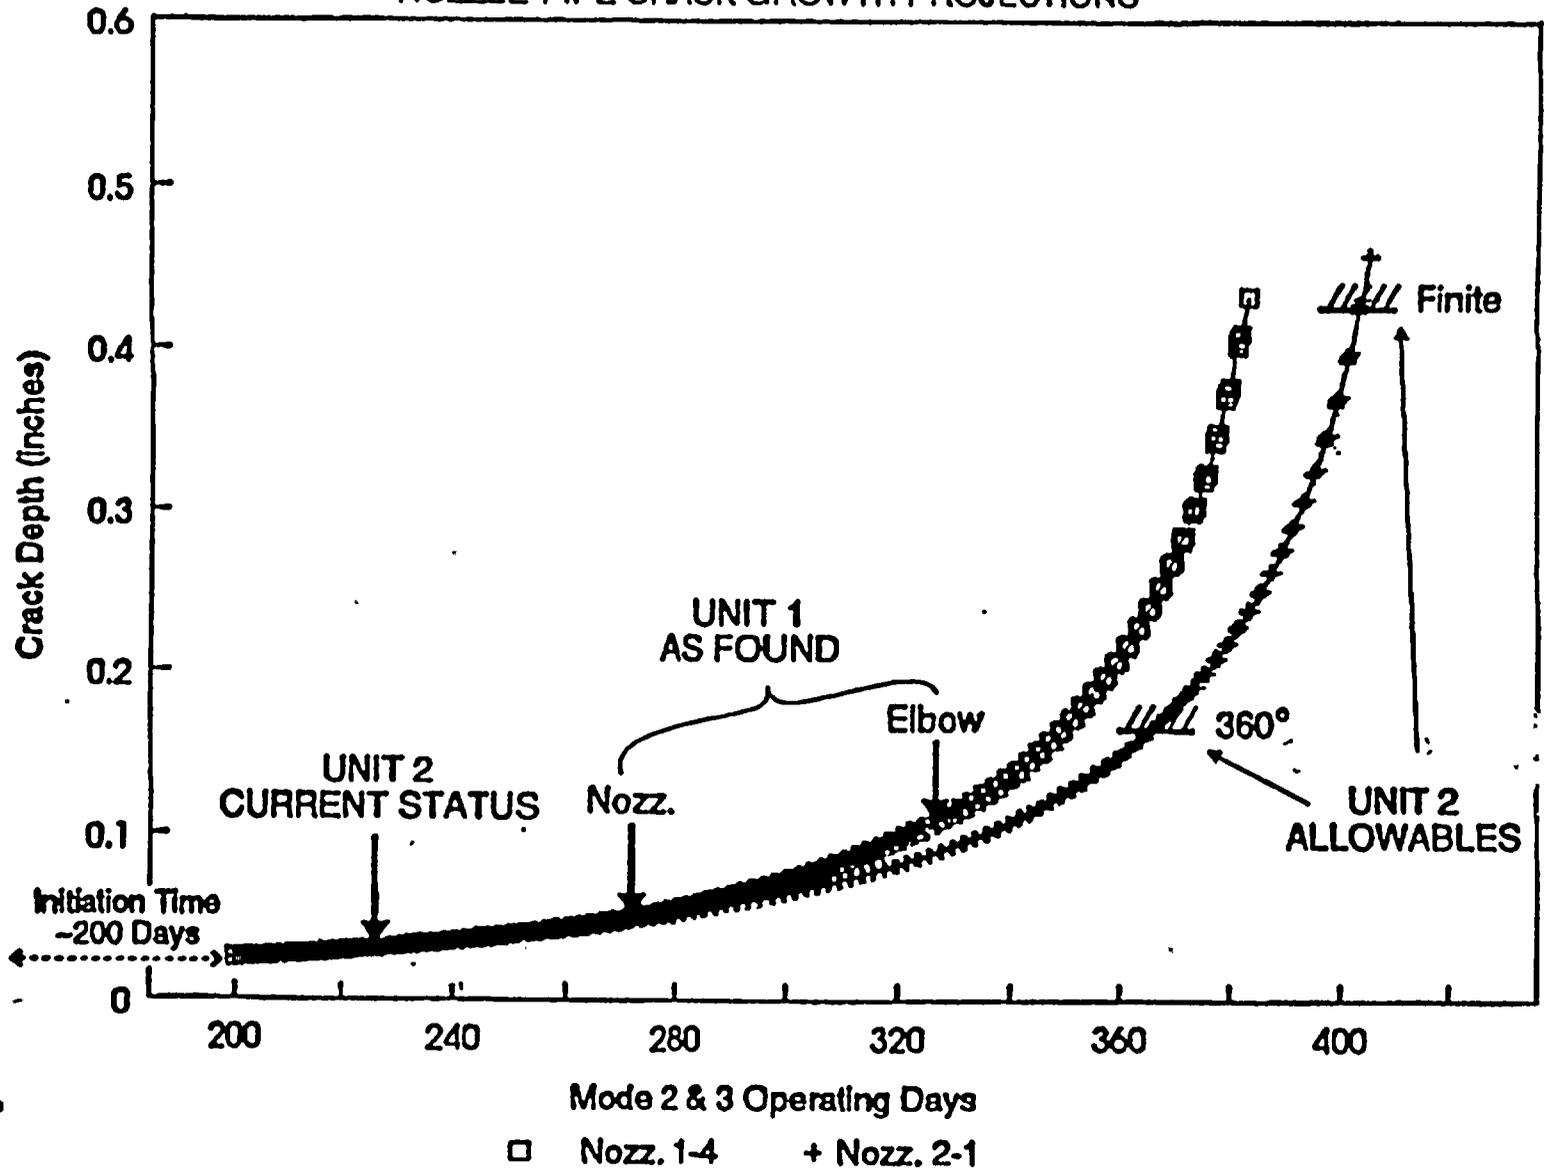
NOZZLE-PIPE CRACK GROWTH PROJECTIONS

- **Potential for Unit 2 Cracking Evaluated and Not a Concern**
 - **100 Days Less AFW Days (240 vs 340)**
 - **> 150 Days Additional AFW Days Before Postulated Cracking Would Reach Code Allowable**
 - **~ 5 Additional AFW Days Expected Until 2R5 (Spring, 1993)**
