Docket No. 50-275, OL-DPR-80
Docket No. 50-323, OL-DPR-82
Diablo Canyon Units 1 and 2
Response to NRC Request for Additional Information
WCAP-14707 and 14708

**RESPONSE TO NRC REQUEST FOR ADDITIONAL INFORMATION
WCAP-14707 AND WCAP-14708**

Drilled TSP Hole Crevice Conditions

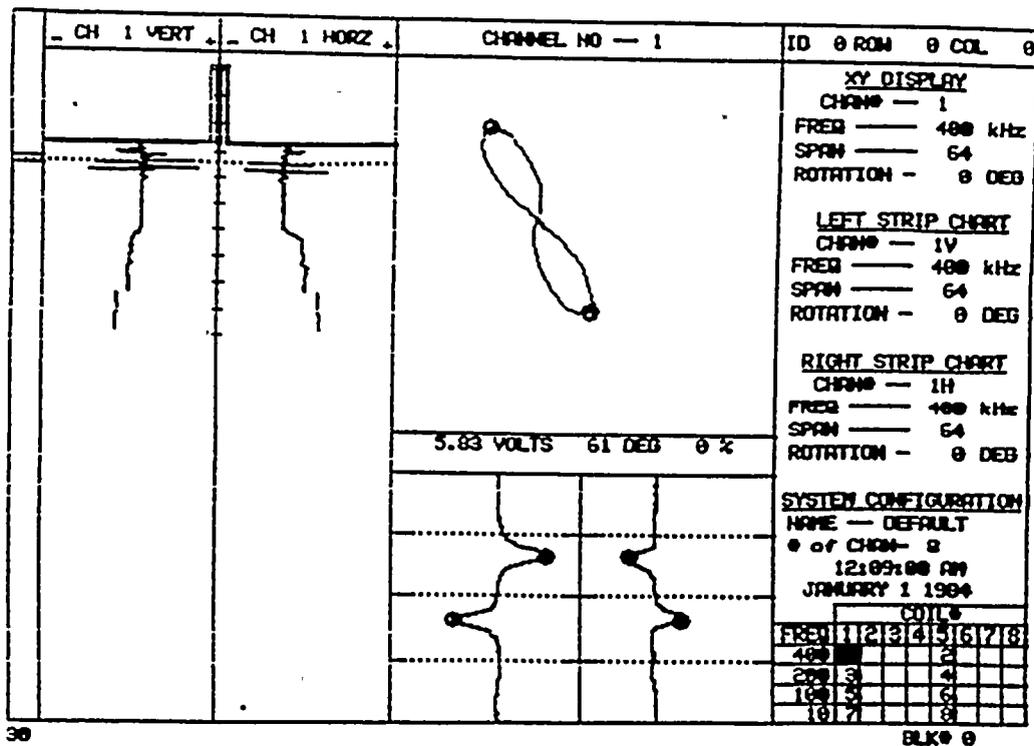
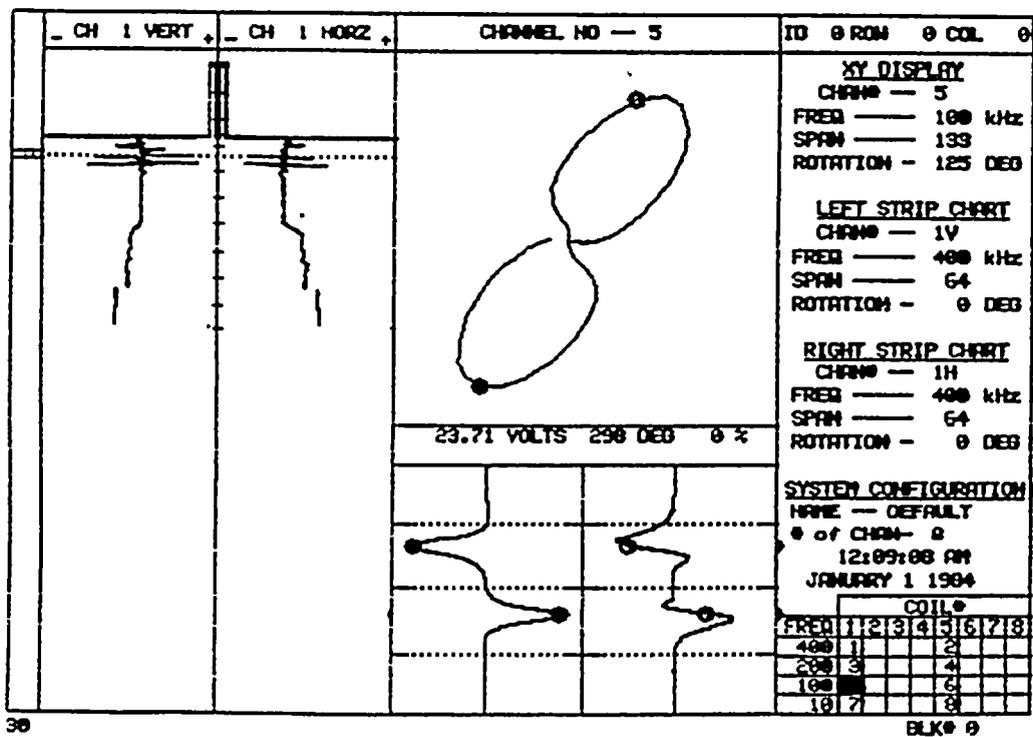
typical bobbin response as a figure 8 lissajous from a TSP with an open crevice and no TSP corrosion. Figure 4-2 shows distortion of the TSP lissajous obtained from a TSP with a 20-mil deep, 1/4-inch wide, 360 degree circumferential groove machined in the center of the TSP. This signal response is typical of TSP corrosion signals that preceded development of dents in operating plants. The accumulation of high density magnetite in the crevice causes an interference or distortion in the TSP signal. Figure 4-3 shows the same TSP simulant as Figure 4-2, but the groove was filled with magnetite. The "spike"-like signals represent the iron oxide influence and provide insight to characterize a TSP intersection.

Figure 4-1. Bobbin Coil Lissajous Signal for TSP with No Degradation or Magnetite

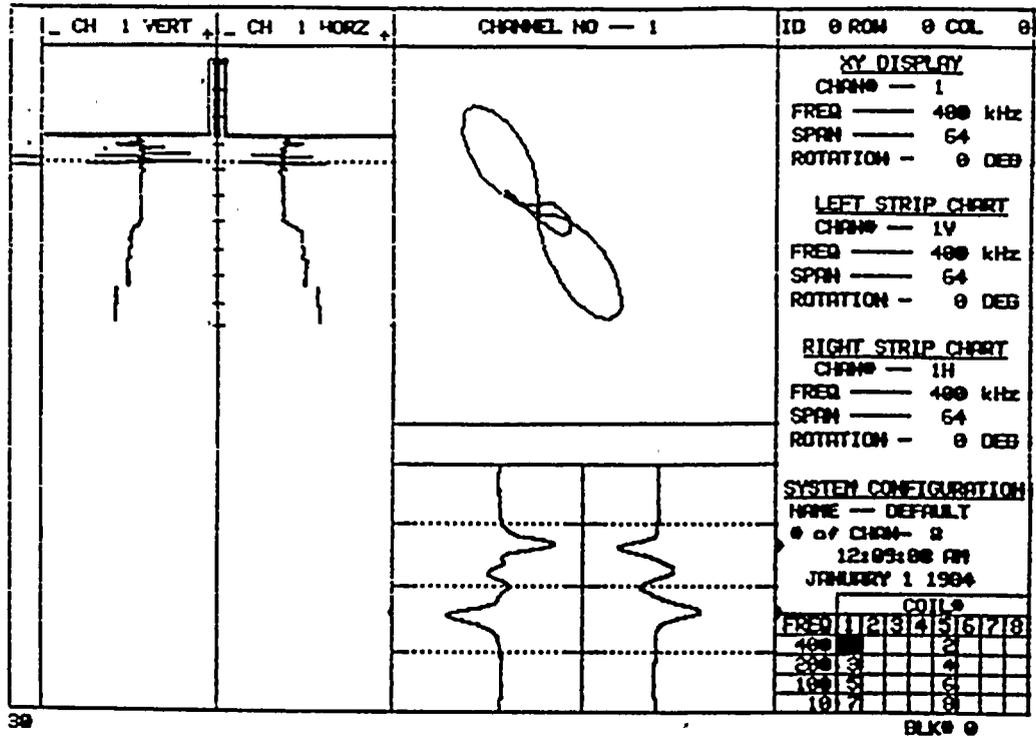
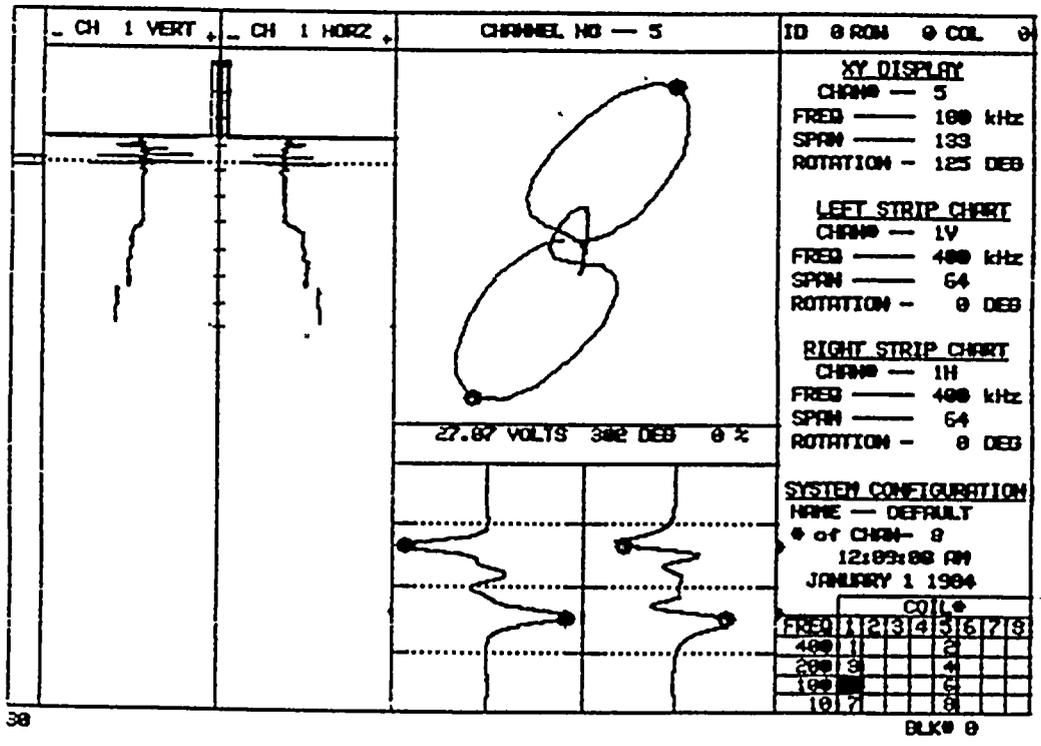
Figure 4-2. Bobbin Coil Lissajous Signal for a TSP with a 20 mil Deep, 0.25" Wide, 360 Degree Groove in Center of TSP

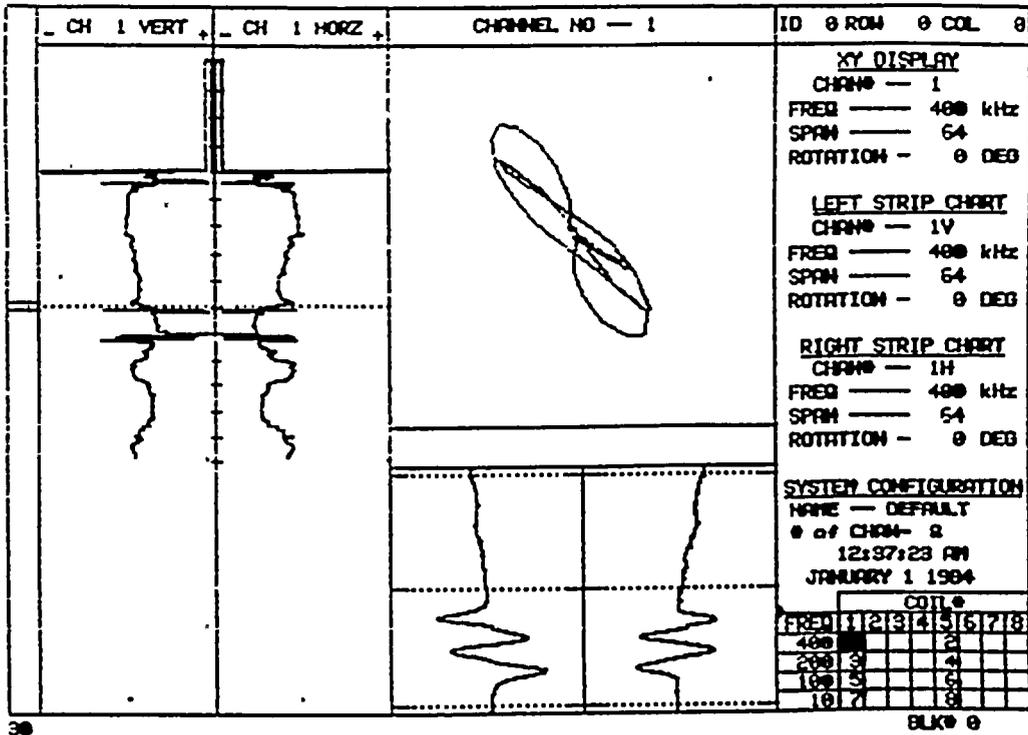
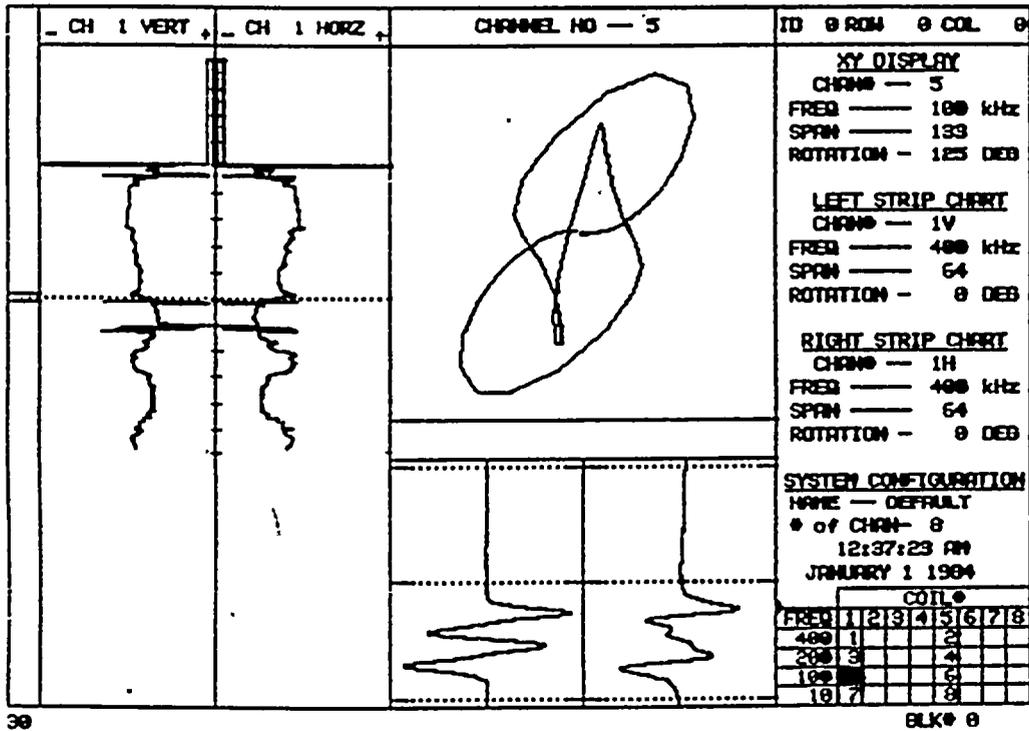
Figure 4-3. Bobbin Coil Lissajous Signal for TSP of Figure 4-2 with Magnetite Added to the Crevice Region

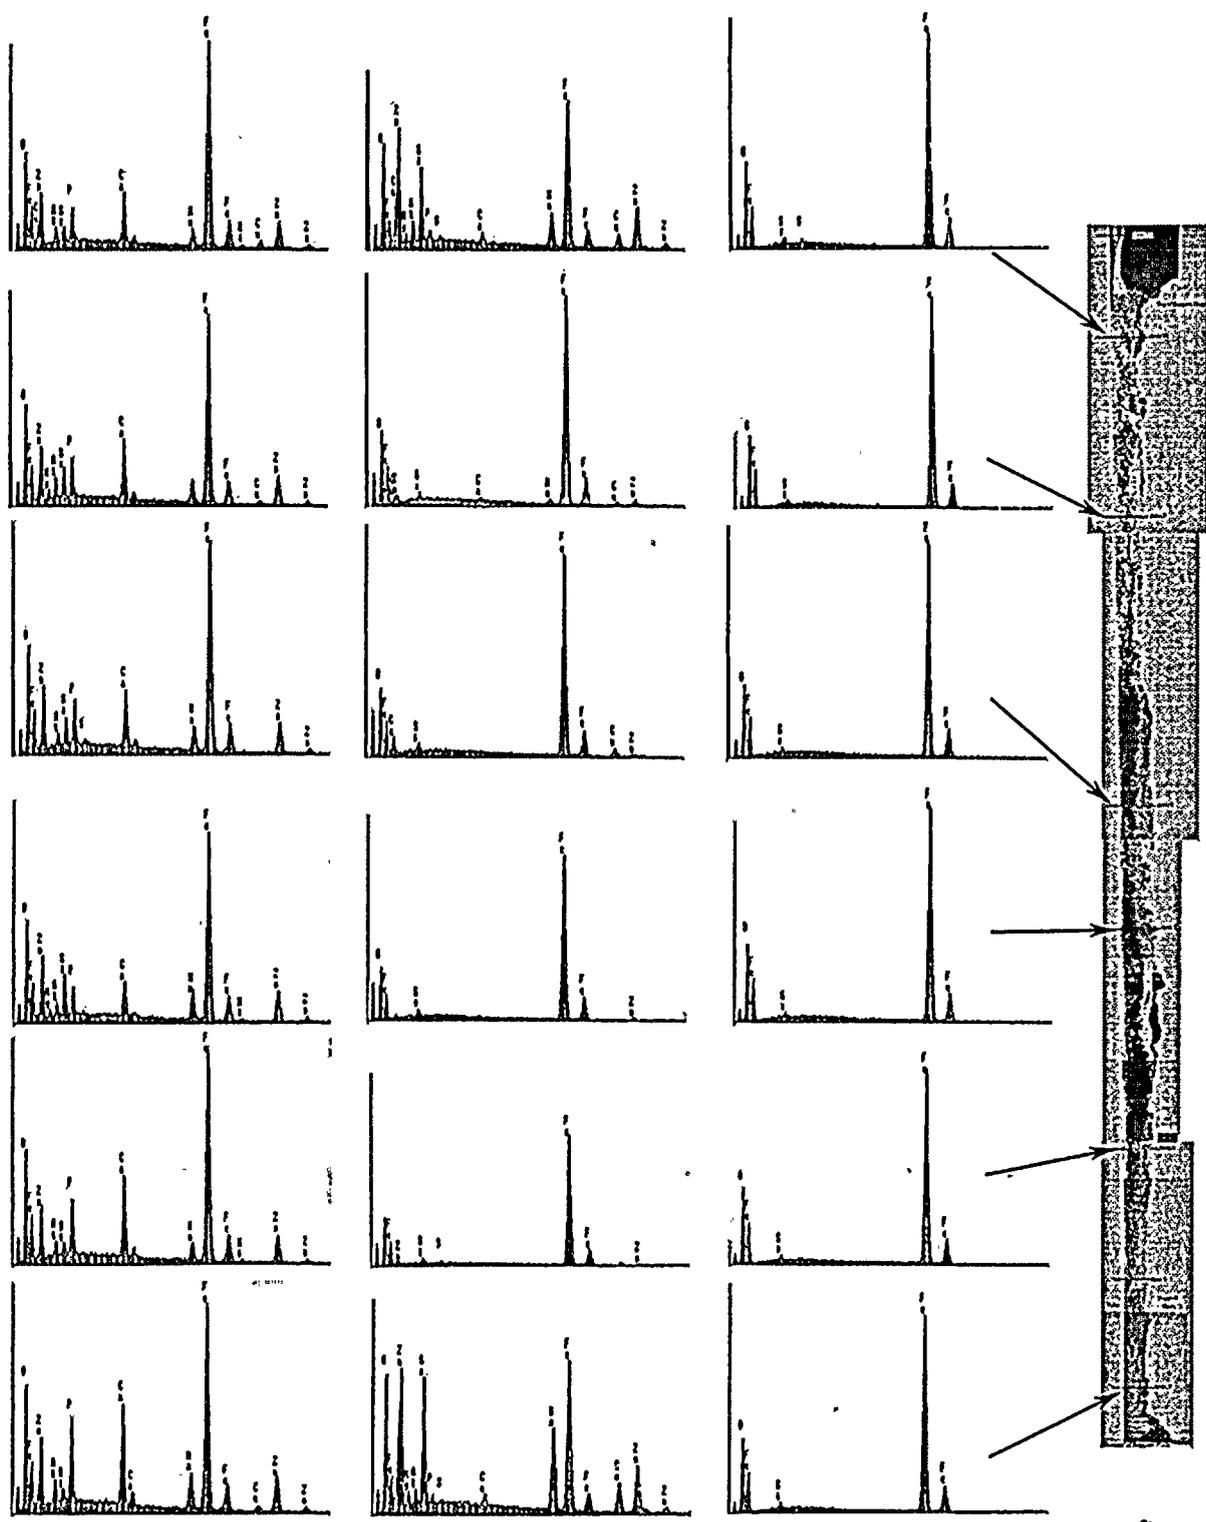
The porosity of the deposits adjacent to the tube and the TSP is low, i.e., in the range of 1 to 10 percent void. The central region of the 120 degree section has a higher porosity, ranging to 50 percent void (see Figure 1). The corresponding region of the 300 degree section has no corresponding void space (see Figure 2). This variation in porosity may represent the operational crevice condition or it may be an artifact of sample preparation. There is a possibility, for example, that the cutting and polishing operations resulted in some crevice material dropouts that contributed to this apparent porosity. This is partly supported by examination of the micrographs, which show regions where the deposit forms bridges across the crevice with adjacent and irregular void patterns suggestive of material that dropped out. Figure 3 shows this in an enlargement of a portion of the 120 degree section.

Figure 1. Elemental Composition Profile of 120 Degree Sector
Dampierre Tube Support Plate Crevice

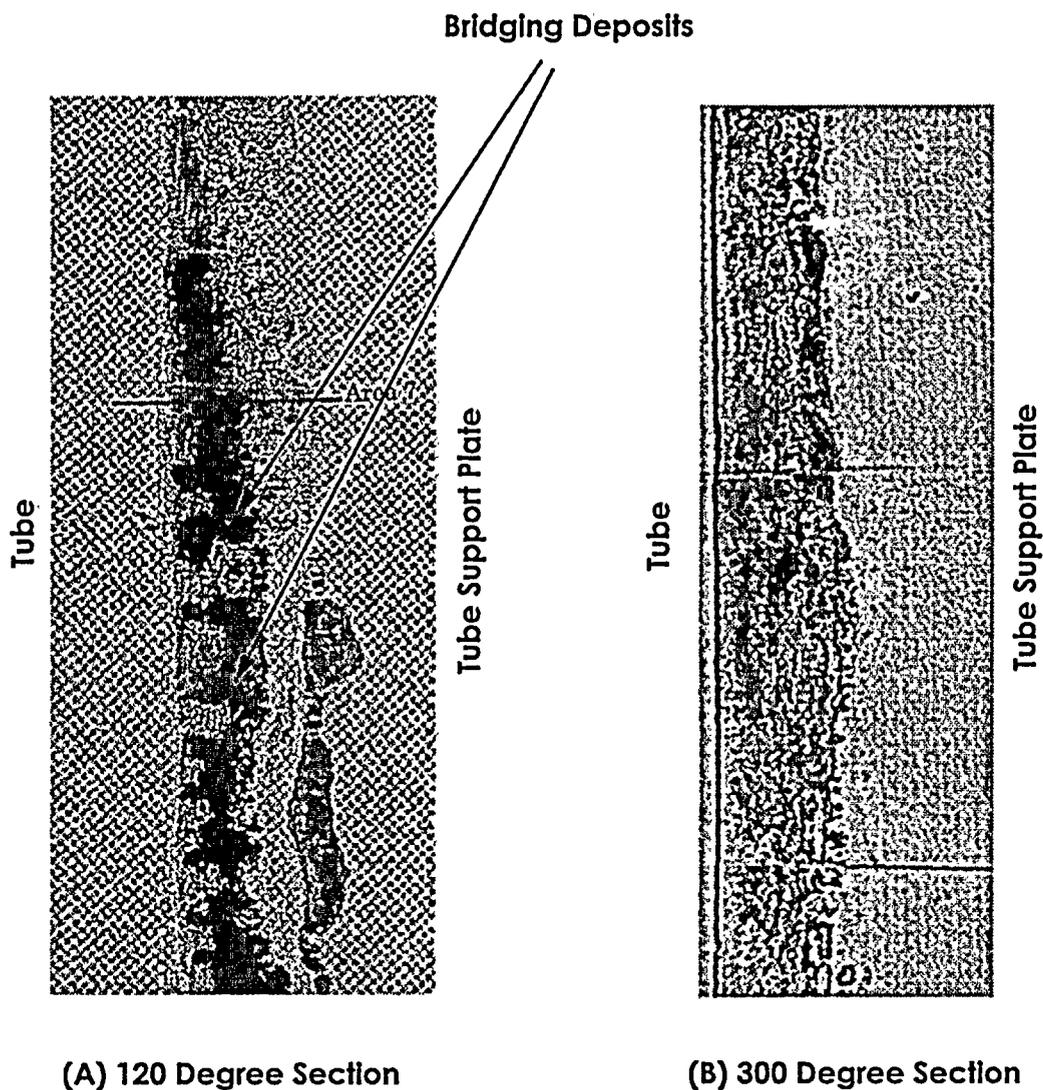
Figure 3. Section of Dampierre 1 TSP Crevice at 120 Degrees Showing Deposit Formations Bridging the Central Crevice Region in Some Areas (A). The 300 Degree Section Reveals More Uniform Deposits (B).

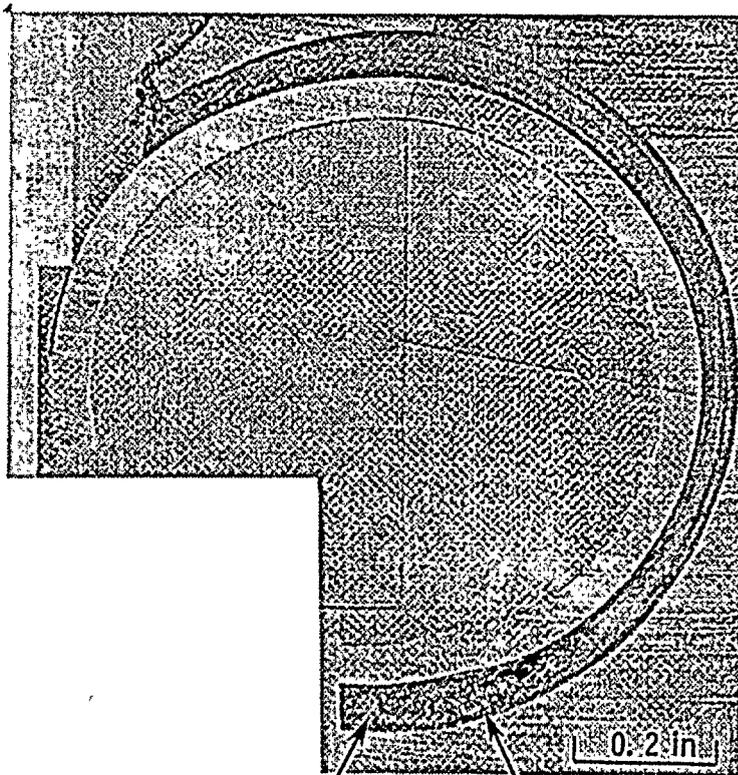
Figure 4. Crevice From Dented Steam Generator Establishes
That "Porous" Steam Generator Deposits Sustain
Denting Forces

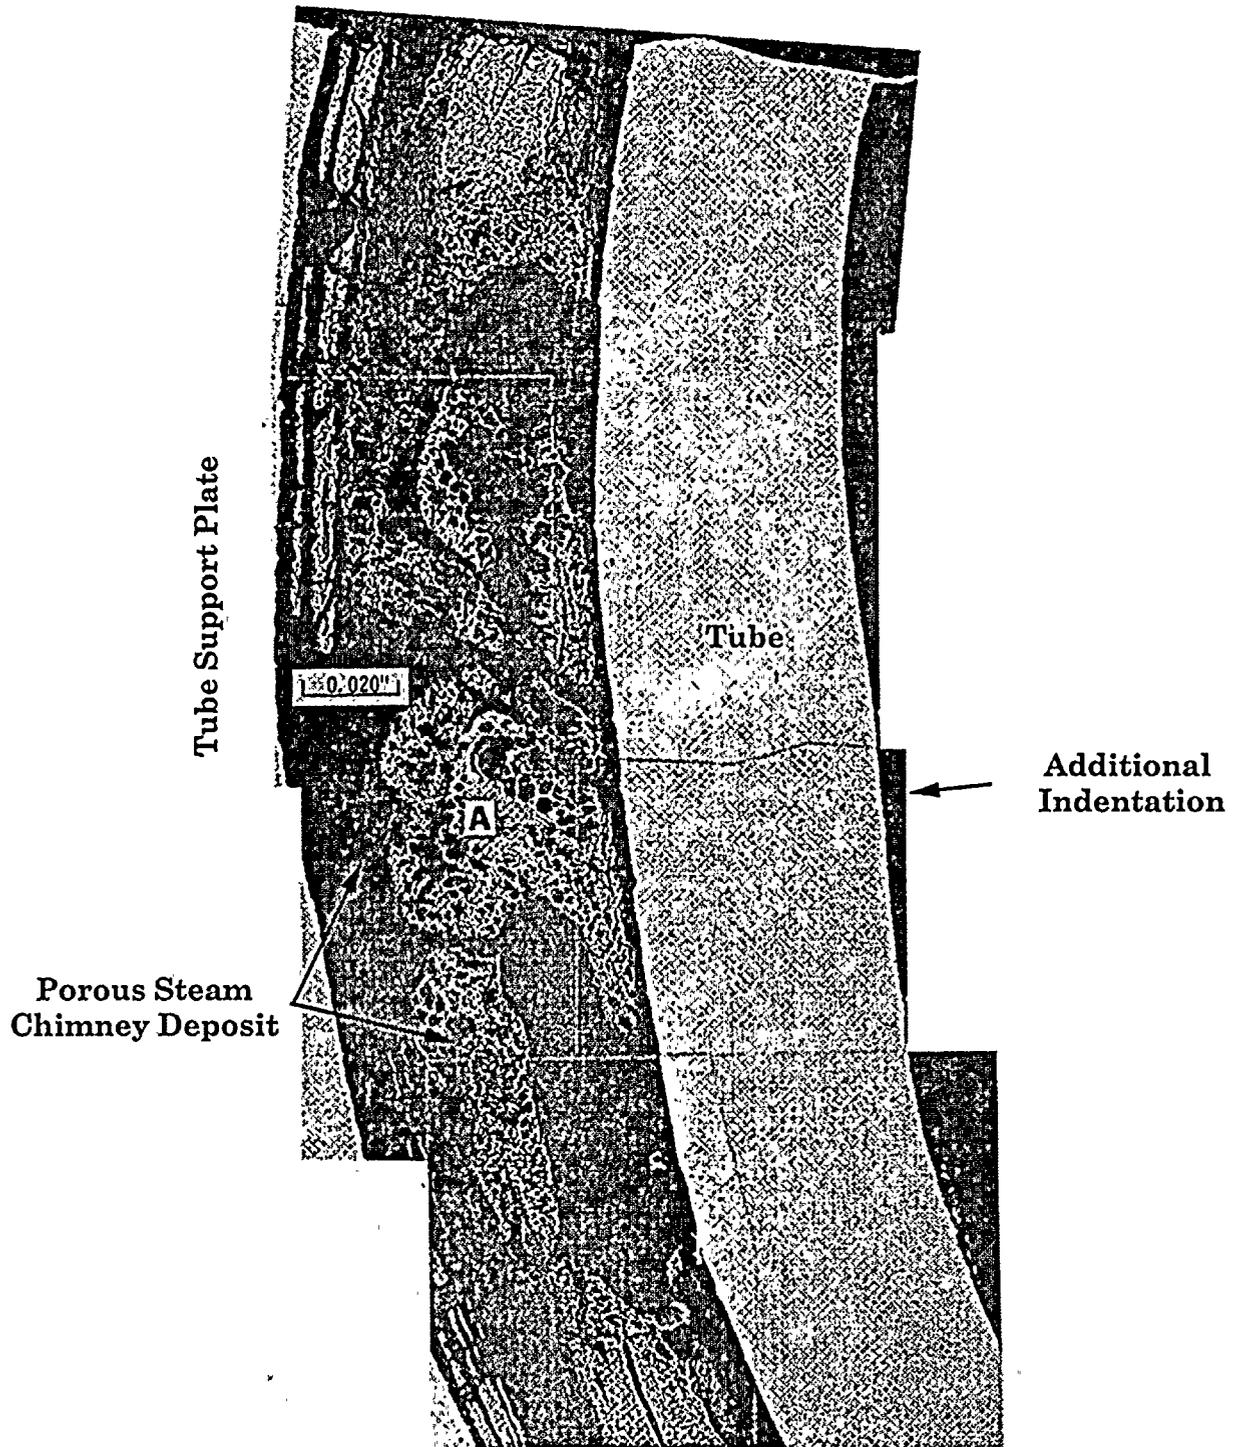
Another possibility is that steam chimneys formed in a portion of the crevice and contributed to the porosity. An example of such porosity was observed in a TSP section removed from Turkey Point 4, Steam Generator C, in 1976 while the plant was still operational, as shown in Figure 4. The particular TSP intersection shown was cut axially for one sample and then the remainder was polished in the direction of the face of the TSP to provide the metallographic sample illustrated in Figure 4. Denting magnetite has formed over the entire circumference of the crevice boundary, and the tube was uniformly dented, in the radial direction, by the forces exerted by this corrosion product. A region of exceptional morphology exists, just to the right of the 180 degree location, on the sample at the top of the figure. This area is enlarged in the cutaway and shows a porosity that is believed to exist as a result of a "steam chimney" in the crevice that allowed refreshment of secondary side contaminants to concentrate

Figure 5. Turkey Point 4 Dented TSP Section Shows Additional Deformation of Tubing in Porous "Steam Chimney" Region.

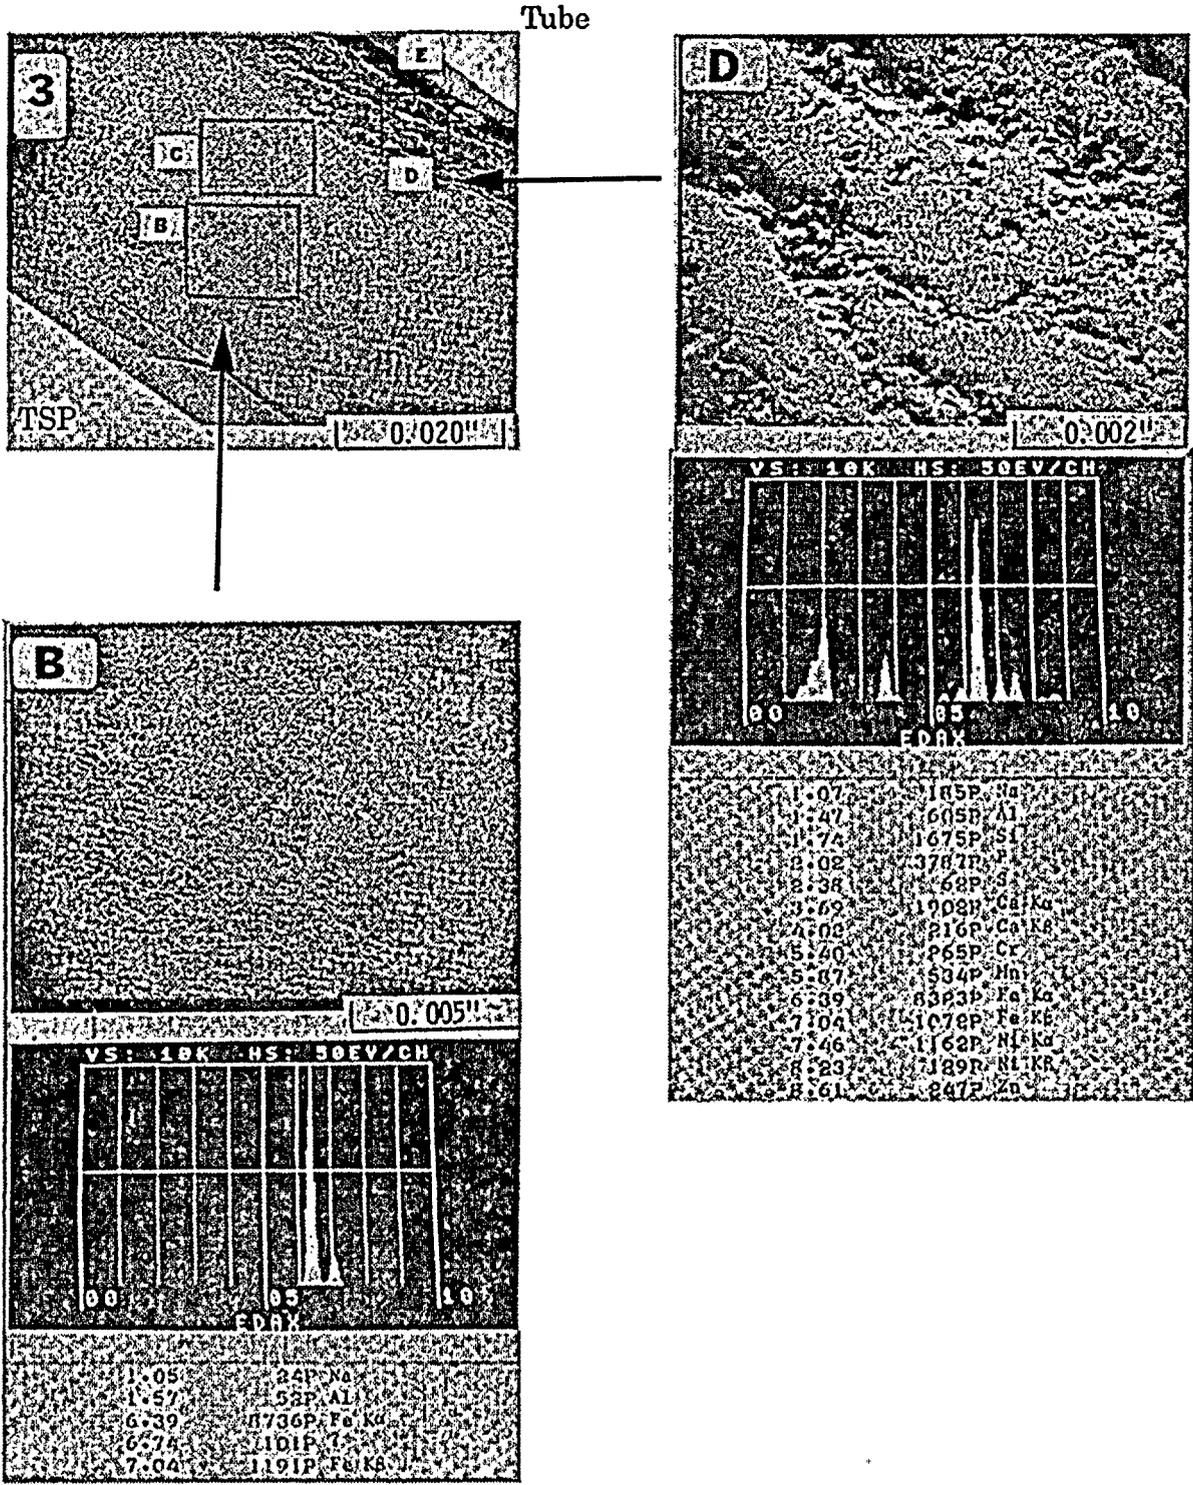
Figure 6. Micrographs and Energy Dispersive X-ray Analysis Shows Mineral Forming Elements in the Crevice Region Near the Tube and Iron Oxide Composition in the Denting Region Closer to the TSP. (Turkey Point 4 Dented Tube Support Plate Examination)

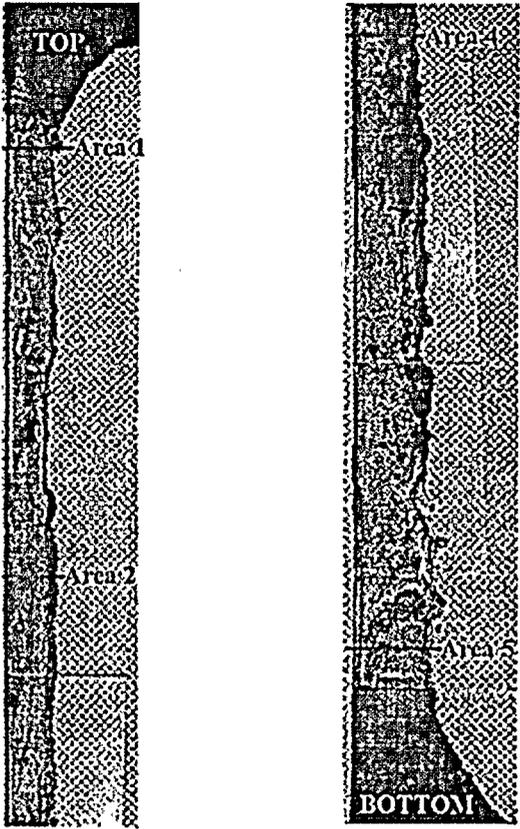
**Figure 7. Metallographic Cross Section of Ringhals 3 TSP
Sample Displays the Same General Features as the
Dampierre 1 Crevice Examination.**

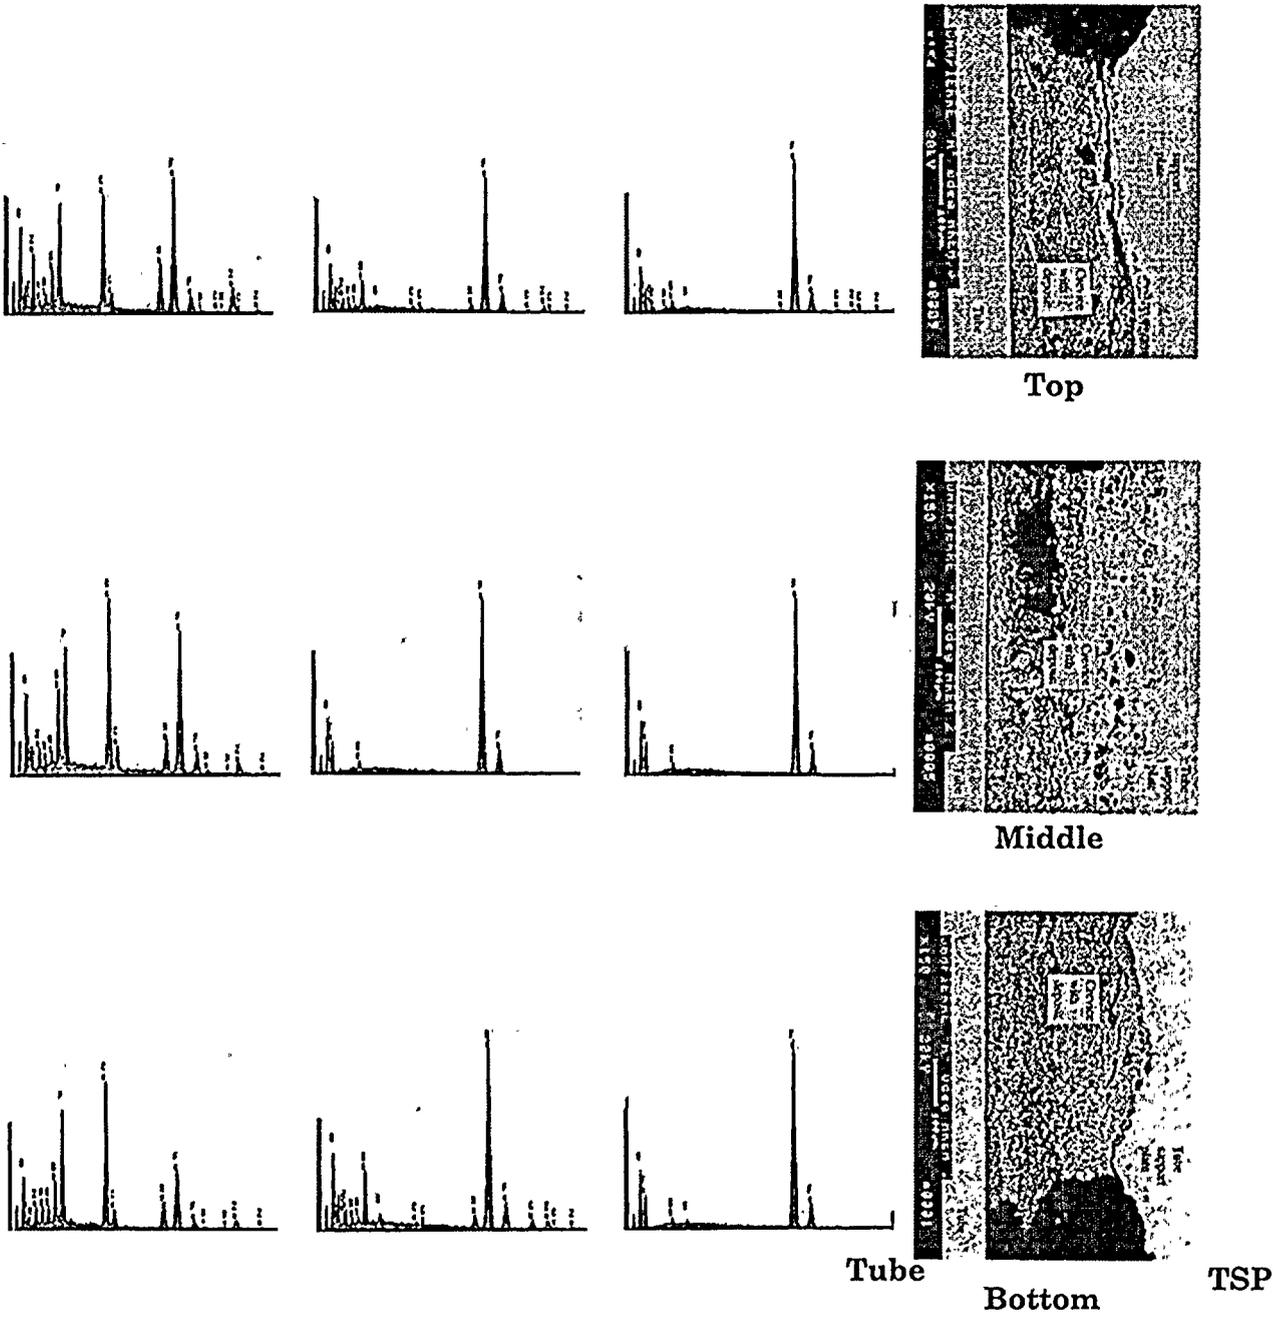
Figure 8. Cross Section Crevice Examination of
Dampierre 1 Tube Support Plate Specimen
Following Chemical Cleaning Test
