Subject: 10CF21 Notification of existence of a reportable
 defect in class IE Diesel Generator.

EI-3313

Subject: 10CFR21 - Conclusion of Investigation of Probable Causes of a Defect in Class 1E Equipment Reported by EI-3306. Palo Verde, Unit 3, D-C Serial 17609966 & 969.

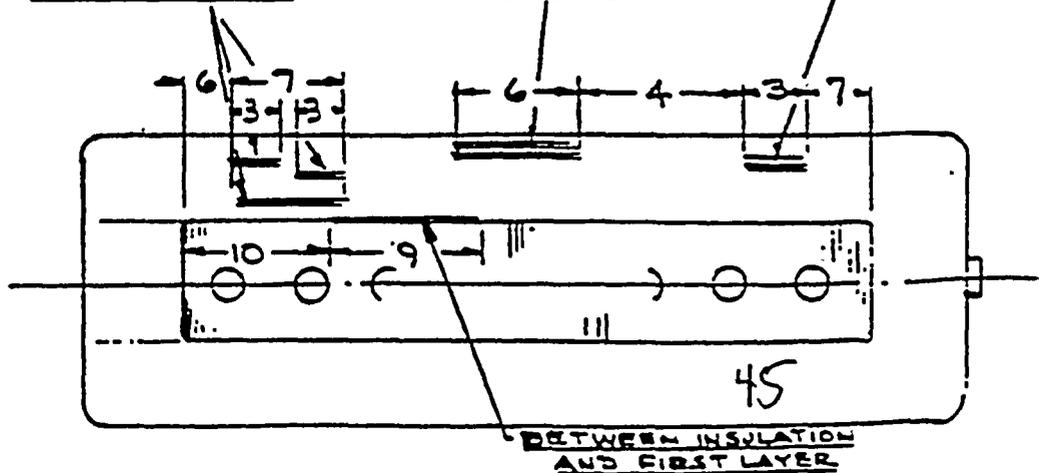
- a) Pole stack was tight.
- b) One end ring tab was bent.
- c) Insulation washer (bottom) was in good condition - no cracks or breaks.
- d) Coil winding, which remained on pole assembly, appears to be bonded and tight. There are voids in between layers on one side of pole only. These were .010 to .015 wide and one wire deep. Location of voids per sketch below:

- BETWEEN LAYERS BETWEEN LAYERS BETWEEN LAYERS
384, 485, 586 687, 889 586, 687

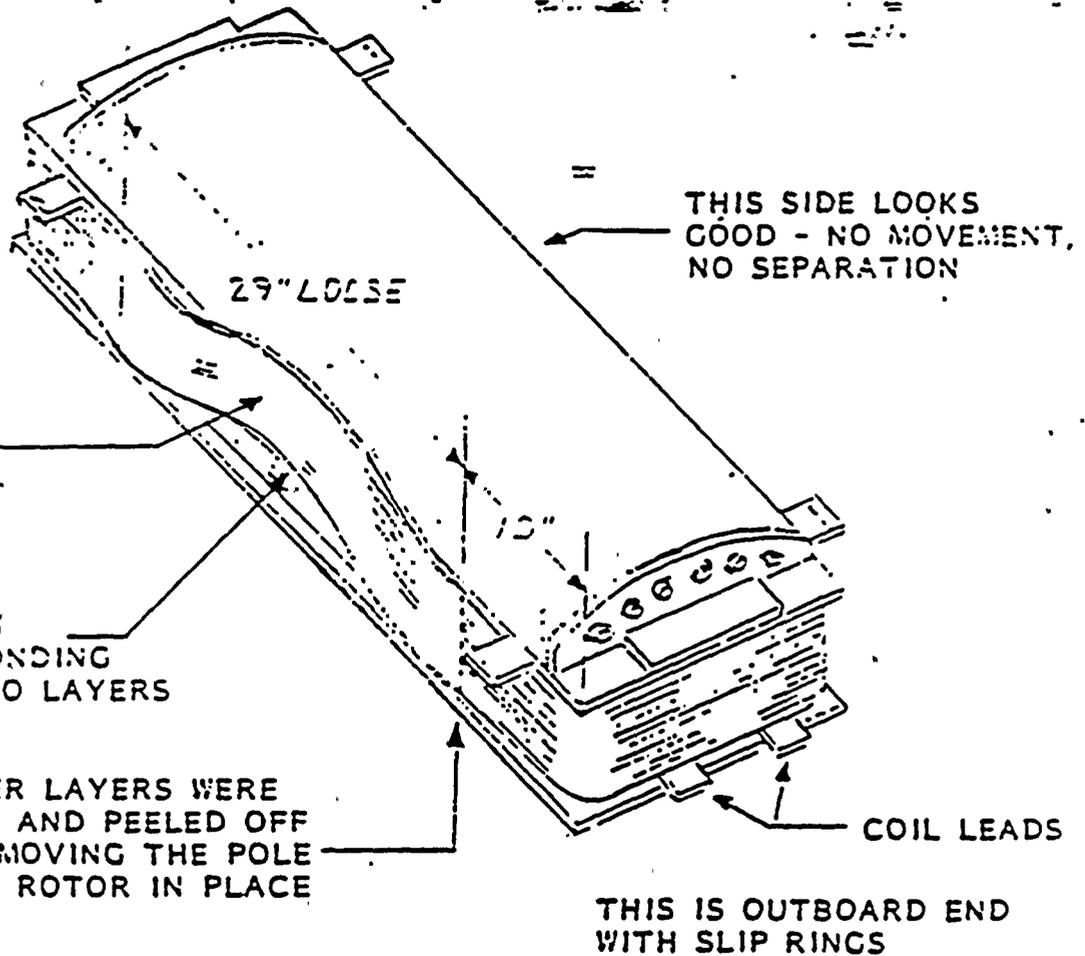
Sketch of the failed rotor pole coil, Serial Number 17609966

As apparent from Ref. f., the outer winding layer, one wire thick, separated on one side of the pole from the rest of the coil "as a sheet" deflecting outward due to centrifugal forces acting on individual wires (turns) of the layer. In spite of the complete resin bond failure between this "sheetlike" layer and the rest of the coil, resin bonds between adjacent wires of this "sheet" remained mostly intact. Although two outer layers were cut and "peeled off" from the coil before it reached our Lab, some wires of the outer layer (with black varnish coat) remained bonded together in pairs, or groups of three and four, giving an indication that the bond between individual wires of the outer layer was considerably stronger than that between the outer layer and the rest of the coil. This fact can be considered as conclusive evidence that the wire

Note: Bottom washer was removed in G.E. Repair Shop. Inspection from the bottom indicates voids and spaces all around, more noticeable on the ends. Two outer layers were cut and peeled off intact as sheets. Wires did not separate.

It is recommended that the failed rotor pole be rewound with no change in the originally specified materials or manufacturing technology. When accepted upon the specified routine inspection and tests, it shall be returned to Palo Verde renewal parts stores for future use.
