Commonwealth Edison Company

Subject: Additional Information Relative to
Provisional Operating License DPR-19
for Dresden Unit 2

INVESTIGATION OF FUEL DEFECTS

DRESDEN-2 CONTROL ROD DRIVE OPERATIONAL REPORT

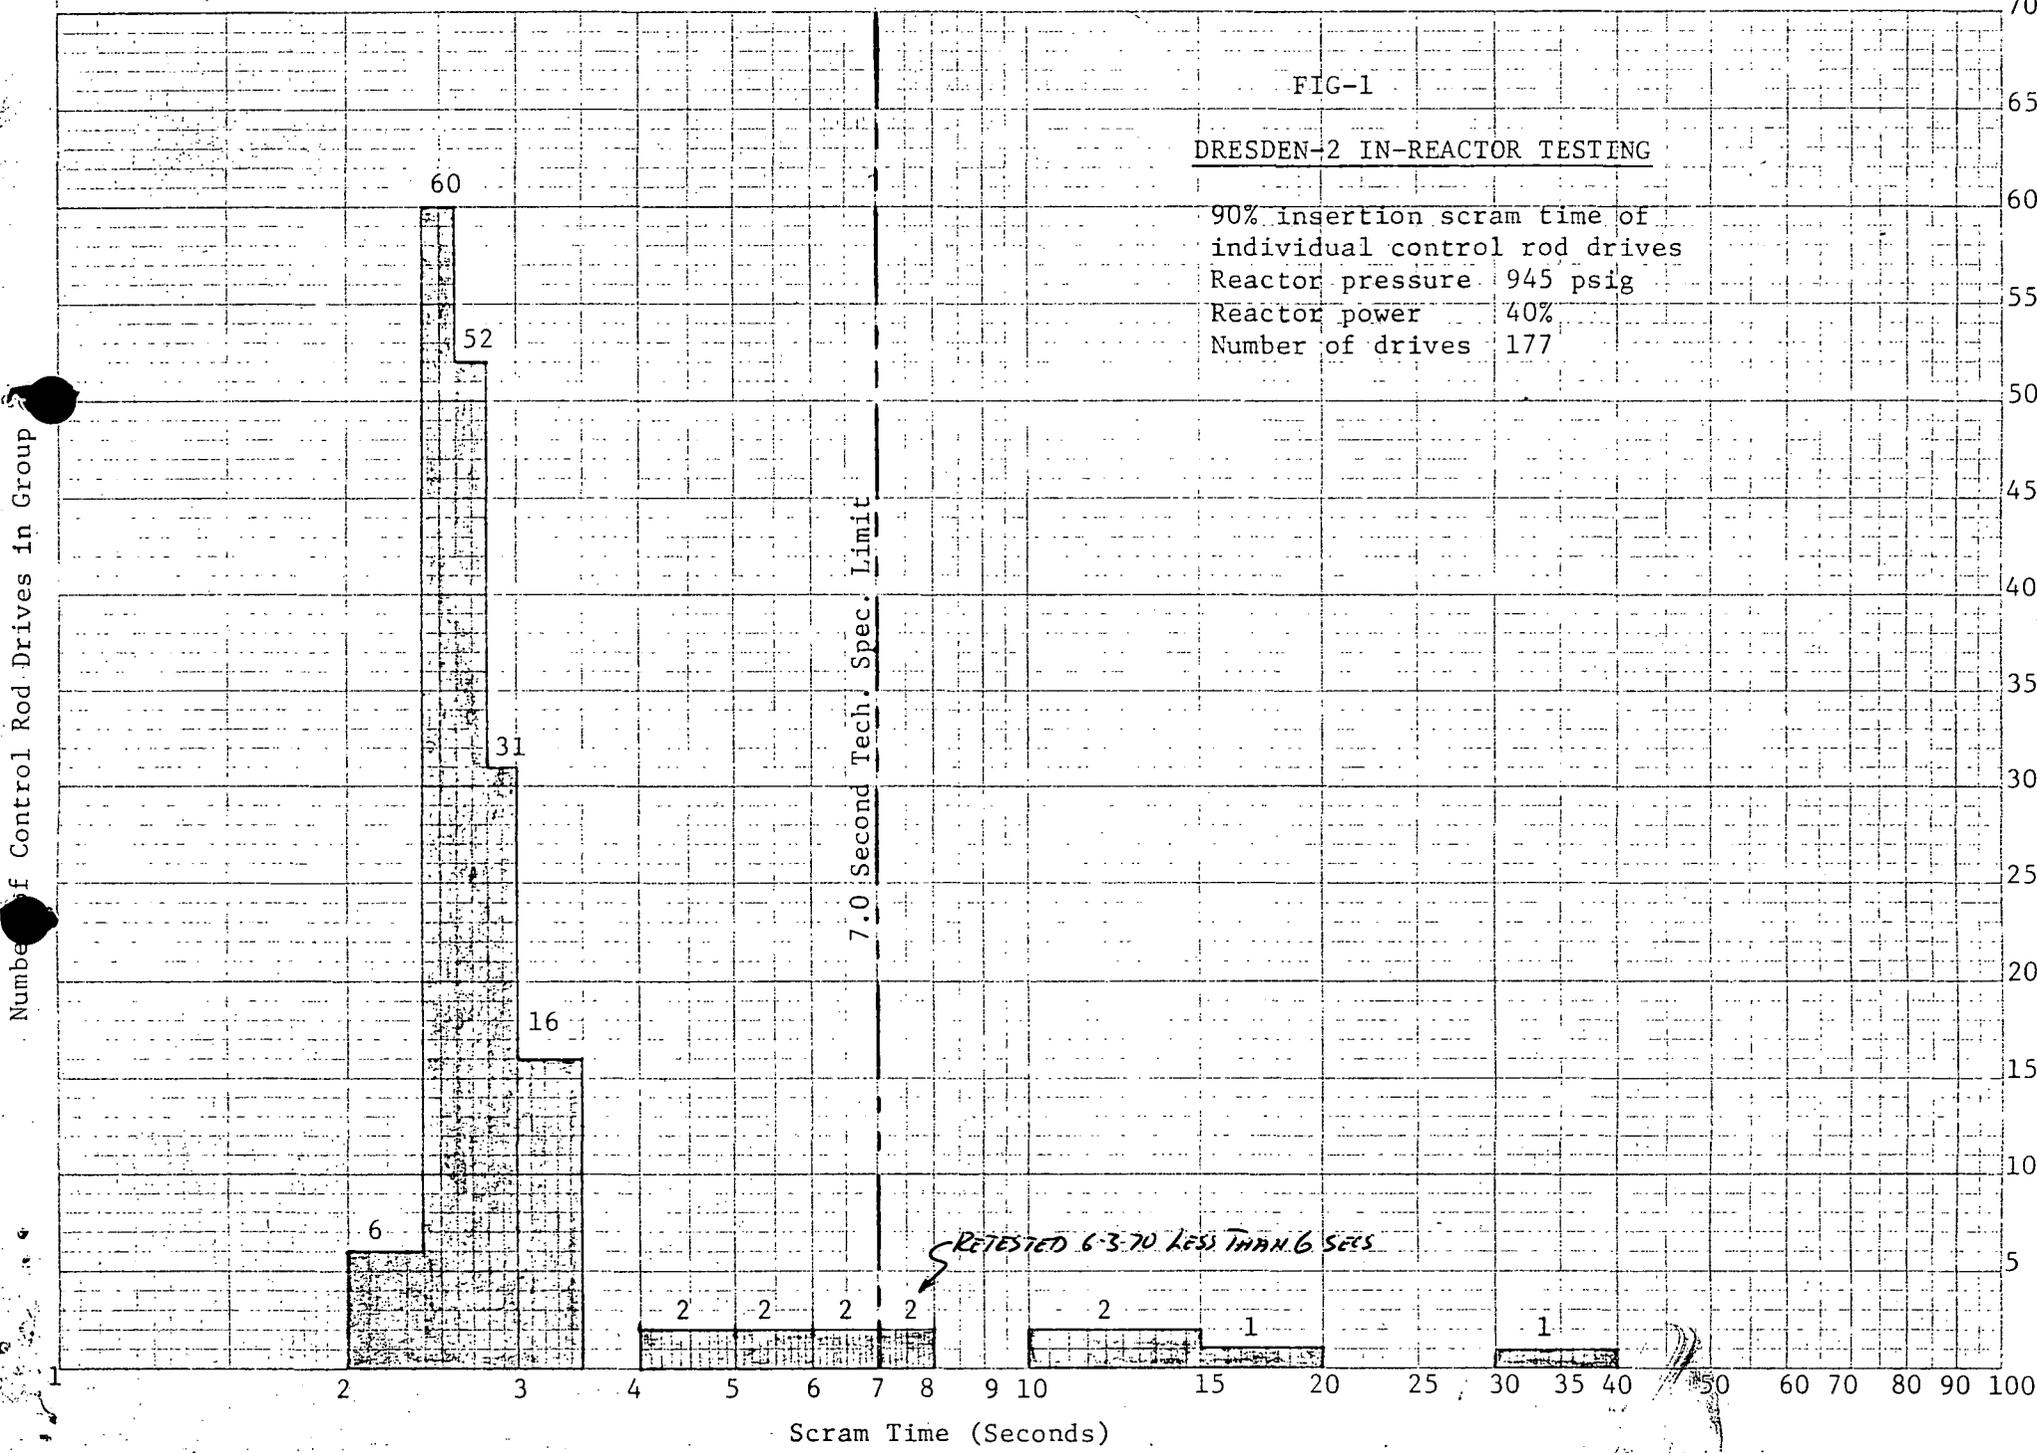
FIG-1

During the Dresden 2 startup test program, it was found on several occasions that several control rod drives were experiencing an increase in scram time between 0.4 and 1.8 seconds. Just prior to the June 5 incident (May 29th thru May 31) tests were conducted to determine scram time performance of all control rod drives. These tests revealed a scram time distribution as indicated on Fig. 1.

DRESDEN-2 IN-REACTOR TESTING

90% insertion scram time of individual control rod drives
 Reactor pressure 945 psig
 Reactor power 40%
 Number of drives 177

RETESTED 6-3-70 LESS THAN 6 SECS
