Subject: Dresden Station Units 2 and 3
 Drywell to Torus Vacuum Breakers
 Dresden Station Special Report No. 23A,
AEC Dkts 50-237 and 50-249

DRESDEN STATION SPECIAL REPORT NO. 23A

Supplemental Information Concerning Dresden Units

2 & 3 Drywell to Torus Vacuum Breakers

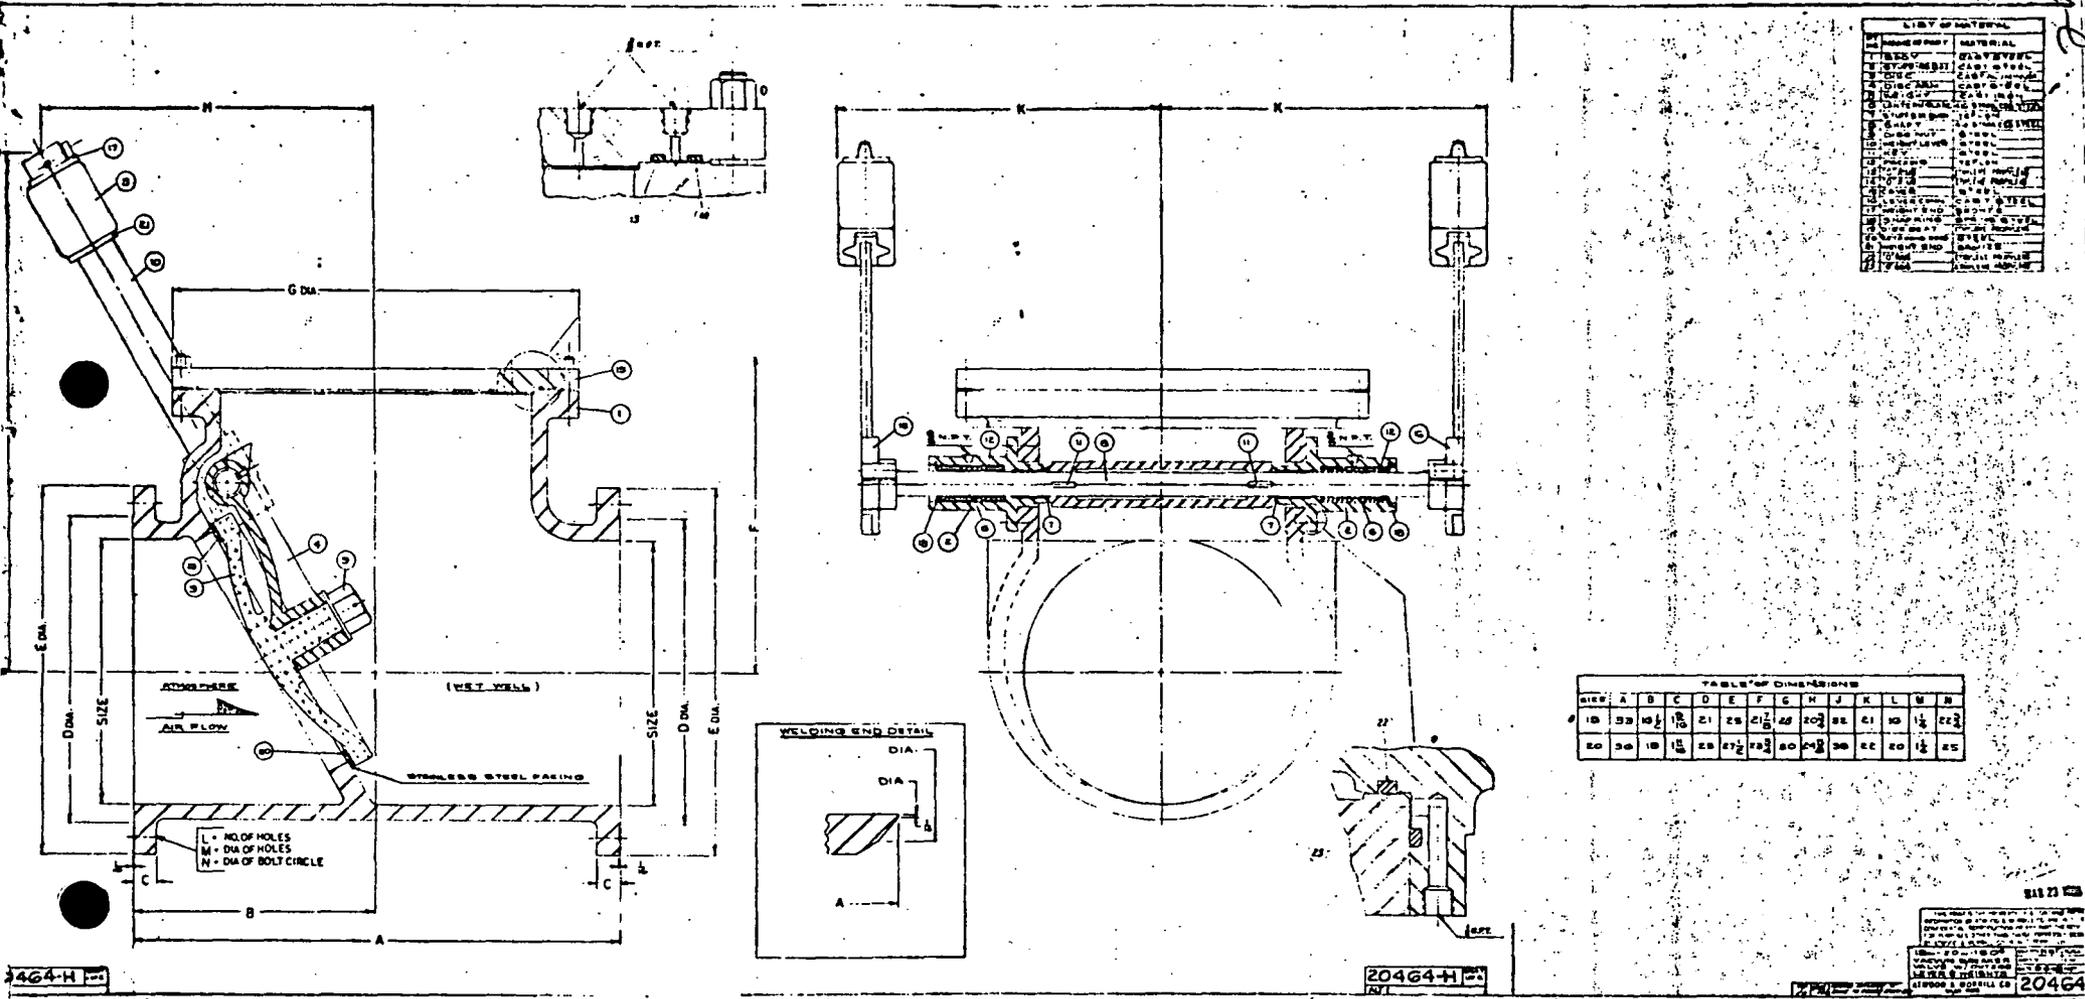
FIGURE I

Upon disassembly of the valves, it was determined that the discs of some of the valves were not squarely seating due to corrosion between the disc and the disc arm. The corrosion closed up the clearance between these pieces and prevented the disc from properly aligning with the seat. Referring to Figure 1, it can be seen that the disc is held onto the disc arm by means of an integral post or hub and a nut. Due to the corrosion, extreme difficulty was experienced in disassembling the disc from the disc arm. Attempts at separating these pieces caused failures of the post or hub flush with the rear surface of the disc or at the base of the threads for the retaining nut on several valves. The disc material is cast aluminum and the disc arm is cast steel. There was a fairly sharp corner at the base of the post and it is theorized that the lack of an adequate radius was at least partially the cause of failure. A compounding cause of failure is attributed to the seizure of the disc and disc arm. Normal closure of the valve with adequate clearances would place the base of the post in simple compression. However, the seized joint prevented proper alignment resulting in the force of closure of the valve continually being taken at the same point on one edge of the disc. This placed a bending stress on the base of the post in the area of the sharp corner every time the valve was cycled. Surveillance frequency on these valves had been increased from monthly to weekly in the light of the difficulties with the Quad-Cities valves and prior experience with the sticking of the bushings as reported in Special Report No. 23. It should be noted that all failures were caused during the disassembly and no failures were evident in the as found condition of the valves.

All twelve valves on Unit 3 underwent modification to prevent future recurrence of this problem. The posts were cut off of the discs and the discs faced on both sides to obtain true surfaces.

Redesigned post assemblies were obtained from the manufacturer of the valves. The new posts were machined from 304 stainless steel and were threaded on each end. The discs were bored to accept the new posts and the disc was attached to the post with a nut which was then locked in place. The posts were assembled to the disc arm with a high temperature, low chloride, anti-seize compound to preclude future corrosion and subsequent seizing.

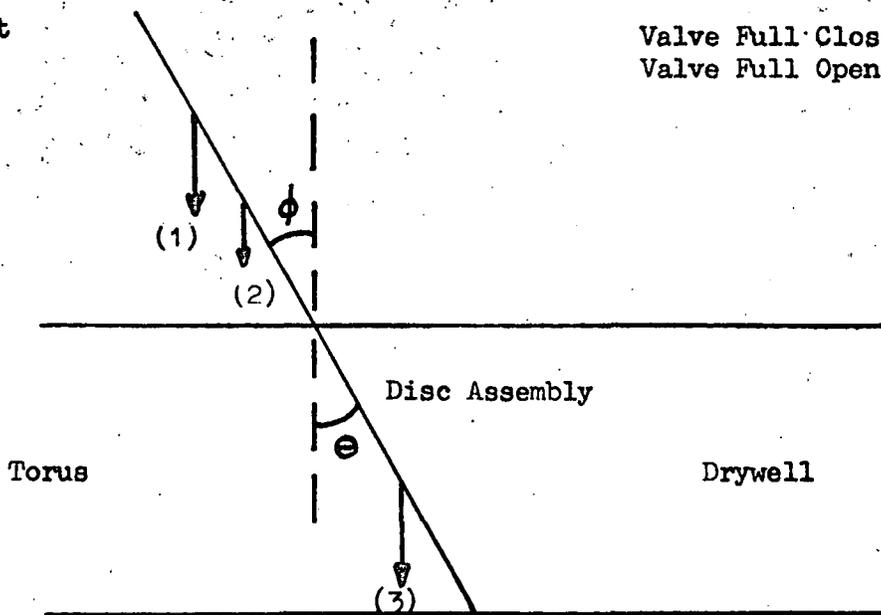
Schematic Representation of 18" Vacuum Breakers on Dresden 2 and 3

During the course of these modifications it became evident that the counterweight assembly on Dresden 3 also differed from that reported in Special Report No. 23. The counterweight configuration described in that report does indeed exist at the present time on Dresden 2. The Dresden 3 system utilized twenty-five pound weights as opposed to ten pound weights and had considerably longer counterweight arms. Consequently, modifications were in order in this area also.

One of the two counterweight arms and twenty-five pound weights were completely removed from each valve. The remaining arm was rotated 20° to a position 10° from vertical with the valve in the fully closed position. This configuration is contrasted with the original configuration of Dresden 3 in Figures 2 and 3. While the Dresden 2 counterweights are presently as reported in the Special Report, and are now technically acceptable, they will undergo modification to make them identical to Dresden 3. In addition to making the counterweight assemblies similar, it will increase the range of counterweight adjustment and yield identical limit switch installations. This modification is to be accomplished by August 31, 1973. The Dresden 2 valves will undergo modification of the discs to accept the redesigned posts and new ethylene propylene seats will be installed during the next refueling outage, presently scheduled for fall of 1974.

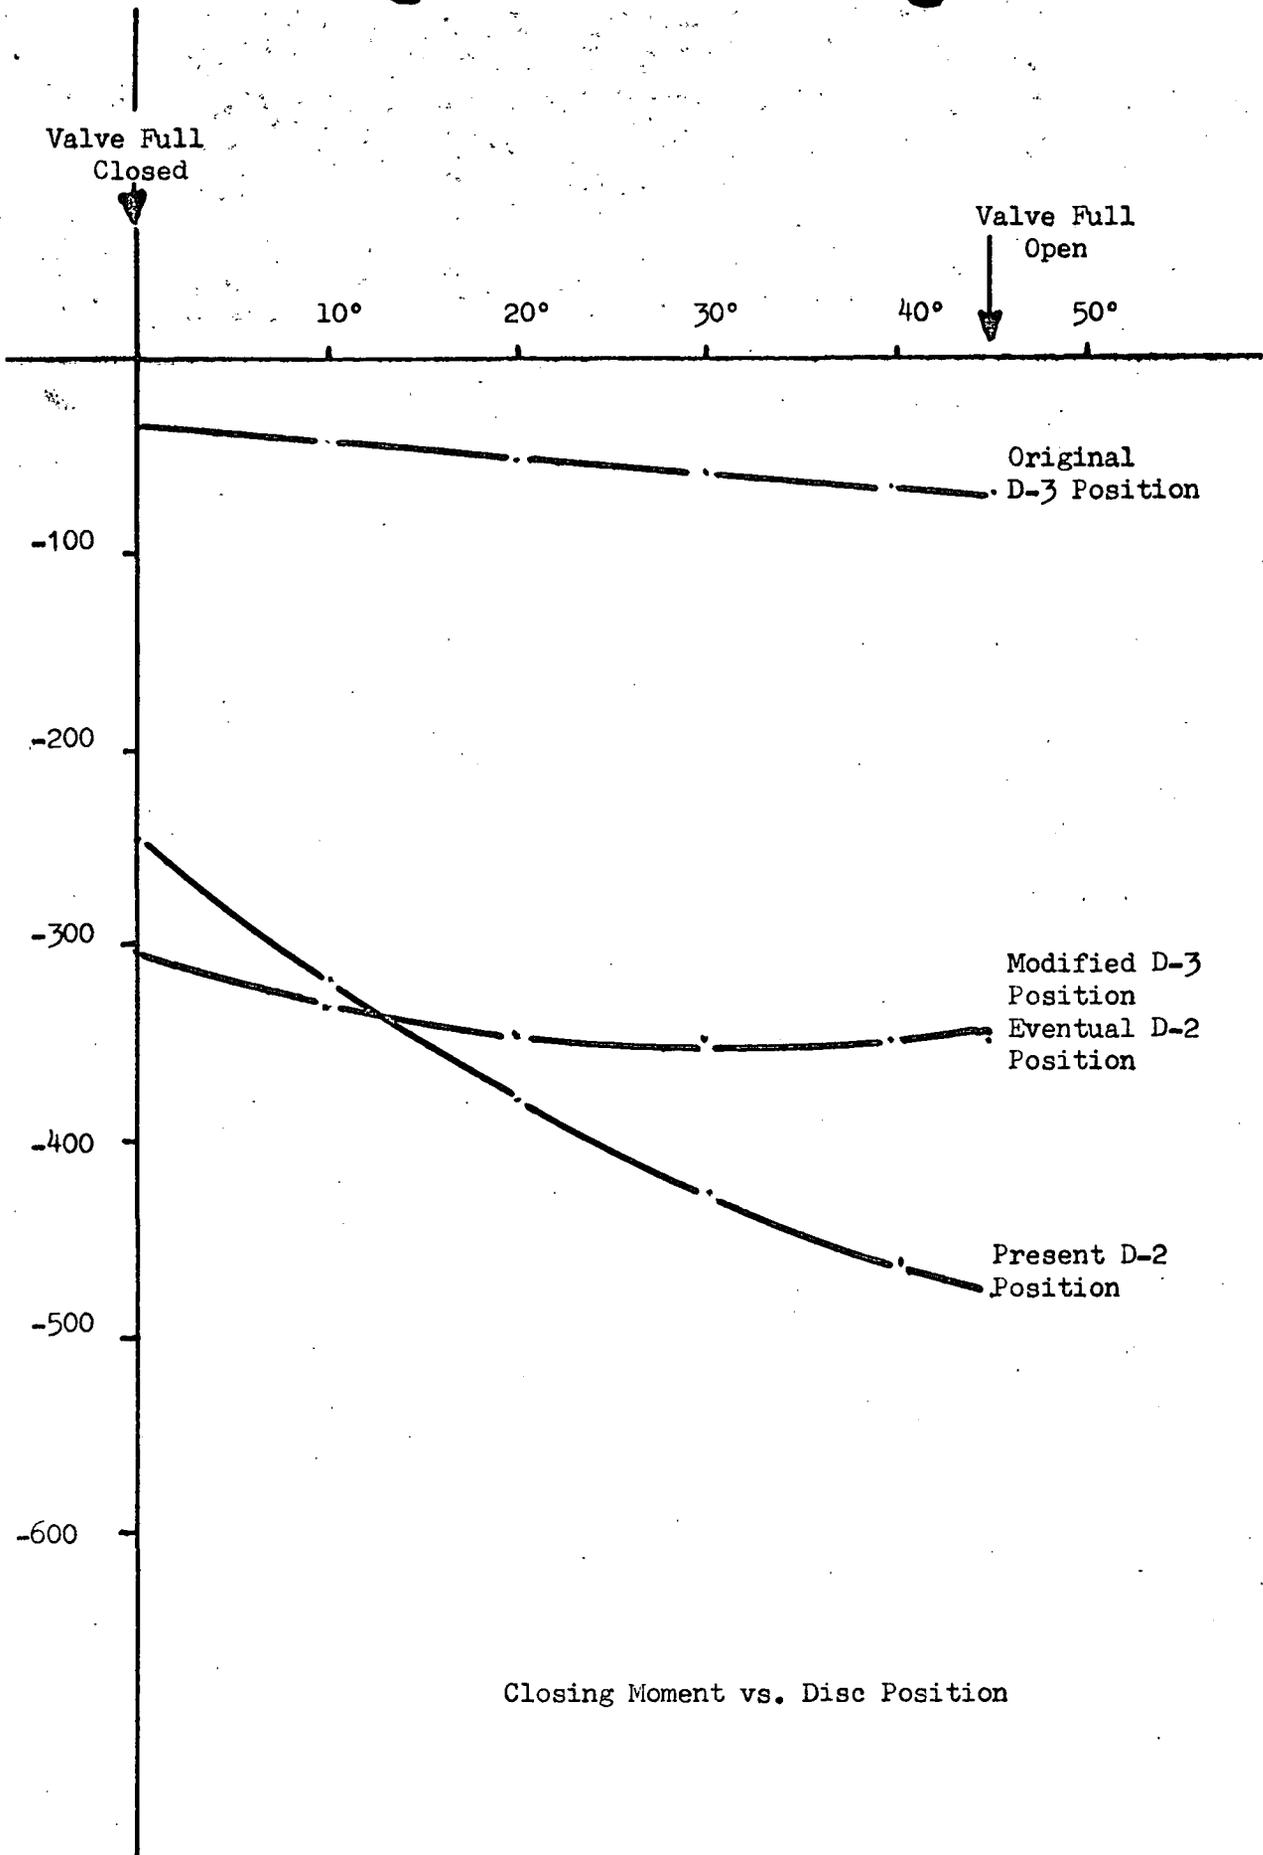
Figure 3

Closing Moment vs. Disc Position
