Subject: Supplement B to Special Report No. 18  
for Dresden Unit 2/3 - AEC Dkts 50-237 and 50-249

Supplement B to Special Report No. 18

Dresden 2/3 Safety Valve Investigation

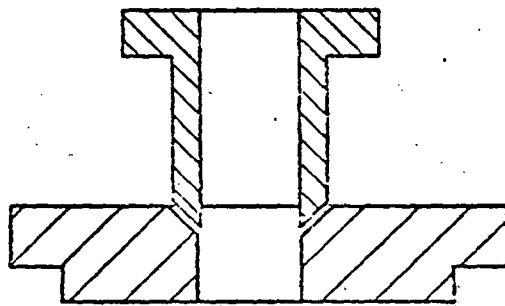
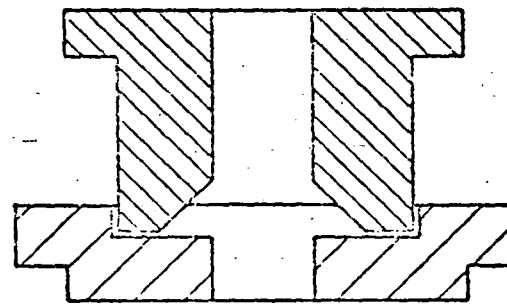
Figure 1 Proposed modification of the upper spring washer and compression nut.

The connection between the upper spring washer and the spring compression nut is not adequate to resist the eccentric load applied by the safety valve spring without tilting. The compression nut can be increased in diameter so that the eccentric load applied by the spring to the upper spring washer can be resisted without tilting of the upper spring washer. (See Figure 1)

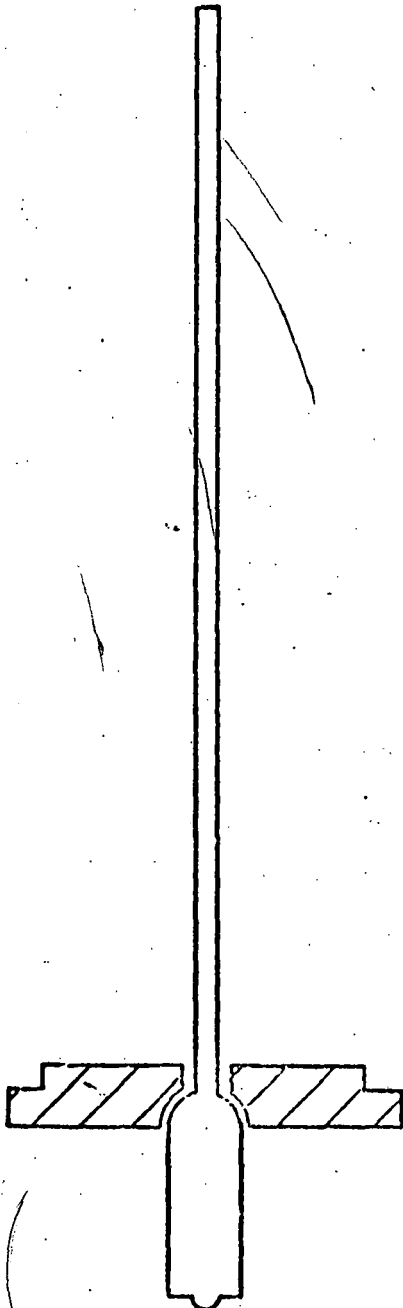
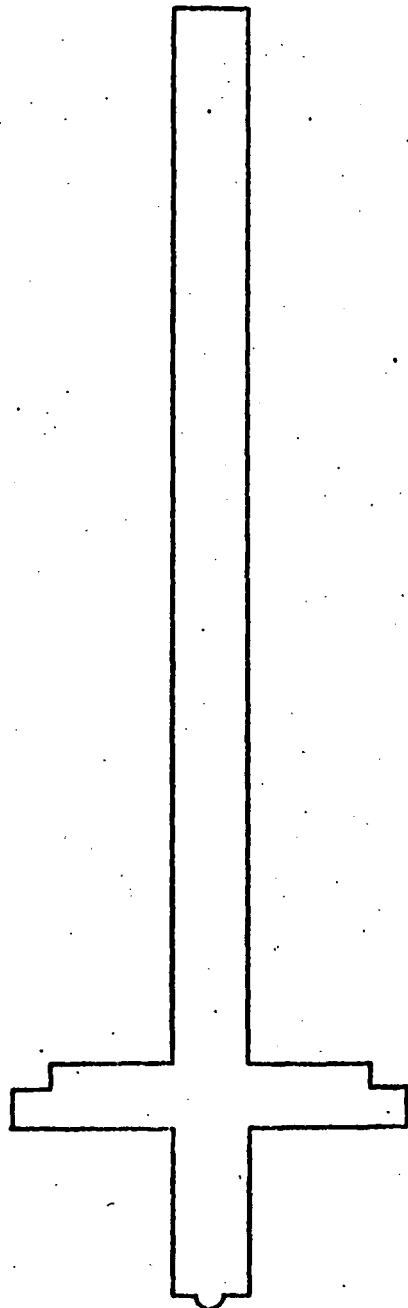
Figure 2 Proposed modification of the lower spring washer and spindle.

The connection between the lower spring washer and the safety valve spindle is a spherical surface whose purpose is to permit the lower washer to tilt to accommodate the eccentric load that the spring exerts on the washer. This tilt capability is believed to be responsible for the alignment problem. Briefly stated, this design feature can be postulated to allow tilt angle changes when the valve is subjected to shaking forces. Tilting of the washer to a different degree relative to the tilt angle when the valve was set can result in variations in pop point since the tilting causes variations in the compressed length of the spring. One solution to this problem would be to make the lower spring washer and the spindle an integral component of the valve thus eliminating the tilt capability and the problems which appear to be associated with it. (See Figure 2)
