# Commonwealth Edison Company

Dresden Nuclear Power Station  
R. R. #1  
Morris, Illinois 60450  
October 2, 1972

SUBJECT: LICENSE DPR-19, DRESDEN NUCLEAR POWER STATION - UNIT #2

This is to inform you of the results of our investigation into the reduction in flow on the "B" main steam line of Dresden Unit 2. (Ref. letter September 7, 1972).

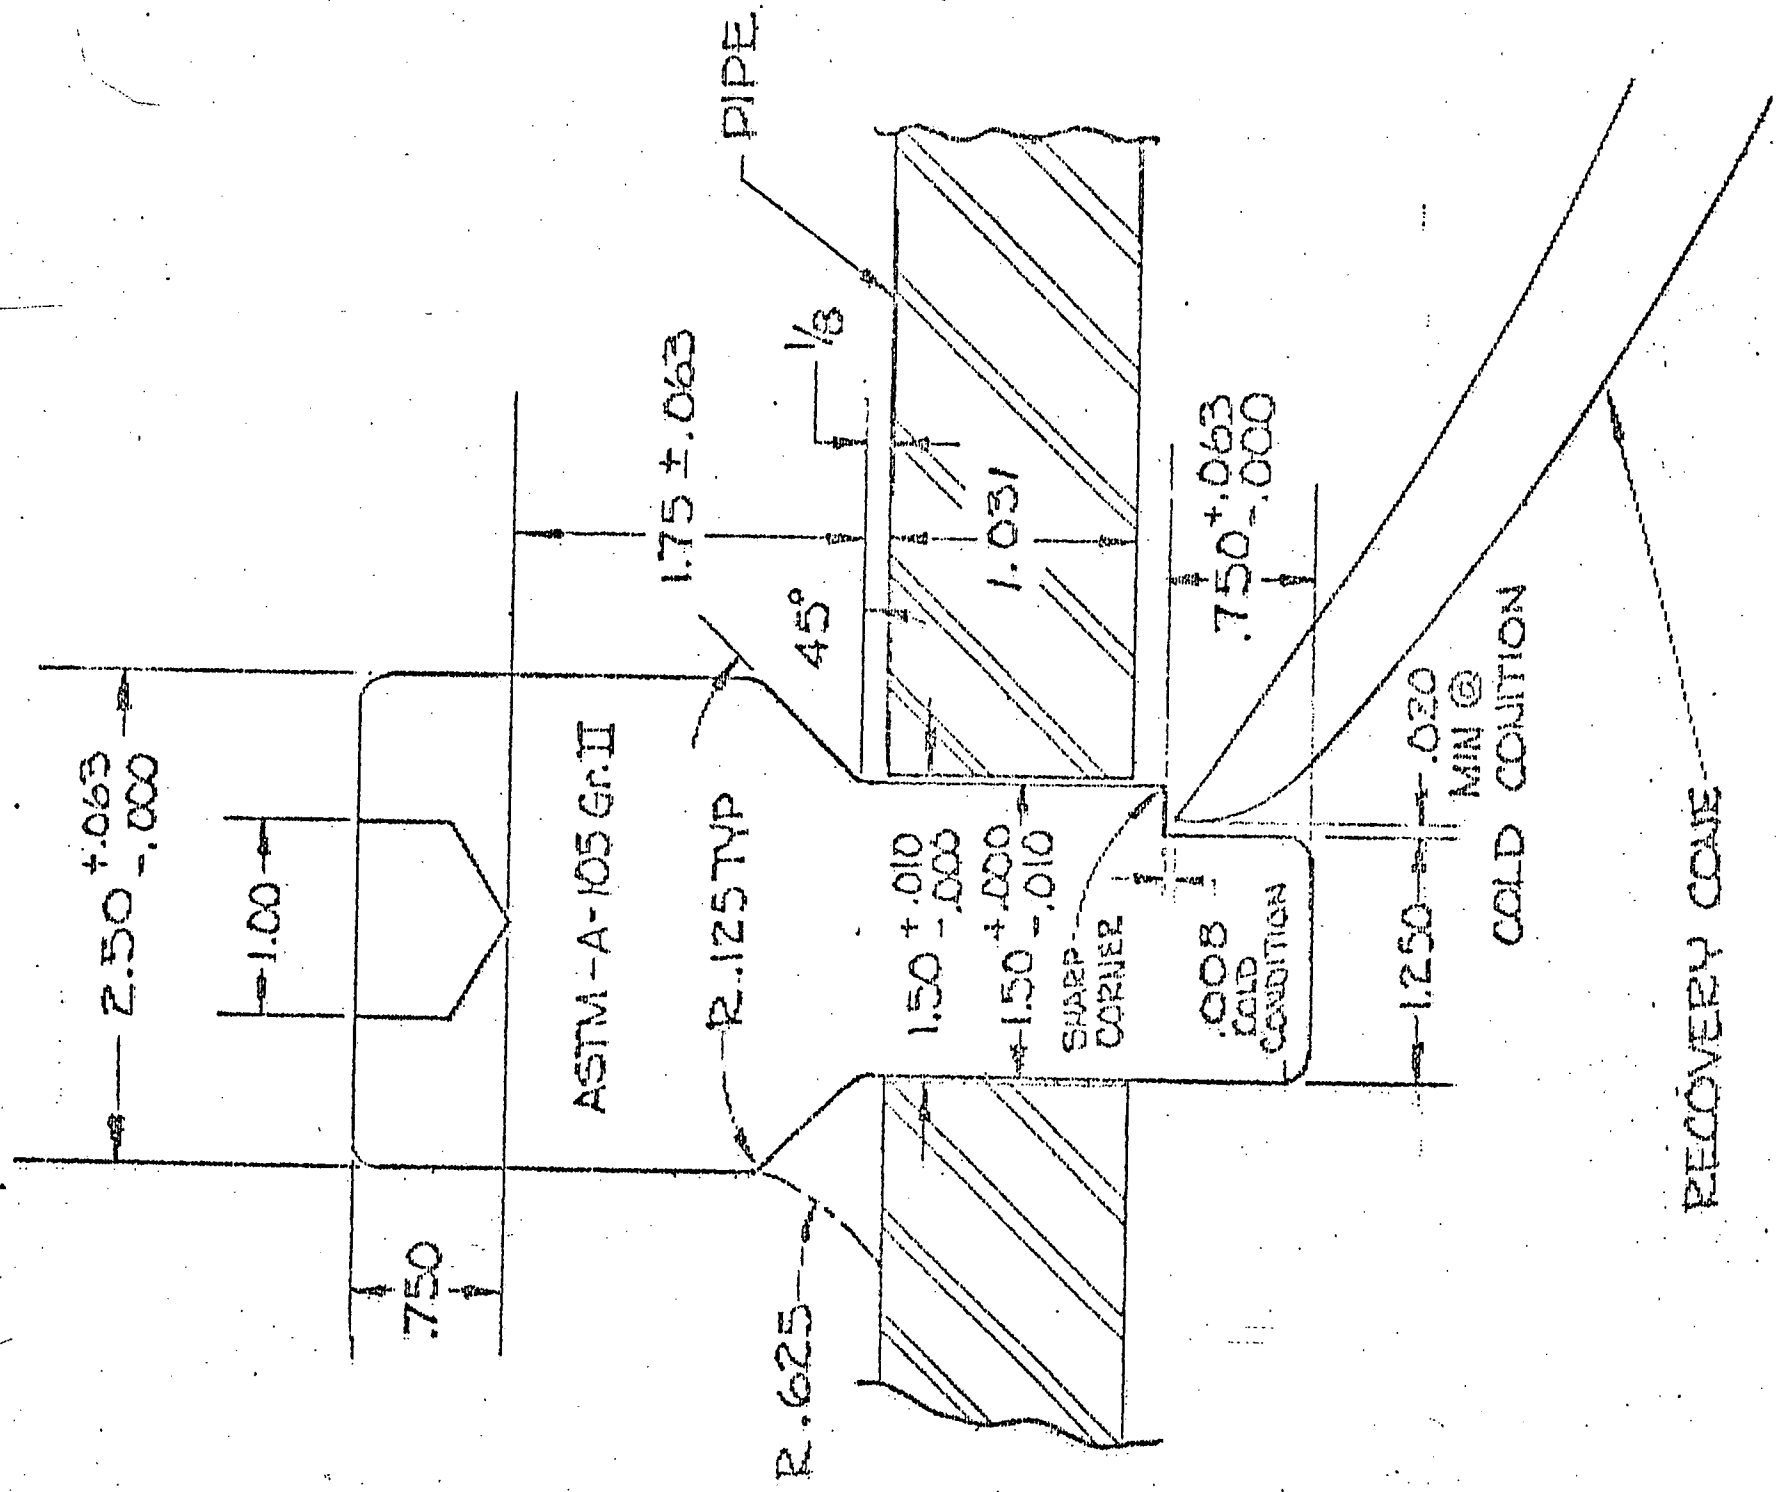
FIG. 1

1. The Dresden II main steam flow element is modified by installing three (3) pins at 120° apart downstream of the recovery cone, with a clearance of .020" minimum to take care of the differential thermal expansion between pipe (carbon steel) and flow element cone (stainless steel) as shown on Figure 1, attached. Based on the assumption that the throat-to-recovery-cone weld on the A, C & D lines fail, these pins are designed to prevent the recovery cones from moving down stream into the MSIV. These pins will also prevent any vibration of the downstream recovery cone that may exist during operation. Stress analyses show that if the downstream cone should fail and be held by only one pin, the pin shear stress will be 13,866 psi if 100 psid exists across the restrictor. This assumption is very conservative because normal operating differential is approximately half of this. The allowable stress for this emergency condition is 90% of yield strength, or 27,800 psi (Note:  $S_m = 18,600$ ). Since the maximum stress with only one pin carrying the load is 13,866 psi, the design of the pins is more than adequate.

Area replacement was also considered in designing these pins, based on ASME-Section III, 1971, Paragraph NE-3643.3 - Reinforcement for Openings.

$$\text{Area removed} = 1.389 \text{ in}^2 \quad / \quad \text{Area Available} = 1.688 \text{ in}^2$$

Combined stress in 1½" pin weld is 9,259 psi. Includes pressure and temperature stress plus the stress due the cone resting on one pin. Allowable stress is 18,600 psi.

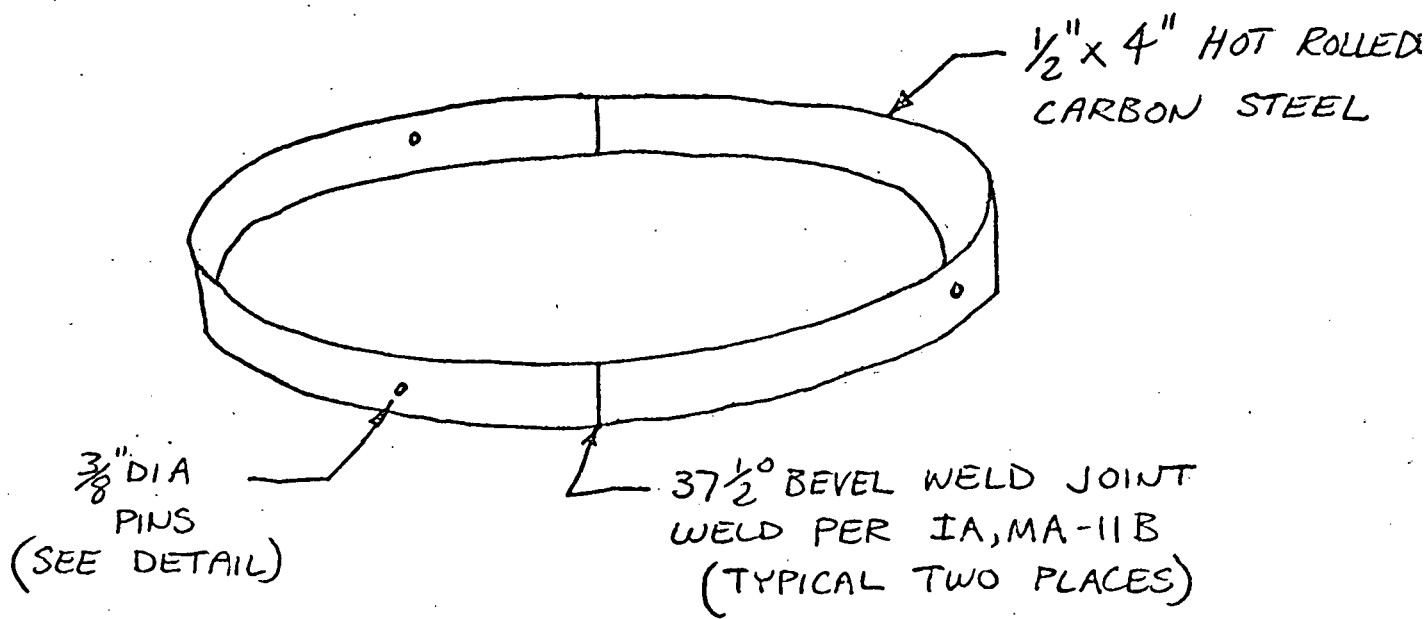
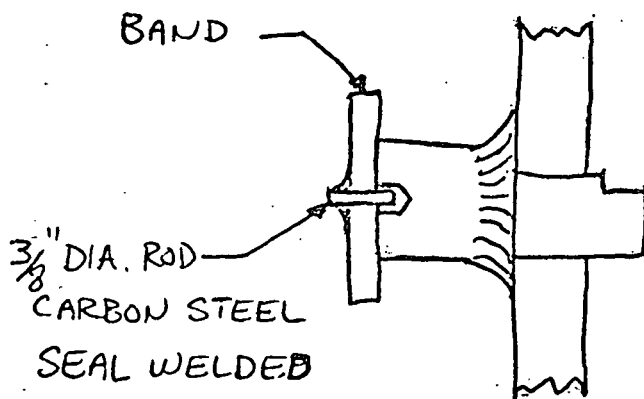
FIG 1A

A retaining clamp, or "belly band", has been installed around these pins as indicated on Figure 1A attached. Because the pins are not threaded into the pipe, this was added to prevent expulsion of the pins in the unlikely event that the welds were to fail.

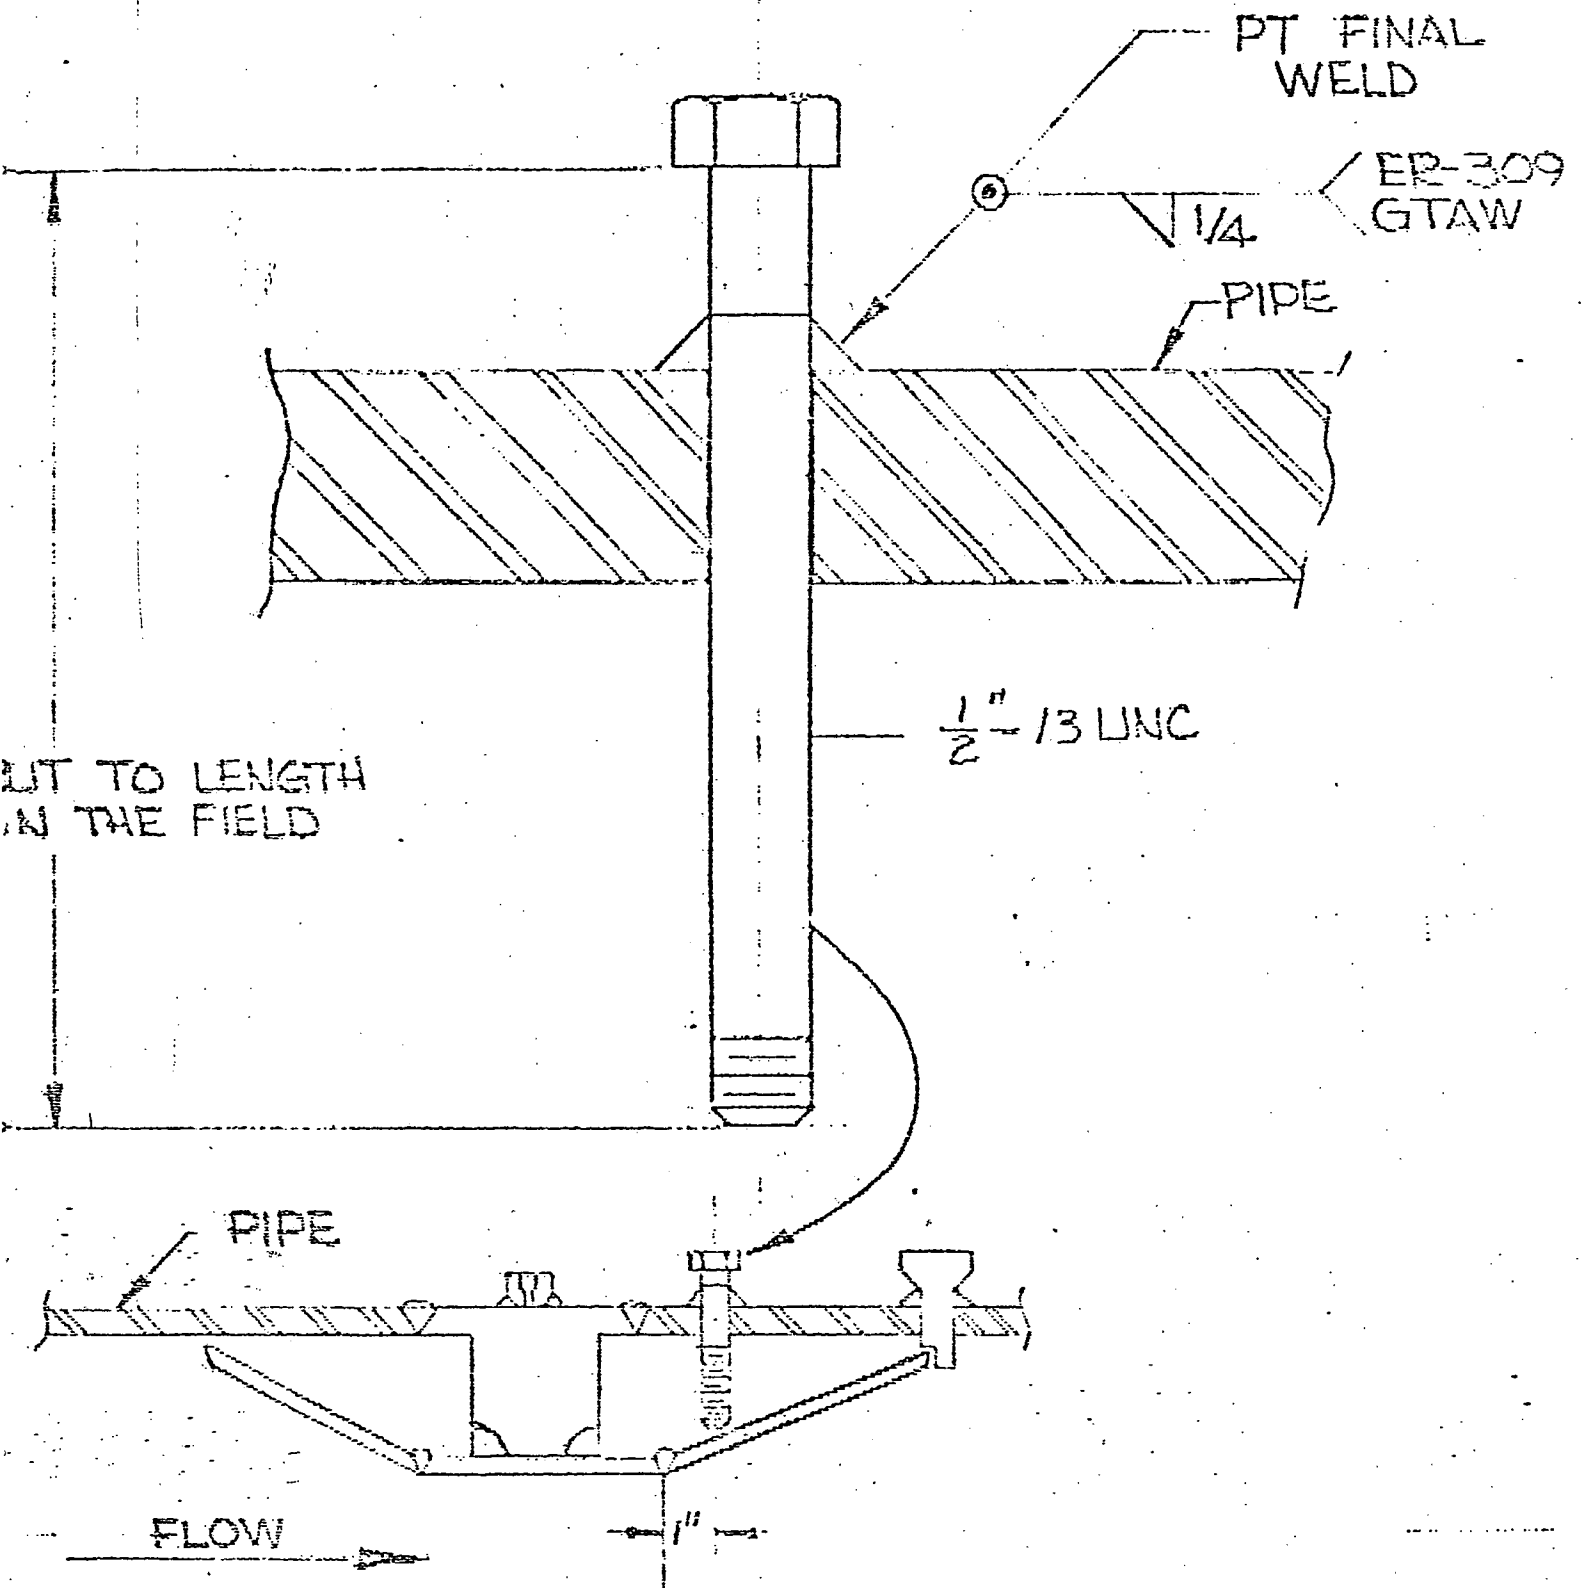
# RECOVERY CONE PIN

2. Figure 2 shows the design of the 3-½"-13 UNC bolts installed at the upstream end of the recovery cone, 120° apart. These bolts will prevent any vibration of the cone, in case of failure at the weld adjacent to the three bolts, hence no effect on the differential pressure signal. Material, welding rod, examinations of weld, and exact location and clearances are as shown on the attached Figure 2.
3. The initial pin weld passes were visually inspected and the final passes were inspected by liquid penetrant. The 1½" bolts were ultrasonically inspected following installation to ensure integrity of the weld, pin, and pipe. The final installation was then hydrostatically tested at 1000 psig cold.
