NRC INFORMATION NOTICE 2017-05:

POTENTIAL BINDING OF SCHNEIDER ELECTRIC/SQUARE-D MASTERPACT NT AND NW 480-VAC CIRCUIT BREAKER ANTI-PUMP FEATURE

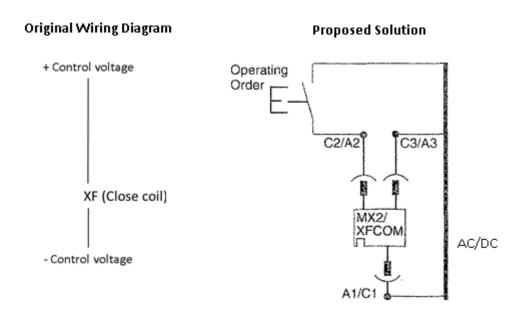
Appendix B, "Quality Assurance Criteria for Nuclear Power Plants and Fuel Reprocessing Plants," to 10 CFR Part 50, Criterion III, "Design Control," requires, in part, to subject design changes to control measures commensurate with those applied to the original design. The Masterpact breakers used at River Bend and at several other sites are a modification from the original General Electric AKR electrically-operated breakers. The original breakers used an electrical anti-pump interlock feature. The change from the electrical anti-pump interlock to a mechanical anti-pump interlock feature introduces mechanical binding as a potential failure mode.

Additional breaker testing by Schneider Electric identified the following five scenarios in which the circuit breaker could be more susceptible to the mechanical binding condition that would prevent the breaker from being able to reclose on command:

Figure 1 The XF coil in the original logic is replaced by an XFCOM coil, which releases the close coil plunger as soon as the close signal is received, eliminating the potential for binding

In Technical Bulletin TB-12-007, Revision 3, which is attached to the referenced 10 CFR Part 21 report (ADAMS Accession No. ML16278A471), AZZ/NLI provided a proposed modification to the breaker and an updated circuit diagram, shown in Figure 1. This modification replaces the normal XF coil in the breaker with an XFCOM coil. The XFCOM coil acts as a oneshot and releases the close coil plunger immediately after the close signal is applied to the breaker and will not reactivate the close coil plunger unless power is first removed from the operating order signal of the XFCOM and then re-applied. With the closing coil plunger retracted, this modification is designed to eliminate the potential for mechanical binding from the anti-pump feature.
