Commonwealth Edison
 One First National Plaza, Chicago, Illinois
 Address Reply to: Post Office Box 767
 Chicago, Illinois 60690

Subject: Dresden Station Unit 2
 Feedwater Nozzle Temperature Transients
NRC Docket Nos. 50-237

DRESDEN UNIT-2 FEEDWATER NOZZLE
TEMPERATURE DATA REVIEW AND TESTING

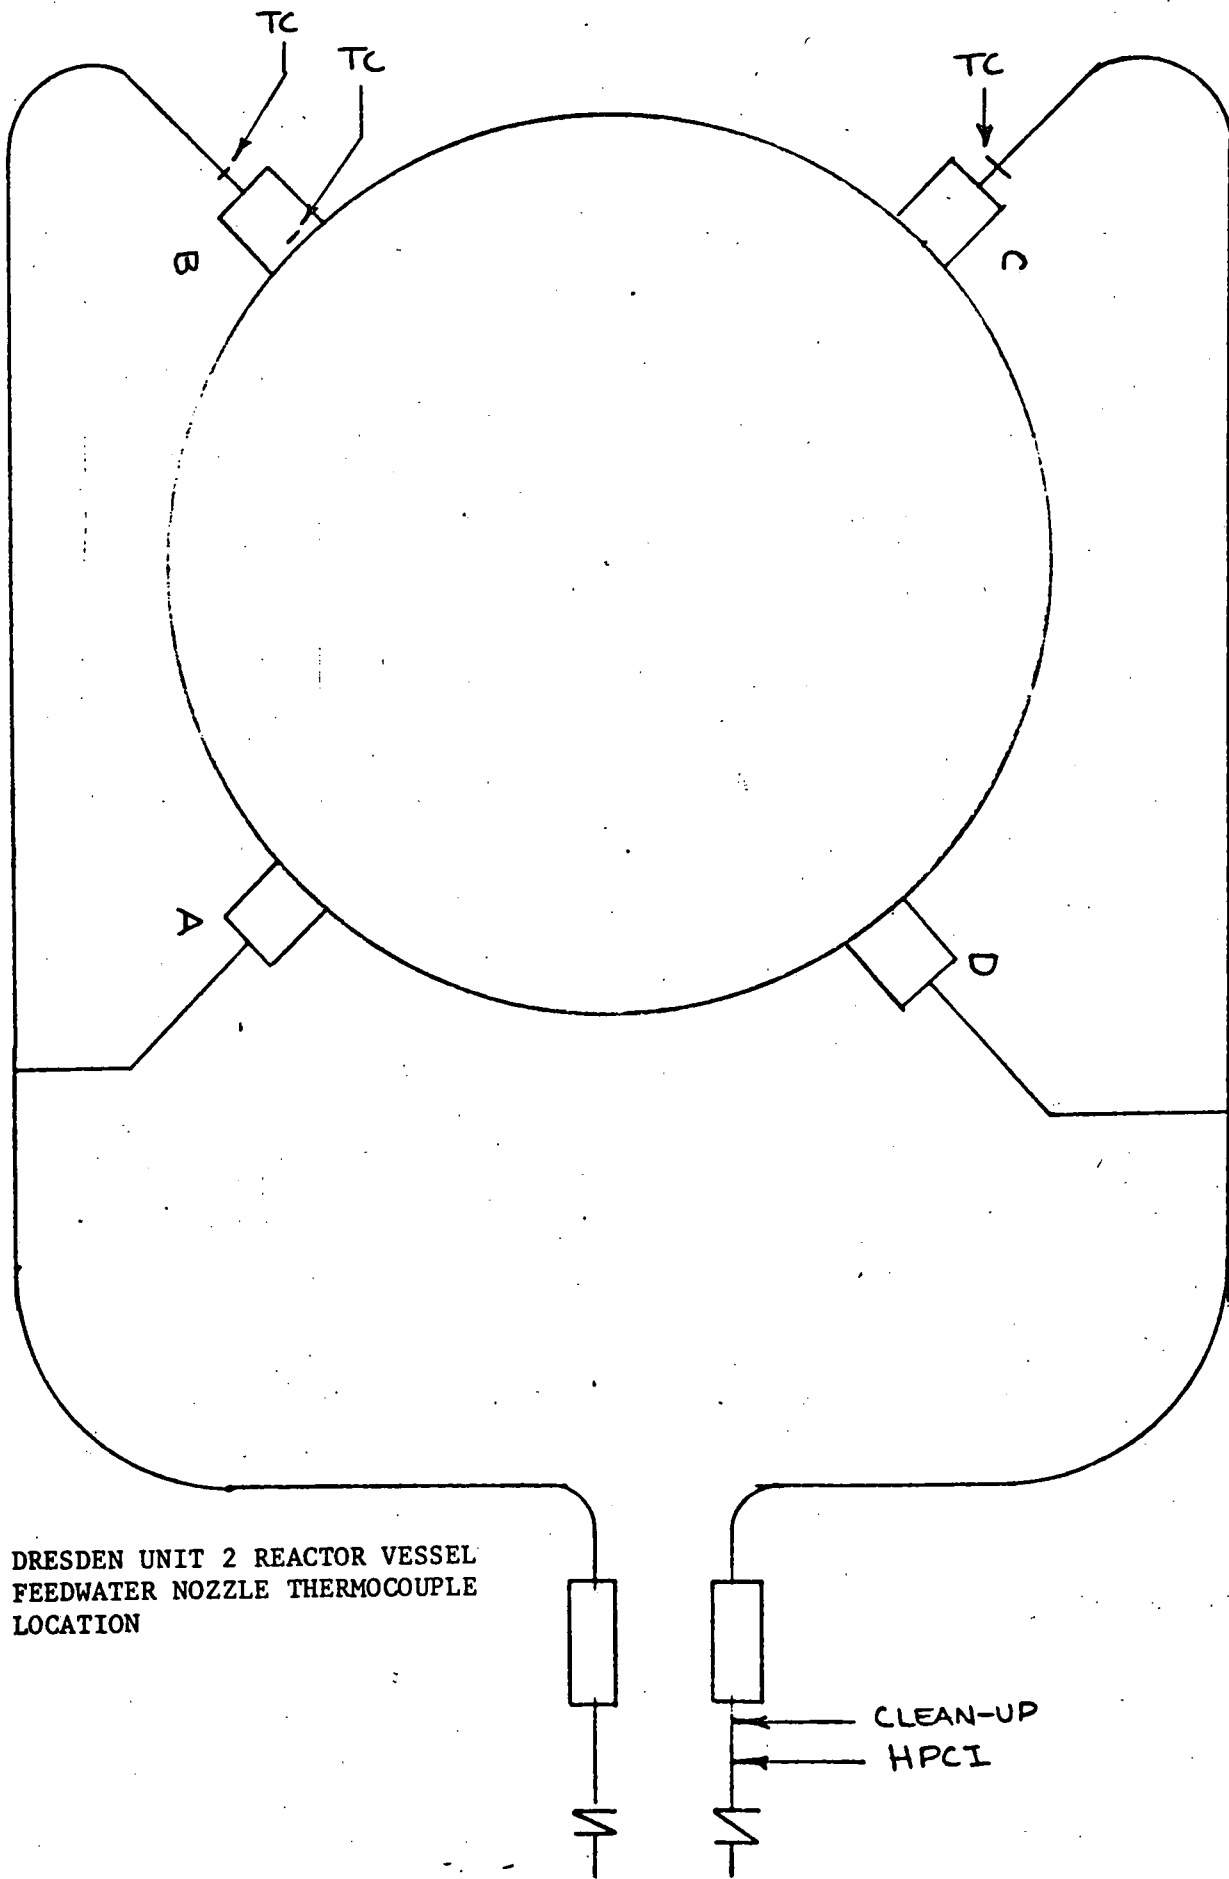
- FIGURE 2 -

steam valves and monitoring final feedwater temperature. Data gathered during this startup was taken and reviewed (final feedwater temperature, nozzle temperature, 4B and 4C and startup regulating valve position). This review showed that by altering the heater startup procedure, the maximum rate of change of the final feedwater temperature was limited to 320°/hour during cutting in the first set of feedwater heaters and to an overall change of 80°F/hour over one and one-half (1½) hours. See Figure 2 for the actual recorder trace. Feedwater nozzle temperatures, data, startup Feedwater Regulator Position data, and Feedwater Flow data was reviewed and no other significant information was obtained. Feedwater nozzle temperature (thermocouple mounted on feedwater line - outboard of safe end) tracked the final feedwater temperature and it was verified that the startup feedwater regulating valve did not cycle during startup. During previous startups, it was found that head-up rates in the range of 400-500°/hour with 90° temperature changes were common. See Figure 3 for a typical recorder trace.

DRESDEN UNIT 2 FINAL
FEEDWATER TEMPERATURE
DURING STARTUP WITH SPECIAL
OPERATING PROCEDURE

In order to investigate a possible method for limiting final feedwater temperature changes, a special operating procedure was prepared for cutting in feedwater heaters. This special procedure directed the operator to limit the final feedwater temperature increase to 100°F/hour. This rate of increase was controlled by slowly opening the extraction

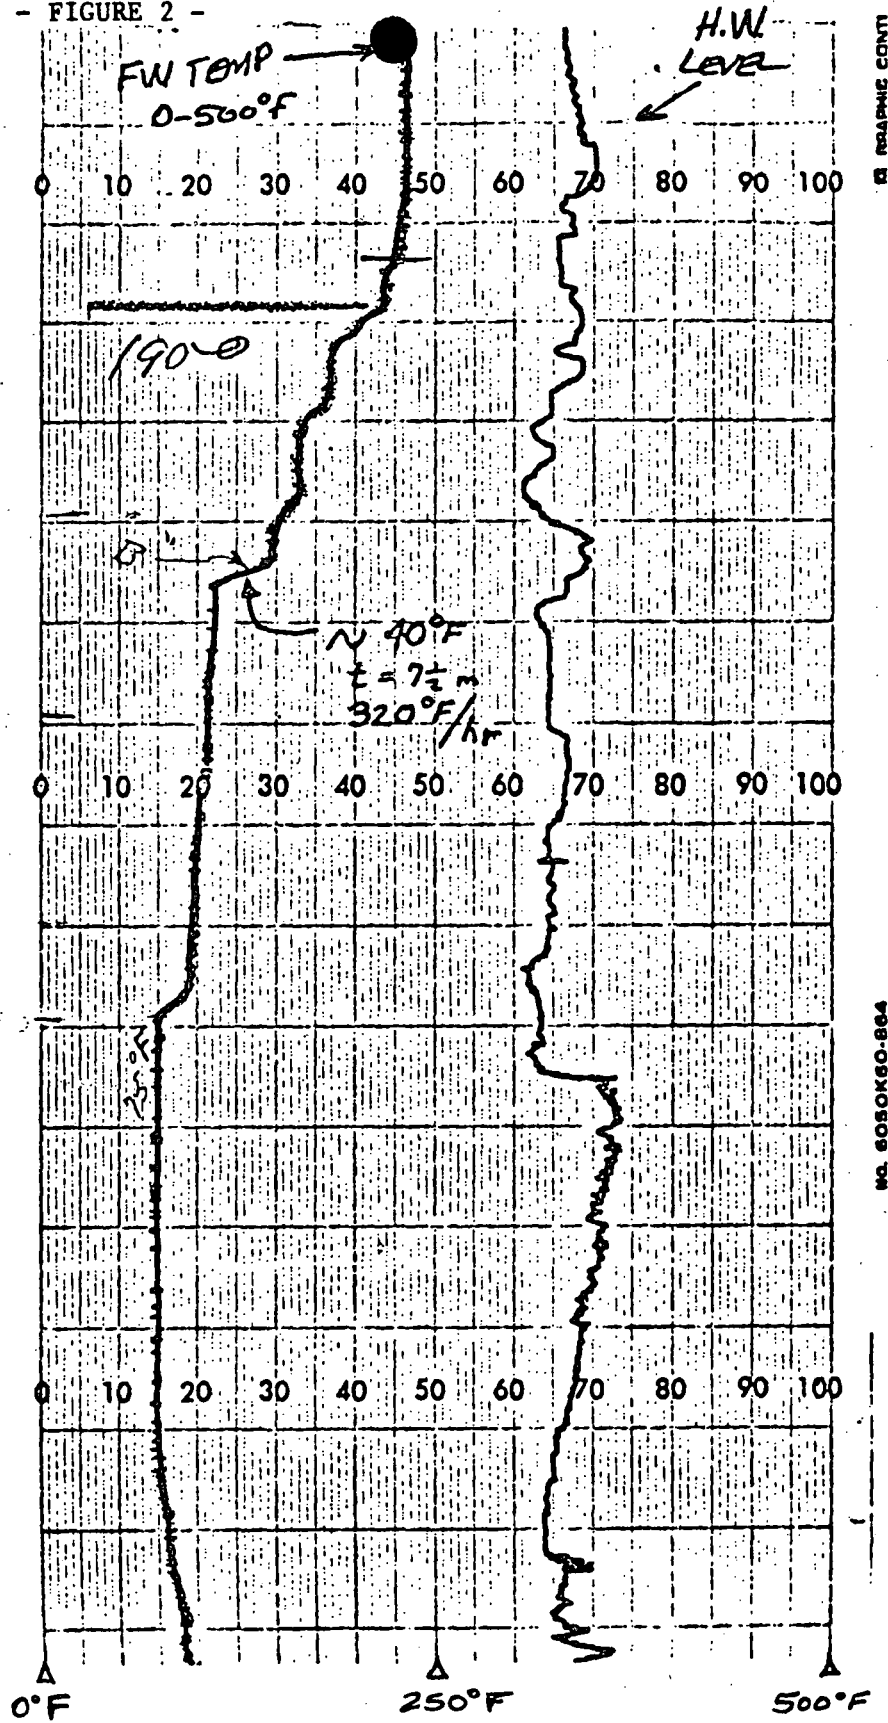
- FIGURE 3 -

DRESDEN UNIT 2 FINAL
FEEDWATER TEMPERATURE
DURING ROUTINE STARTUP

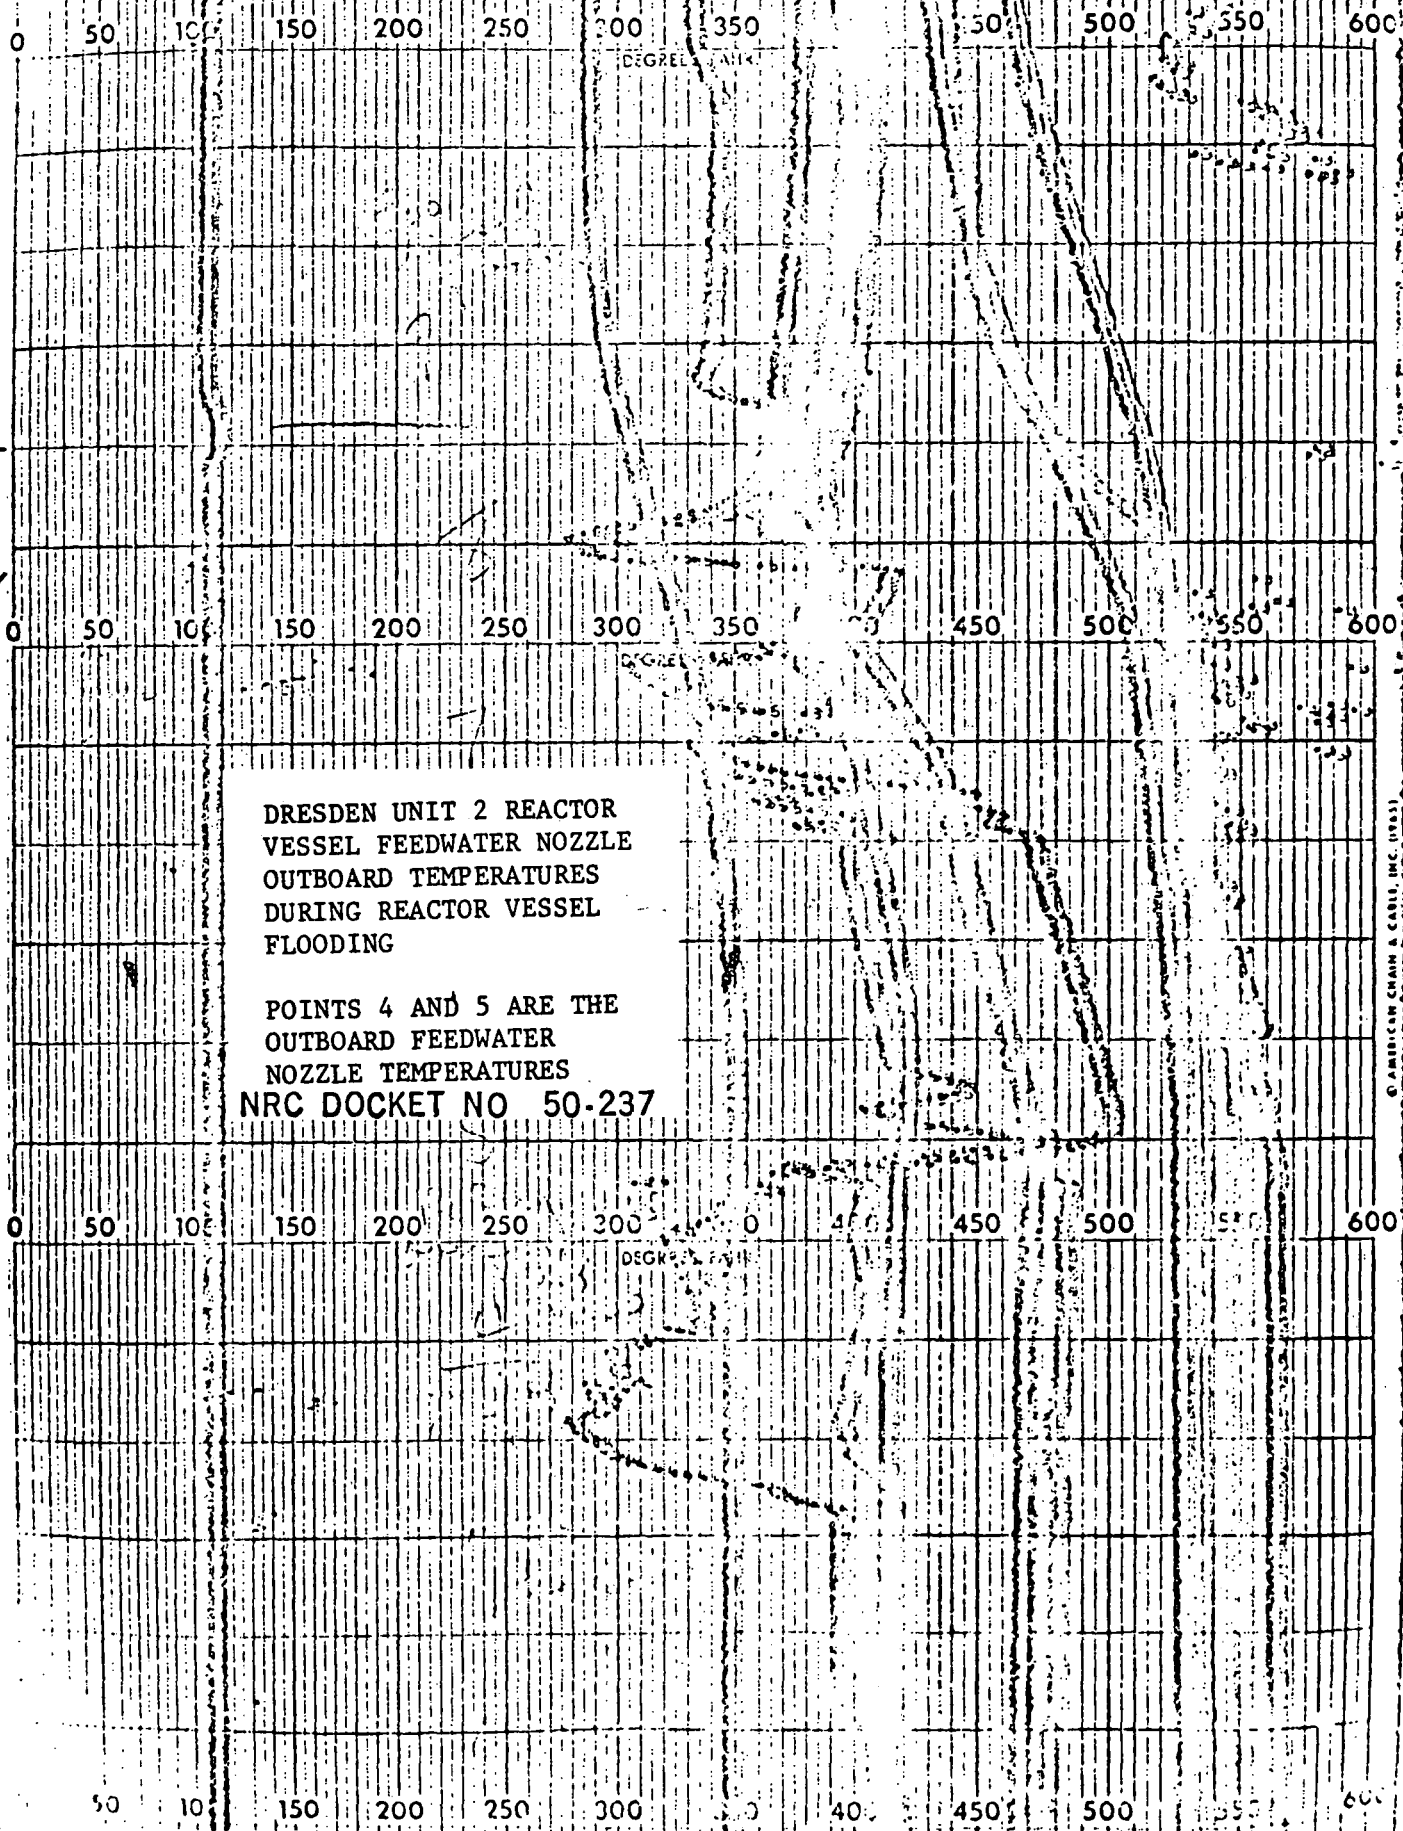
FIGURE 4

The final figure in the report did not reproduce clearly. The "saw tooth" traces are the nozzle temperatures during a flood up for vessel cooldown.

Feedwater nozzle temperature undergoes significant transients during a "flood-up" of the reactor vessel. During this operation, the water level is brought up rapidly to the main steam lines, then slowly the main steam lines are filled after which the level is raised rapidly up to the reactor vessel flange, the only limit being the shell to flange ΔT limitation. Since this operation is done through the startup regulating line and the valve cycles (open and closed) the feedwater nozzle is heated from reactor heat and then cooled from the colder feedwater. This transient operation causes approximately four (4) temperature swings, the average rate being 280°F/hour with an average temperature change of 94°. See Figure 4 for an actual recorder trace of a "flood-up". After evaluating the above data, it was concluded that the operations which have the greatest affect on final feedwater temperature are cutting in and out feedwater heaters and flooding the reactor vessel.

DRESDEN UNIT 2 REACTOR
VESSEL FEEDWATER NOZZLE
OUTBOARD TEMPERATURES
DURING REACTOR VESSEL
FLOODING

POINTS 4 AND 5 ARE THE
OUTBOARD FEEDWATER
NOZZLE TEMPERATURES
NRC DOCKET NO 50-237

The changes in feedwater nozzle temperatures experienced during a flood-up of the reactor vessel were reviewed to determine possible operational changes to minimize these transients. In light of the reactor vessel to flange differential temperature design limits specified the technical specifications, it appears that the current method of rapid flooding in steps is the only practical method. The reactor vessel is flooded only at the beginning of a refueling outage or on occasions when work in the upper areas of the drywell are planned.

The two (2) major feedwater temperature transients, feedwater heater startup and shutdown and reactor vessel "flood-up" can be minimized to some extent. The number of feedwater heater startups and shutdowns cannot be limited; however, procedures for minimizing the rate of temperature change are effective. The high rate of feedwater nozzle temperature change during reactor vessel "flood-up" is fixed; however, having recognized this as a significant factor, the number of "flood-ups" will be limited to the extent practicable.
