Re: Homestake Mining Company – Grants Reclamation Site  
Evaporation Pond Investigations

Alan Kuhn Associates LLC

**SUBJECT: REPORT OF 2016 ANNUAL INSPECTION OF TAILING IMPOUNDMENTS AND PONDS, HOMESTAKE GRANTS PROJECT, GRANTS, NEW MEXICO**

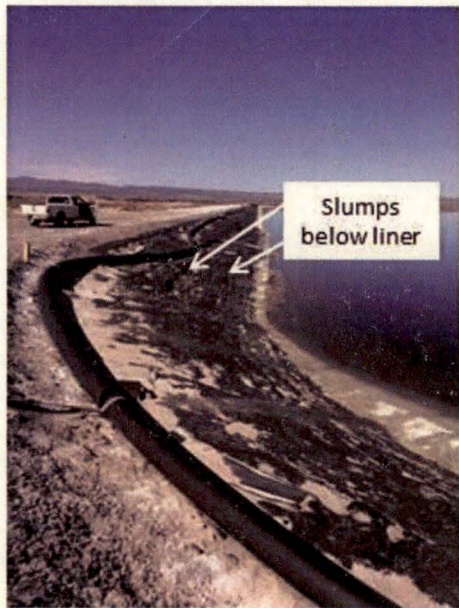
The small impoundment (location of evaporation pond #1, or EP1) remains in generally good condition. The slumps in the subgrade fill of the south inslope, under the pond liner along approximately 200 feet of the pond westward from the southeast corner (Figure 1), have not visibly changed from 2013 and the liner remains intact. With the pond water level much lower than normal for this time of year, more of this liner was visible and a second, lower slump was exposed approximately two vertical feet below the upper slump. Each slump is an irregular step or bench about 1-1.5 feet high. The function of the liner has not been compromised by this condition. However, weathering cracks have developed at several locations in this area (Figures 2 and 3), and although they do not yet appear to penetrate the entire thickness of the liner, it is likely that

Figure 1 – Slumps below liner at east end of south inslope, EP1

The slump along the south inslope of EP1 should be protected against further displacement to protect the liner. In its present condition, the EP1 liner continues to be serviceable. Site staff should note any changes in the slump and the condition of the liner at that location.

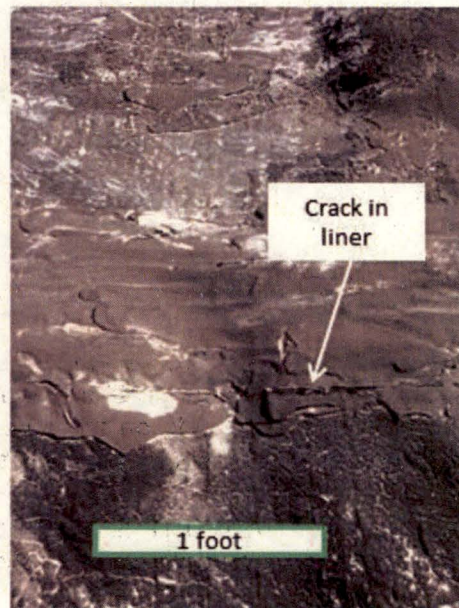
they will expand with time. While the water level was still relatively low and much of the liner on the slopes was exposed during October 2016, HMC personnel marked, cleaned and repaired (by application of hot asphaltic emulsion) cracks or tears in the liner above water level.

Figure 2 – Cracks in liner at east end of south inslope, EP1

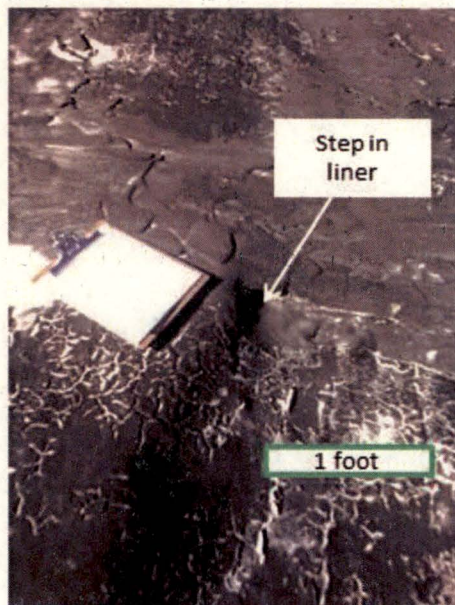
Figure 3 – Small step in liner related to lumps below liner at east end of south inslope, EP1
