**UNITED STATES  
NUCLEAR REGULATORY COMMISSION**

May 10, 2017

**SUBJECT: PILGRIM NUCLEAR POWER STATION – SUPPLEMENTAL INSPECTION  
REPORT (INSPECTION PROCEDURE 95003 PHASE ‘C’) 05000293/2016011  
AND PRELIMINARY GREATER-THAN-GREEN FINDING**

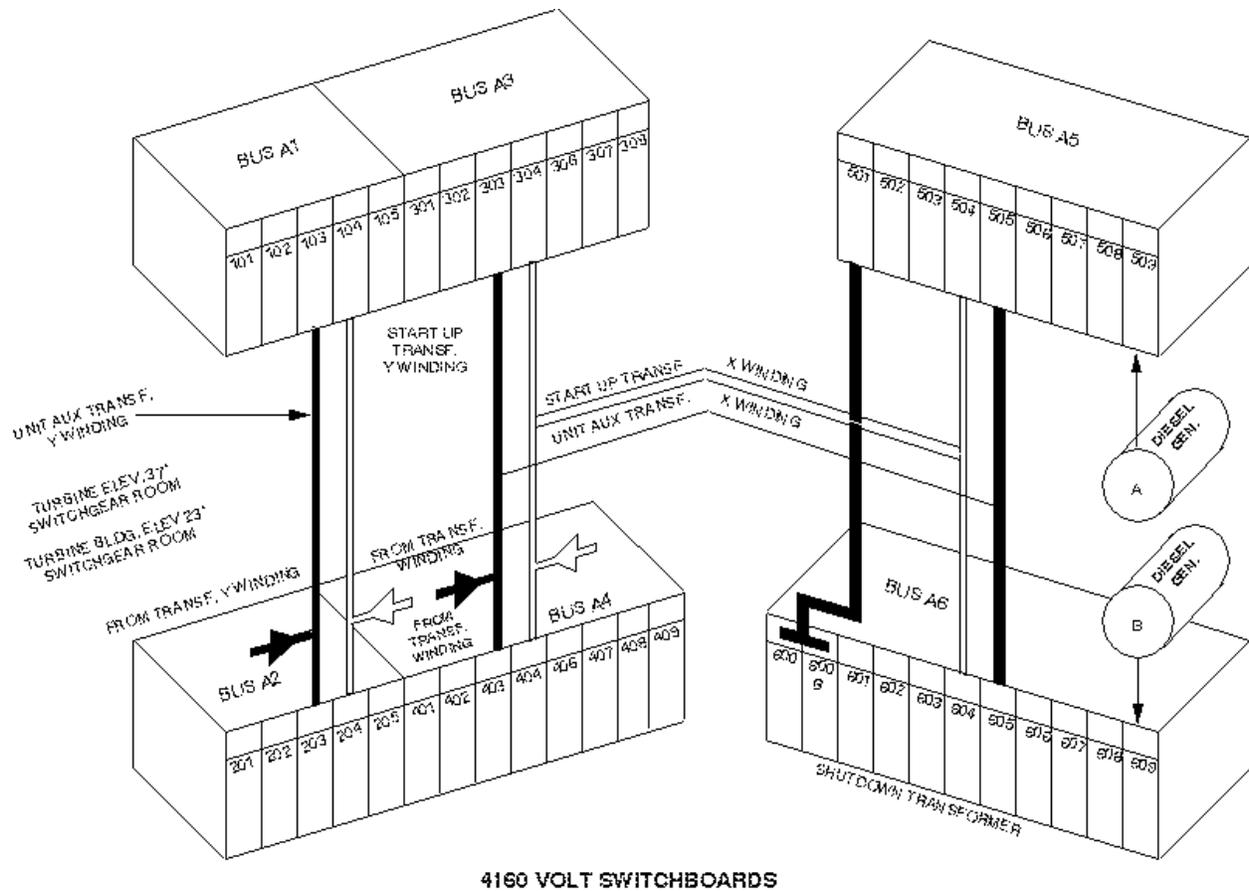
Figure 3

Bus A6 contains 11 cubicles. These include feeds from 'B' emergency diesel generator, offsite power via the startup transformer and unit auxiliary transformer, and power from the 23KV line via Bus A8. Based on the potential to damage the bus work it was assumed that a high energy arcing fault in Bus A6 would result in the unrecoverable loss of the 23KV (Bus A8 feed), SBO diesel generator, unit auxiliary transformer, startup transformer, and B emergency diesel generator feeds. Since a fault on the supply side of the breaker is assumed either as the direct cause or due to fire damage, this would also prevent offsite power from feeding Bus A5 ('A' train safety-related 4KV). Evaluation of small and large fires in Bus A6 breakers was also evaluated. Based on the fire size and location to various control power feeds, various off-site feed damage states and recoveries were evaluated. For cases where recovery could be credible, a failure probability of 0.1 was assumed. Although the manual operation of a 4KV breaker is not complex, the actions would have to occur post-fire, possibly in the vicinity of fire damage. Given this scenario, a 0.1 value seems appropriate for screening.

Bus A4 adjoins A2 and they are parallel to and six feet away from bus A6. There are 13 breaker cubicles in A2/4. A bus duct connects A6 to A4. Two cable trays run between A2/4 and A6 approximately even to the tops of the switchgear. Control cables from A6 run in the tray closest to A2/4. For a high energy arcing fault, these cables are in the zone of influence. Additionally, small and large electrical fires originating in the cabinets have the potential to propagate and cause cable damage. Based on the fire size and location to various control cables, various off-site feed damage states and recoveries were evaluated. For recovery, a failure probability of 0.1 was assumed. Although the manual operation of a 4KV breaker is not complex, the actions would have to occur post fire, possibly in the vicinity of fire damage. Given this as stated above, 0.1 seems appropriate for screening.
