Subject: Dresden Station Units 2 and 3
Fire Protection
NRC Docket Nos. 50-237 and 50-249

Attached are responses to Staff question Nos. 4, 7, 12, and 25 for Dresden Station Units 2 and 3, in addition to a clarification to PF 15 which was previously submitted.

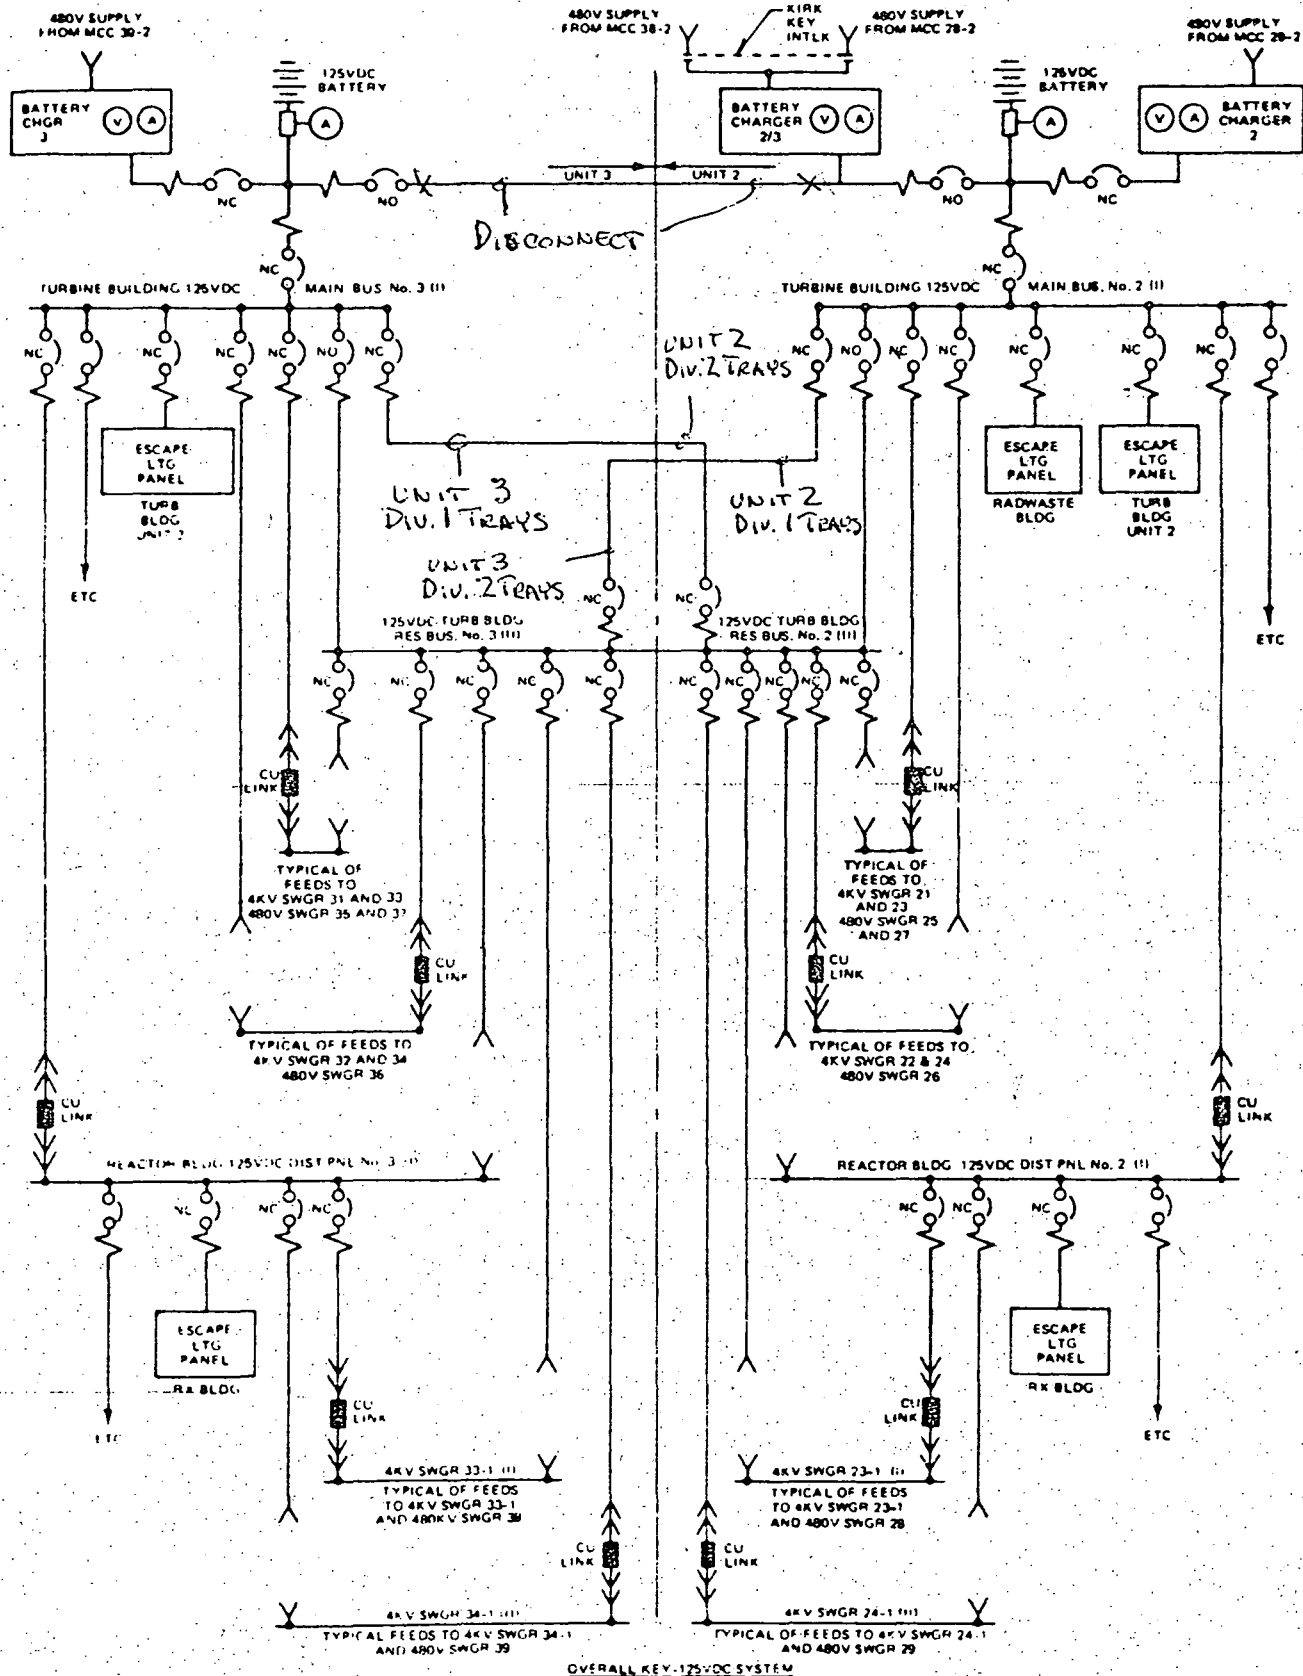
DRESDEN 2&3
 FIGURE 2.1-10

The interconnecting cable between units which connect Unit 2 Main DC Bus 2 (Unit 2 cable separation Division 1) to the Unit 3 Reserve DC Bus 3 (Unit 3 cable separation Division 2) is routed in Unit 2 Division 1 trays to the wall separating Unit 2 and Unit 3. On the Unit 3 side of this wall the cables are routed in Unit 3 Division 2 trays from the wall to the Unit 3 Reserve Bus 3. See Figure 2.1-10 attached.

Inspection has proven that routing of the cable connecting Unit 3 Main DC Bus 3 (Unit 3 cable separation Division 1) to Unit 2 Reserve DC Bus 2 (Unit 2 cable separation Division 2) is not correct. The cable routing from Unit 3 Main Bus 3 is in Unit 3 Division 2 trays up to the wall between Units 2 and 3. The portion of cable from the wall to the Unit 2 Reserve Bus 2 is routed in Unit 2 Division 1 trays. This cable will be rerouted so that the cable from Unit 3 Main DC Bus 3 to the wall between Units 2 and 3 is in Unit 3 Division 1 trays. The routing from the Units 2 and 3 wall to the Unit 2 Reserve DC Bus 2 will be rerouted in Unit 2 Division 2 trays. See Figure 2.1-10. When this cable is rerouted, the interconnecting cables will be separated properly on a divisional basis.

The cable which connects Battery Charger 2/3, which is located in the Unit 2 battery room, to the Unit 3 battery is routed incorrectly from a separation standpoint. This cable will be disconnected and battery charger 2/3 will become a spare charger dedicated to Unit 2. A spare charger will be purchased for use in charging the Unit 3 battery. See Figure 2.1-10.

The result of a fire and/or fire related damage in tray sections common to both the reserve and the main feeds of the services listed above could be loss of both 125 volt systems (Unit 2 and 3) and therefore loss of both Division I and Division II dc systems. See Figure 2.1-10.

Steps are in progress to correct this condition by leaving the CU Links out at the various loads as shown in the Figure 2.1-10. In addition the source circuit breakers at the Main or Reserve Busses will be opened. This will deenergize the cables between the sources and the loads such that a fire at one of the loads would not affect both DC division since the cable from the second division at any load location is not connected to the a source. Administrative control will prevent closing of either the circuit breaker or the links unless the other supply is disconnected both at the circuit breaker (source) and the link (load).
