Subject: Dresden and Quad-Cities Stations  
Proposed Change to Eliminate License  
Requirements for Jet Pump Flow Indication  
from DPR-19, DPR-25, DPR-29, and DPR-30.  
NRC Docket Nos. 50-237, 50-249, 50-254,  
and 50-265

RESPONSE TO REQUEST FOR ADDITIONAL INFORMATION

PROPOSED CHANGE TO TECHNICAL SPECIFICATIONS TO  
DELETE REQUIREMENTS FOR JET PUMP FLOW INDICATION

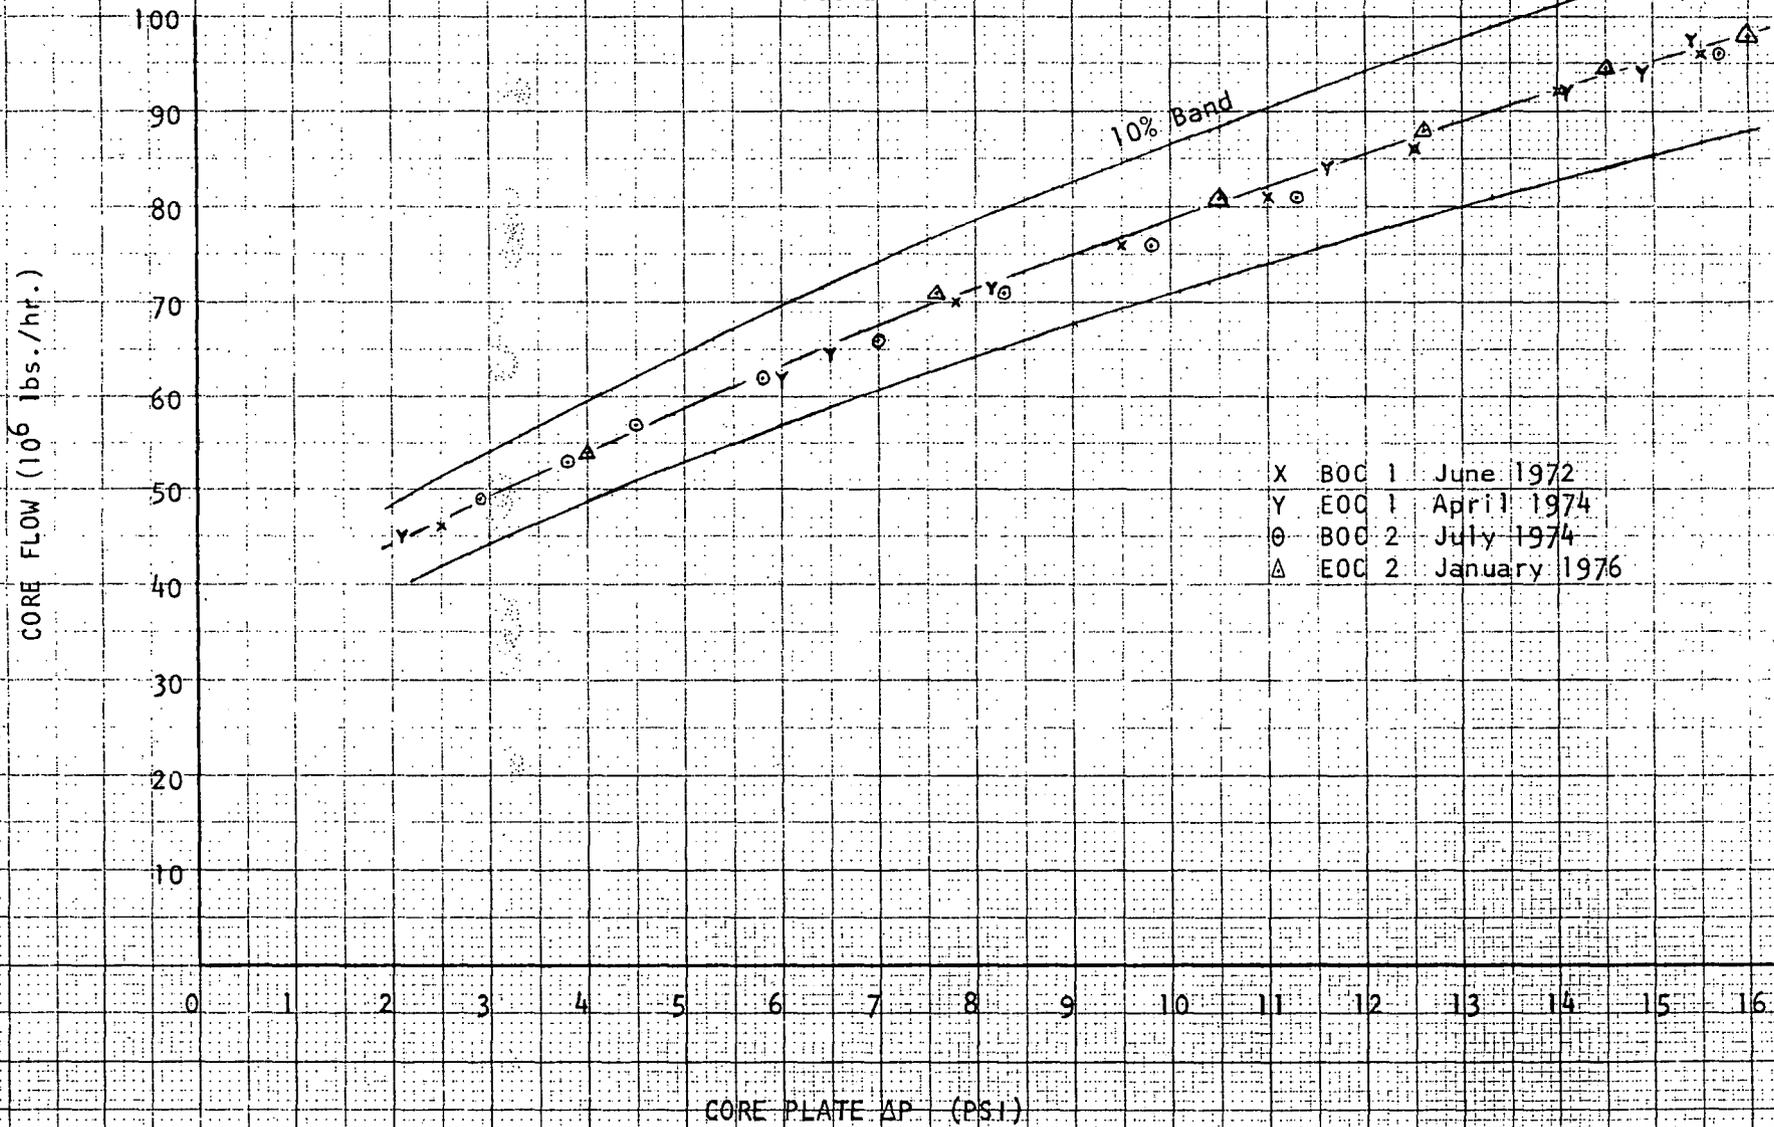
OCNPS UNIT 1  
 CHARACTERISTIC CURVE OF  
 CORE PLATE  $\Delta P$  VERSUS CORE FLOW  
 FIGURE 4-1

From the calibration data that is available, this instrument and others of the same model type have experienced only minimal drift on the order of less than 1% since their initial calibration. Data is available from June, 1972 through January, 1976 that illustrates the total core flow as a function of core plate  $\Delta P$ . This data is graphically shown in Figure 4-1. It can be seen that the core plate  $\Delta P$  has been within approximately 3% of the characteristic curve with the variations primarily due to minor inconsistencies in data-taking. Instrument drifts of 1% or less are probably masked by the accuracy of the data takers.

The characteristic curve in Figure 4-1 is typical of the curve that would be used to verify the total core flow indication according to proposed Technical Specification 4.6.B.1.b. The actual characteristic curve to be used for the required surveillance would be re-evaluated each operating cycle in accordance with Technical Specification 4.6.G.3.

As shown on Figure 6.1, a jet pump failure would be easily determined by use of this curve. It is felt that a calibration frequency of once per operating cycle will adequately insure the accuracy necessary for operational use of this instrument.

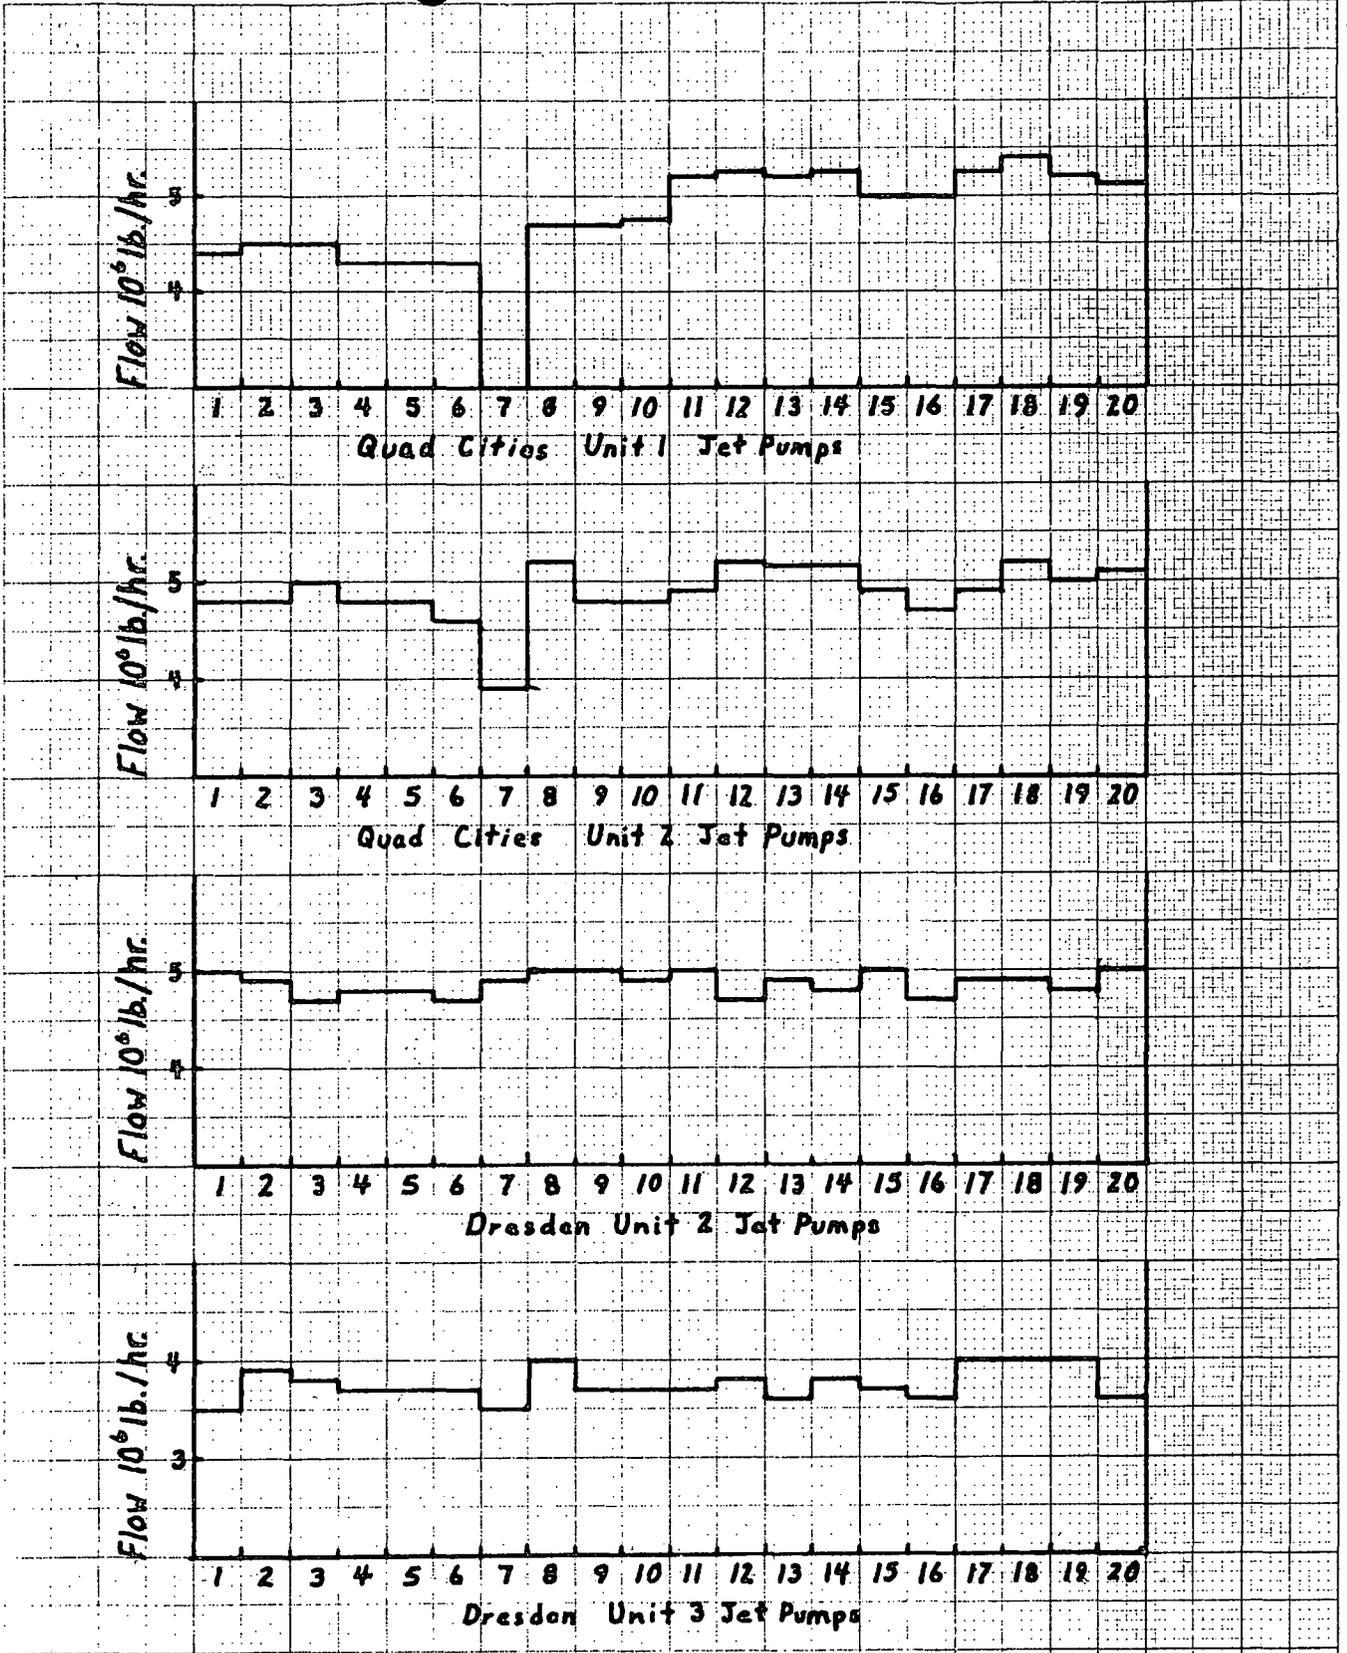
Jet Pump Flow Distribution  
Figure 5-1

RESPONSE: The subject jet pump flow readings are shown in Figure 5-1 in the format requested. The actual flow values plotted on the graphs are shown in Table 5-1. The values shown are from the last set of calibration data obtained in accordance with Technical Specification 4.6.G.3.

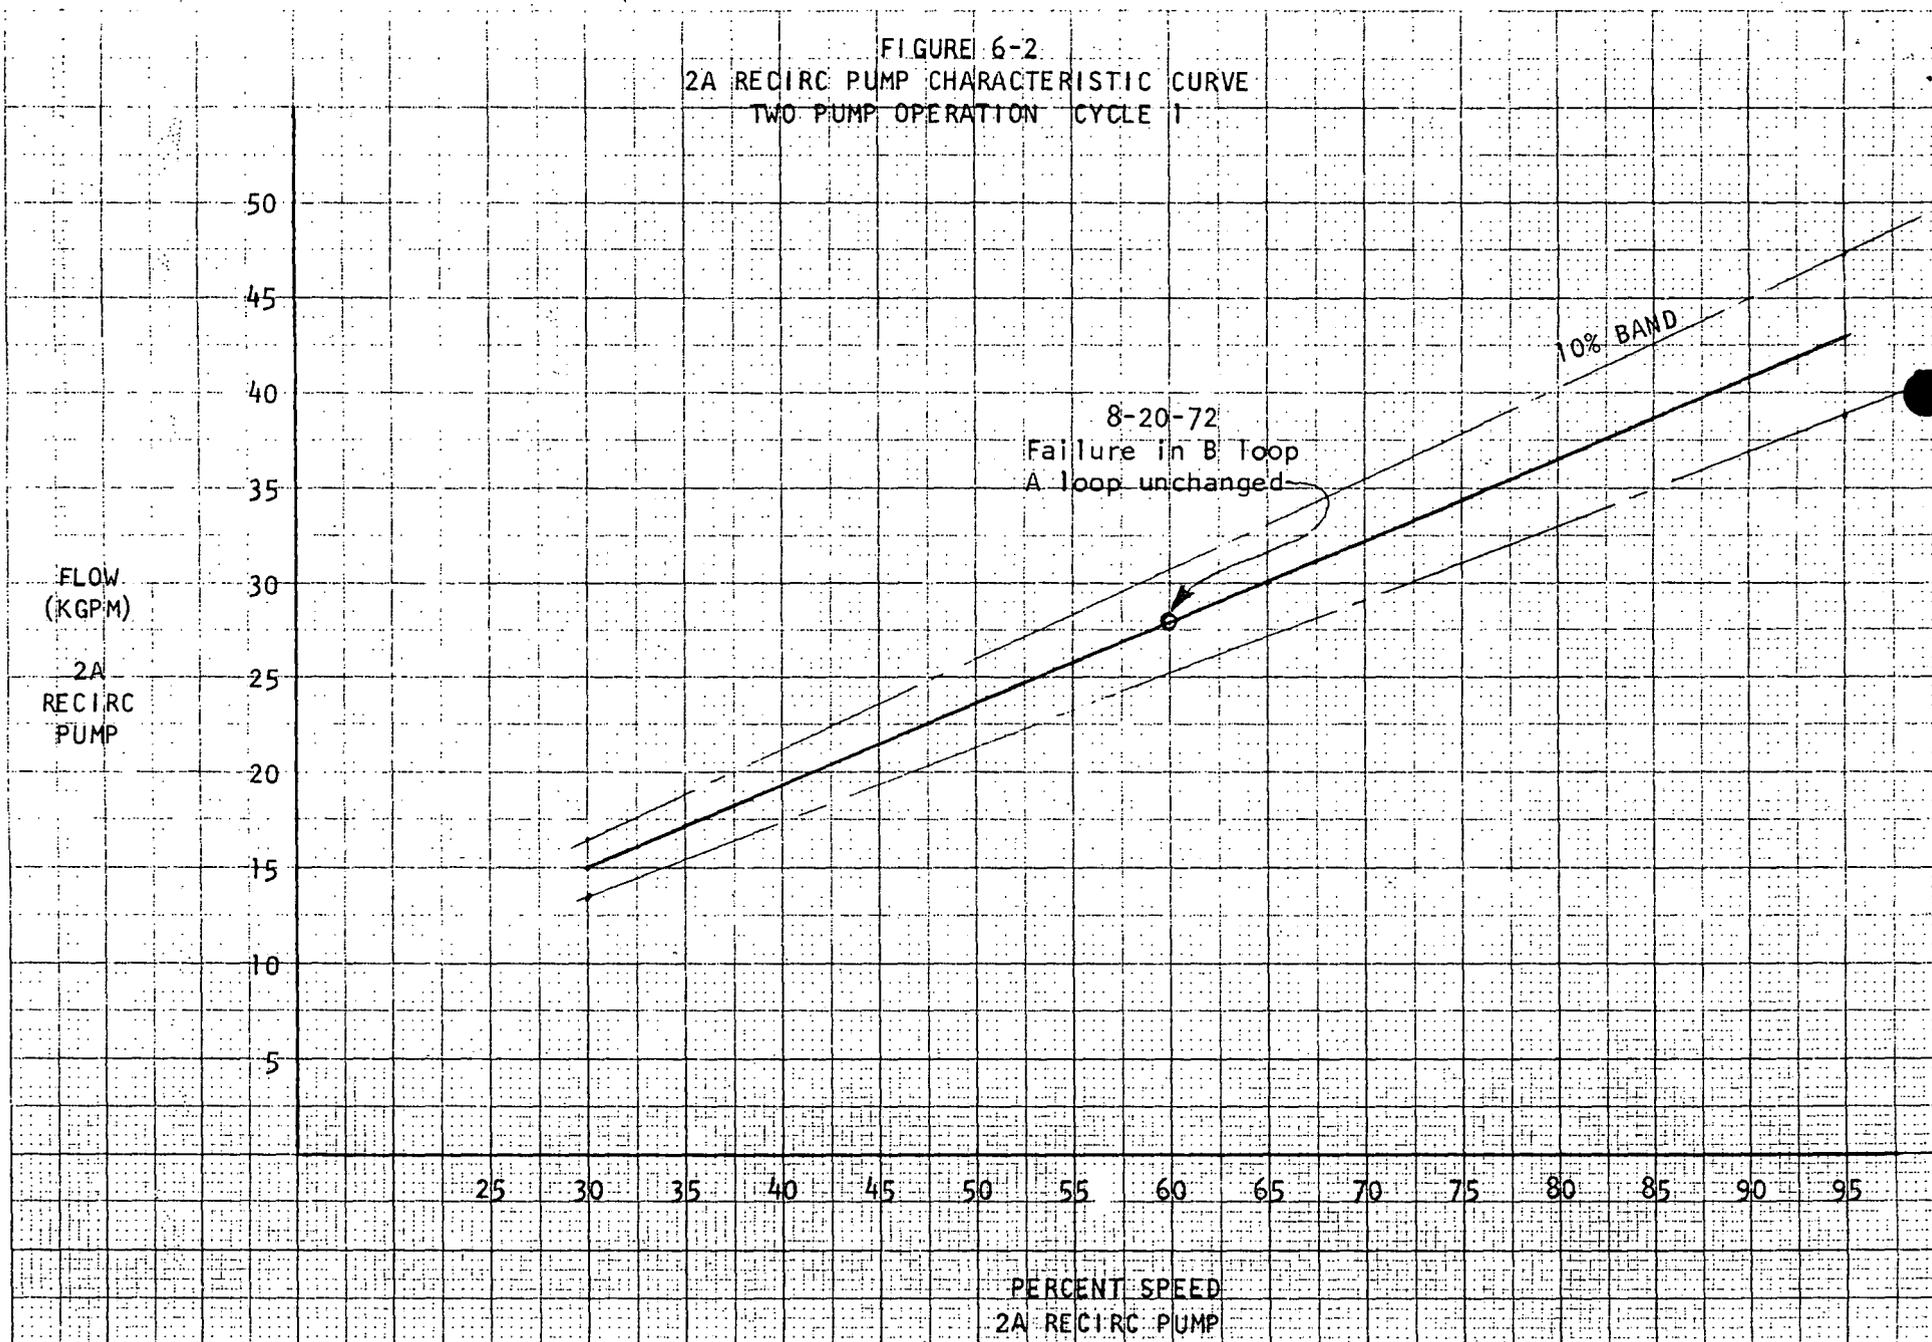
FIGURE 6-2  
2A RECIRC PUMP CHARACTERISTIC CURVE  
TWO PUMP OPERATION CYCLE I

Figure 6-2 shows that the recirculation flow characteristic remains unchanged in the loop that remains intact. Figure 6-3 shows that the recirculation flow characteristic for the affected loop increases by greater than 10% for the same pump speed signal. These curves are utilized to perform surveillance according to Technical Specification 4.6.G.1.a and thus give a positive indication of a change in reactor flow system performance.

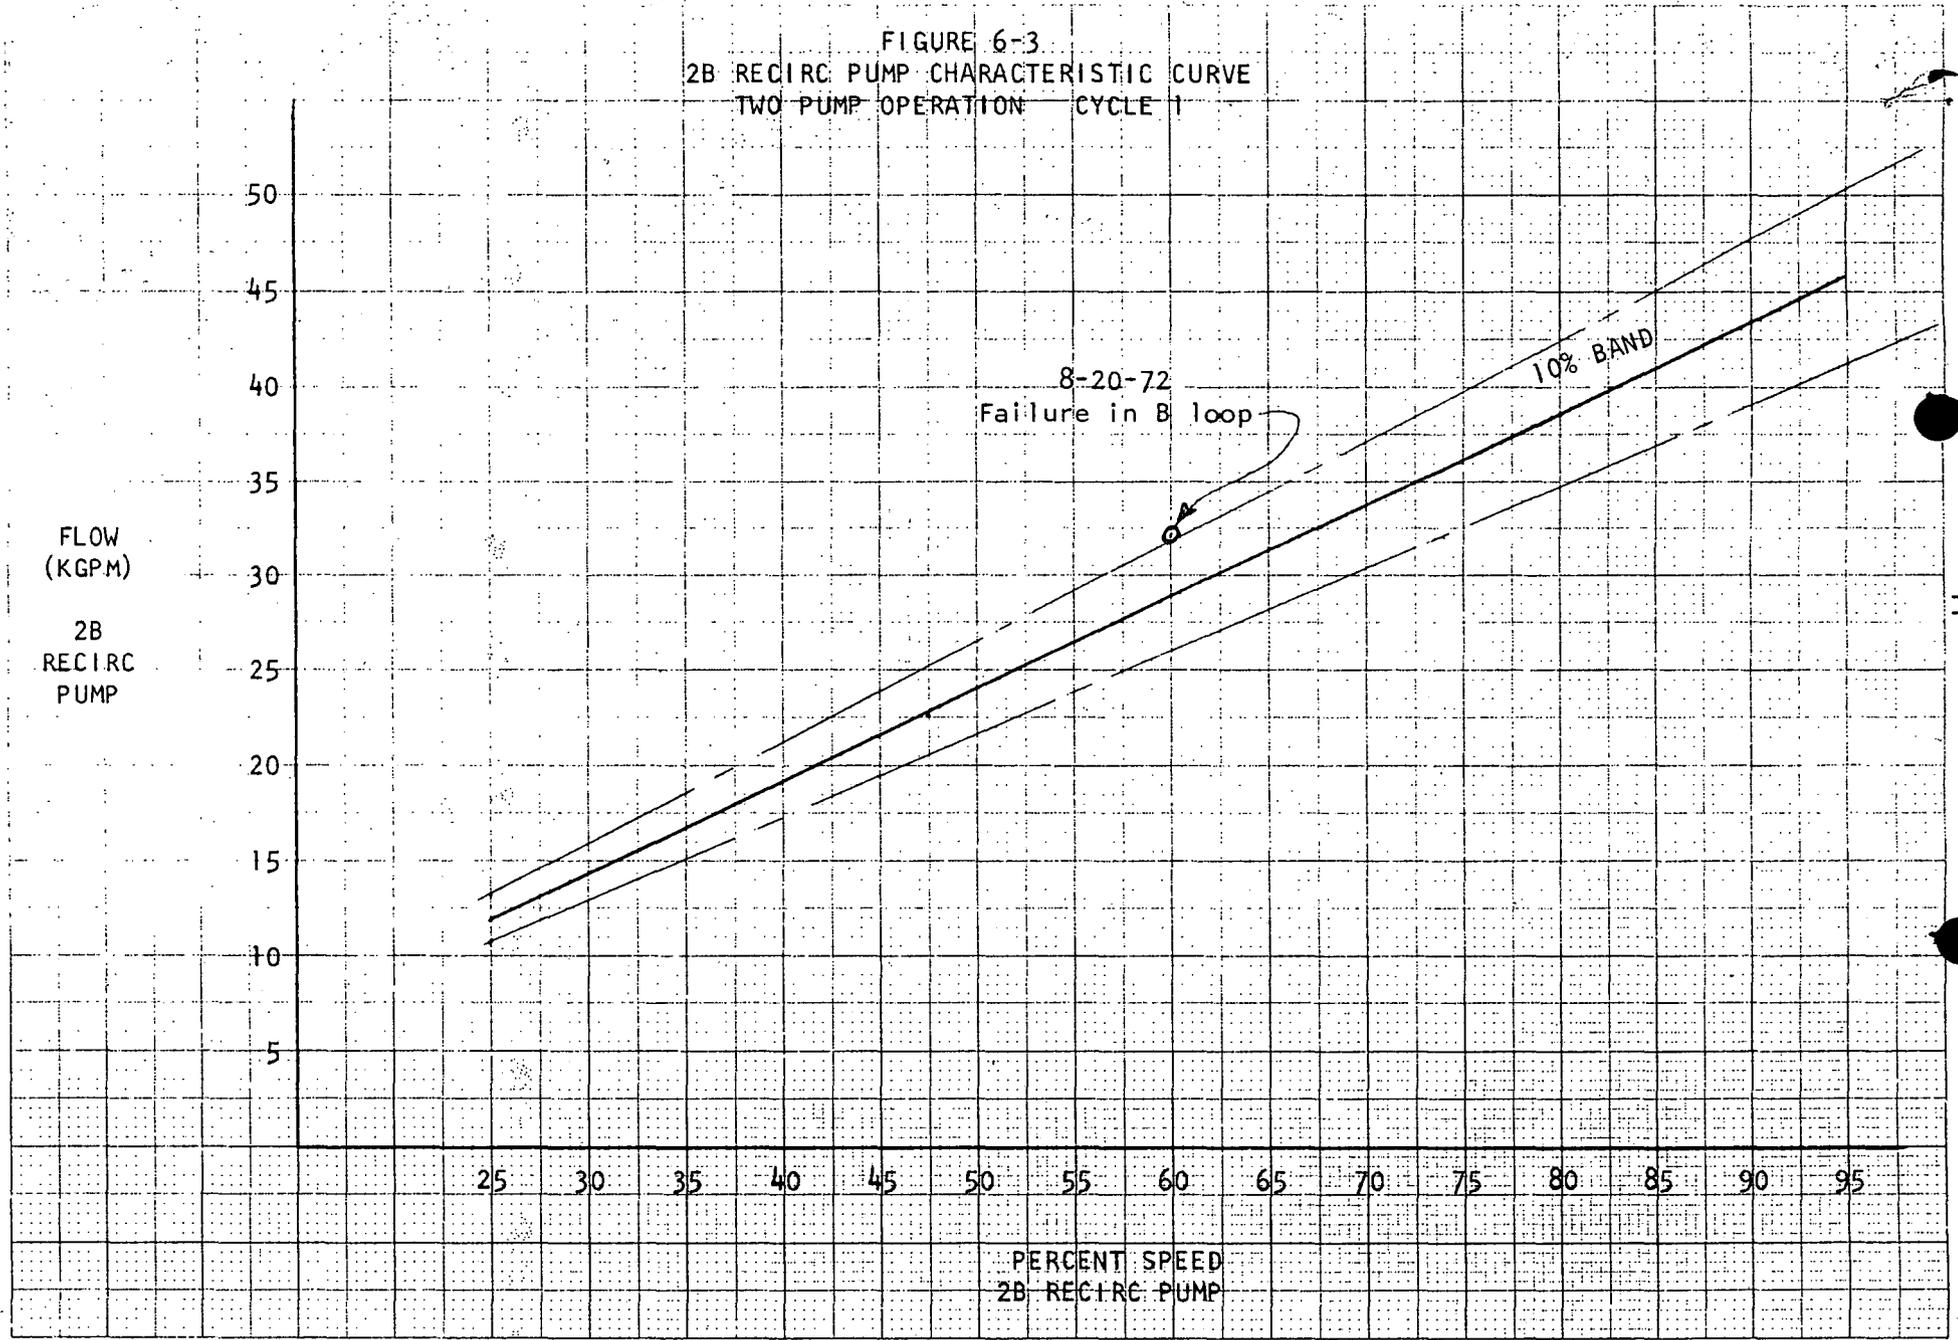
FIGURE 6-3  
2B RECIRC PUMP CHARACTERISTIC CURVE  
TWO PUMP OPERATION CYCLE 1

A further confirmation of this change in flow system performance could be obtained by observing the relationship of recirculation pump  $\Delta P$  vs recirculation loop flow for the same speed setting. The actual failure data showed that the loop flow in the failed loop increased, while the pump  $\Delta P$  for the failed loop decreased at the time of the failure. These same conditions remained unchanged for the unaffected loop.
