**UNITED STATES  
NUCLEAR REGULATORY COMMISSION**

May 12, 2017

**SUBJECT: NINE MILE POINT NUCLEAR STATION – INTEGRATED INSPECTION  
REPORT 05000220/2017001 AND 05000410/2017001**

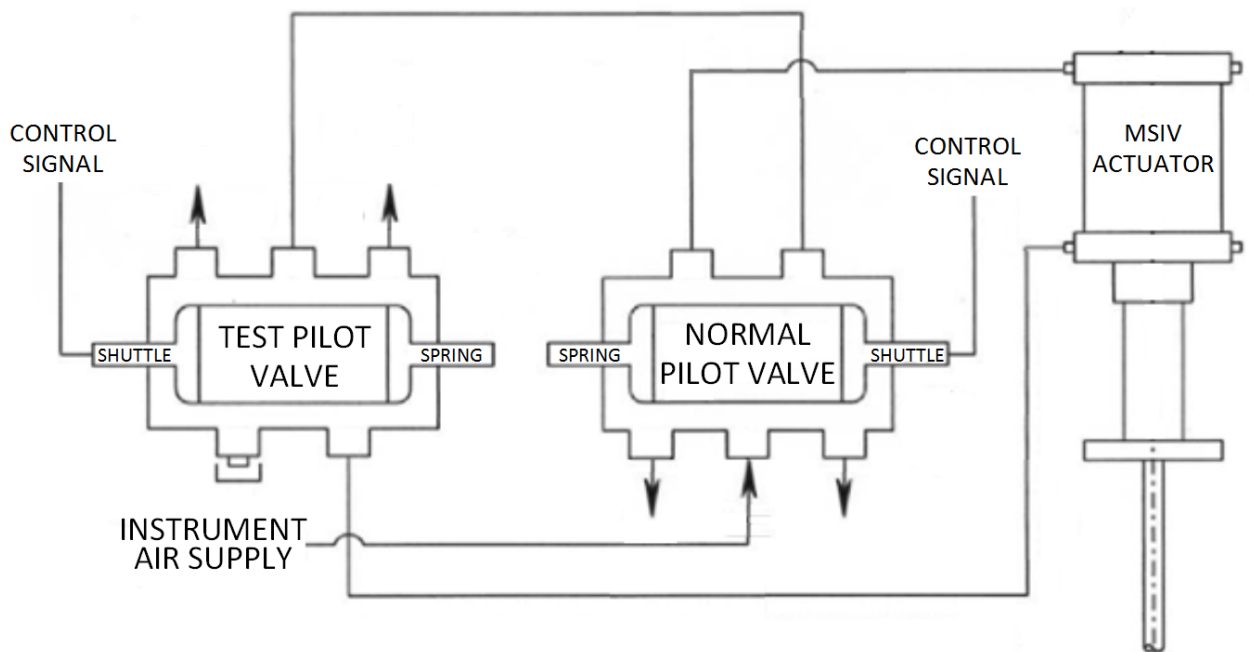
Figure 1

the environment. The inboard primary containment MSIVs are MOVs. The outboard MSIVs, MSIV 01-03 and MSIV 01-04, are air operated valves (AOVs), which utilize the safety-related instrument air system to open the valve and close the valve with spring assist. When called upon to operate either manually or automatically, each AOV has two pilot valves, which are the same style valve but serve different purposes that reposition to port instrument air below the AOV cylinder to open the MSIV and vent the air allowing the springs to close the valve, as seen in Figure 1. One pilot valve is for normal operation while the other is a test pilot valve used to slowly close the MSIV only 7 percent of full travel before repositioning to open the MSIV. These pilot valves are designed with a shuttle and a cage. The shuttle is a shaft with a series of lands to block or open the ports in the pilot valve. The cage contains holes that lead to air supply piping, above or below the AOV cylinder, or atmosphere. The design clearance between the shuttle and the cage is approximately 5 microns.

On December 10, 2016, MSIV 01-04 failed to close during surveillance testing. An Exelon investigation discovered that the MSIV failed to close because the pilot valve was bound. This is similar to an event that happened in September 2015 where MSIV 01-03 continued closed during a partial stroke test, eventually leading to a scram. The cause for the complete valve closure was also due to a bound pilot valve. The inspectors recognized that the valves are commonly supplied with instrument air for valve control, so following the December 2016 failure, the inspectors conducted a walkdown of the instrument air system and reviewed the system maintenance and testing program. The inspectors noted that since May 2016, particulate greater than the 40 micron requirement described in the Unit 1 UFSAR was discovered in the instrument air system, constituting a sample failure. These failures were documented in IRs 02676351, 02703052, and 03949765. The sampling process takes samples from various locations in the instrument air system to determine the quality of the whole system. Section X.I.3.0 of the NMPNS UFSAR states, "Reliable operation of instrument air end users and in-line components is dependent on the filtration and removal of particulates greater than

When the inspectors questioned why the MSIV pilot valves were not evaluated for susceptibility for damage due to foreign material following the failed surveillance, Exelon personnel stated the sample point closest to the MSIVs had not failed for high particulate, therefore they had not evaluated the pilot valves. The instrument air sampling process categorizes particulate quantities based on sizes of 3 to 20 microns, 20 to 40 microns, and greater than 40 microns. Any particulate discovered greater than 40 microns would constitute a failure in accordance with the Unit 1 UFSAR. However, given the 5 micron clearances that exist in the pilot valves, particulate found in any of those ranges would constitute a potential to impact MSIV control without additional filtration. The sample location closest to the MSIVs had historically been found to contain particulate in the 3 to 20 micron range, but the procedure did not require test personnel to alert Exelon supervisory personnel of the potential to damage the pilot valves.

Analysis. The inspectors determined that Exelon’s failure to implement design control measures as described in the Unit 1 UFSAR for the instrument air system was a performance deficiency that was reasonably within Exelon’s ability to foresee and prevent. The inspectors determined the performance deficiency to be more than minor because it was associated with the design control attribute of the Barrier Integrity cornerstone and adversely affected the cornerstone objective of providing reasonable assurance that physical design barriers protect the public from radionuclide releases caused by accidents for events. Specifically, Exelon failed to install additional filtration in the instrument air system upstream of the outboard MSIV pilot valve in accordance with the Unit 1 UFSAR even though the internal clearance of the pilot valve was significantly less than the 40 micron particulate limit. Additionally, example 3.j from IMC 0612, Appendix E, “Examples of Minor Issues,” provides a similar scenario to this issue. Example 3.j details that a performance deficiency is more than minor if the error results in a condition where there is now a reasonable doubt on the operability of a system or component. This performance deficiency was more than minor because without the additional filtration defined in the UFSAR, there existed a reasonable doubt of operability for the Unit 1 outboard MSIVs, as evidenced by the instrument air particulate issues and occurrences of two failures described above.
