May 25, 2017

SUBJECT: SUMMARY OF CLOSED MEETING WITH THE PRESSURIZED
WATER OWNERS GROUP AND THE BOILING WATER OWNERS
GROUP TO DISCUSS ANCHOR DARLING GATE VALVE PART 21
ISSUES

LaSalle Unit 2 HPCS Injection Valve Failure during the February 2017 Refueling Outage

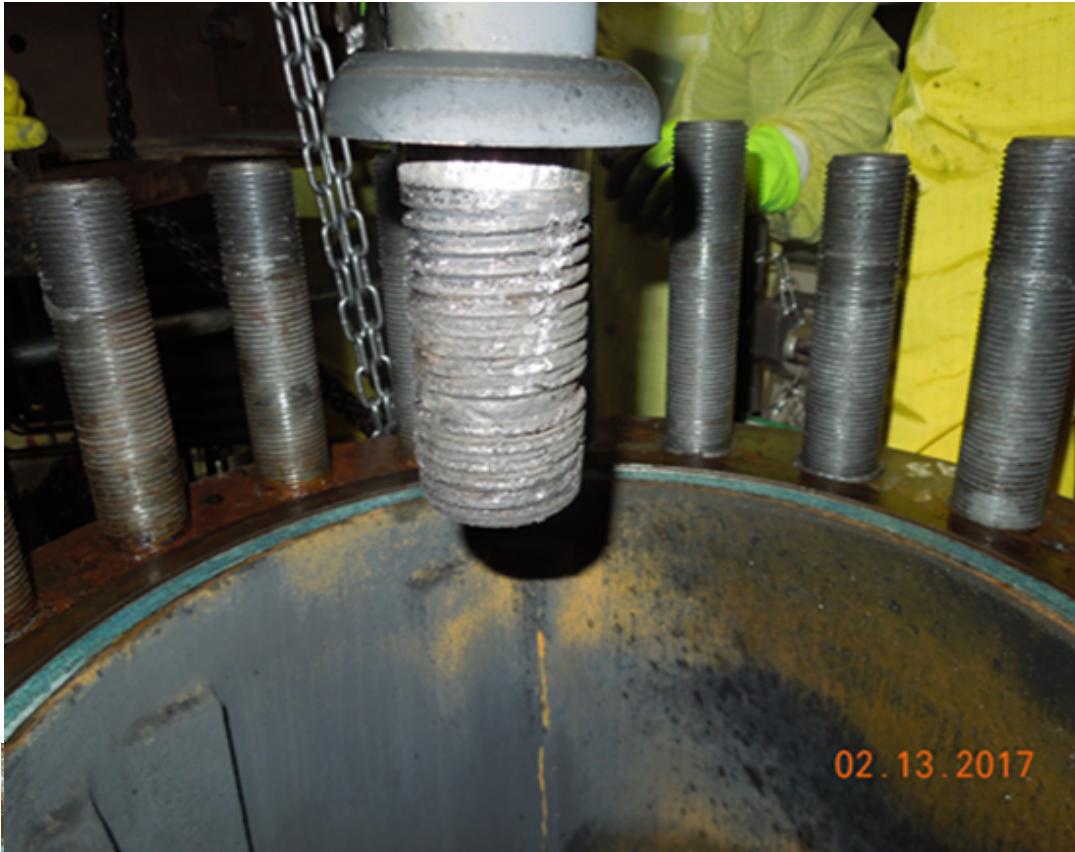
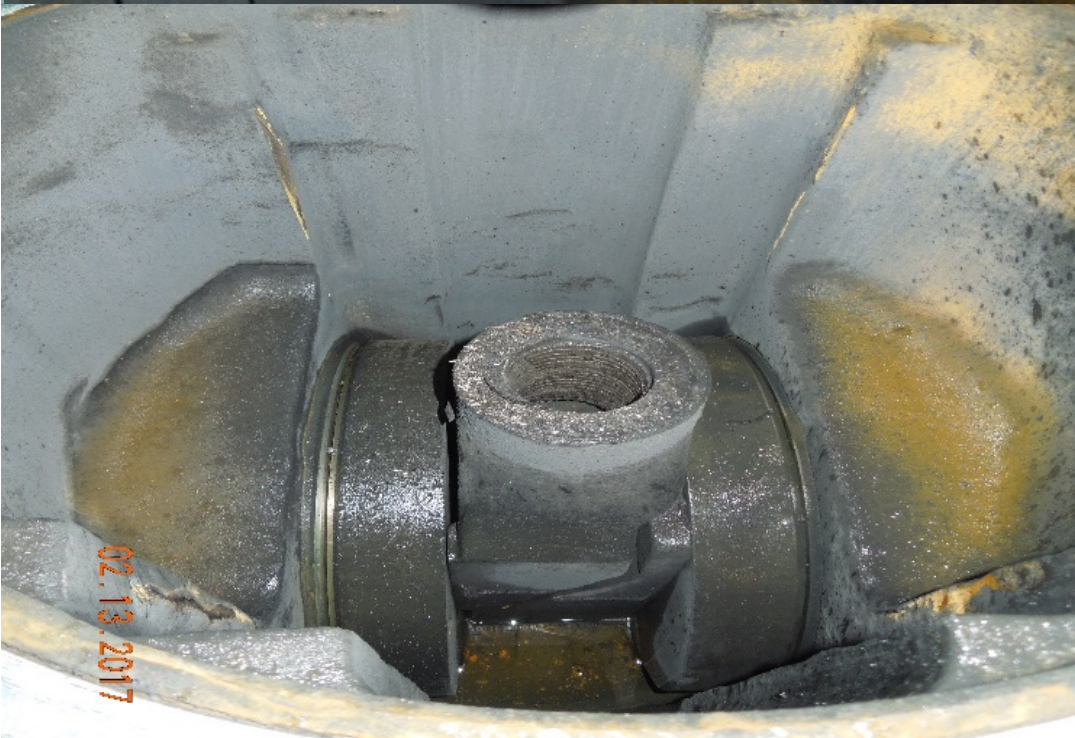
On February 11, 2017, the Unit 2 HPCS injection valve stem was found to be separated from the upper wedge/disc assembly during a fill and vent activity¹. Prior to the failure, the valve had successfully passed a local leak rate test where the valve had cycled successfully several times. Valve disassembly and inspection revealed the wedge pin had sheared and the valve stem threads were damaged. This valve was an Anchor/Darling 12 inch Double Disc Gate Valve (ADDDGV) and was included in those valves associated with the Flowserve and Browns Ferry Part 21 reports submitted in 2013 (ADAMS ML13008A321 and ML13064A012). The licensee was addressing the Part 21 reports by using industry guidance provided by the Boiling Water Reactor Owners Group (BWROG) prior to the failure. Following the identification of the separation, the licensee redesigned and repaired the failed Unit 2 HPCS Injection valve.

Figure: As Found Pictures of Failed Unit 2 HPCS Injection Valve Stem to Wedge Connection
