SUBJECT: SUMMARY OF CLOSED MEETING WITH THE PRESSURIZED  
WATER OWNERS GROUP AND THE BOILING WATER OWNERS  
GROUP TO DISCUSS ANCHOR DARLING GATE VALVE PART 21  
ISSUES

## **LaSalle Unit 2 HPCS Injection Valve Failure during the February 2017 Refueling Outage**

### **Preliminary LaSalle Observations Related to ADDDGV Part 21 Notifications**

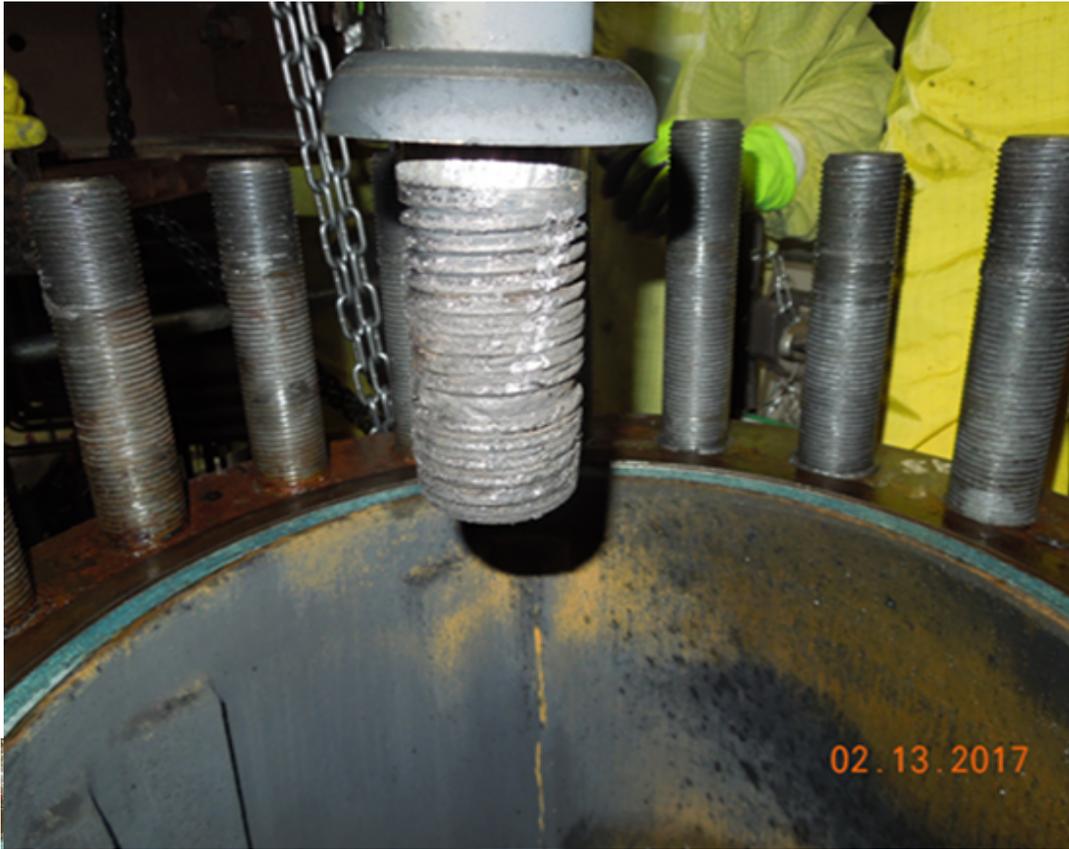
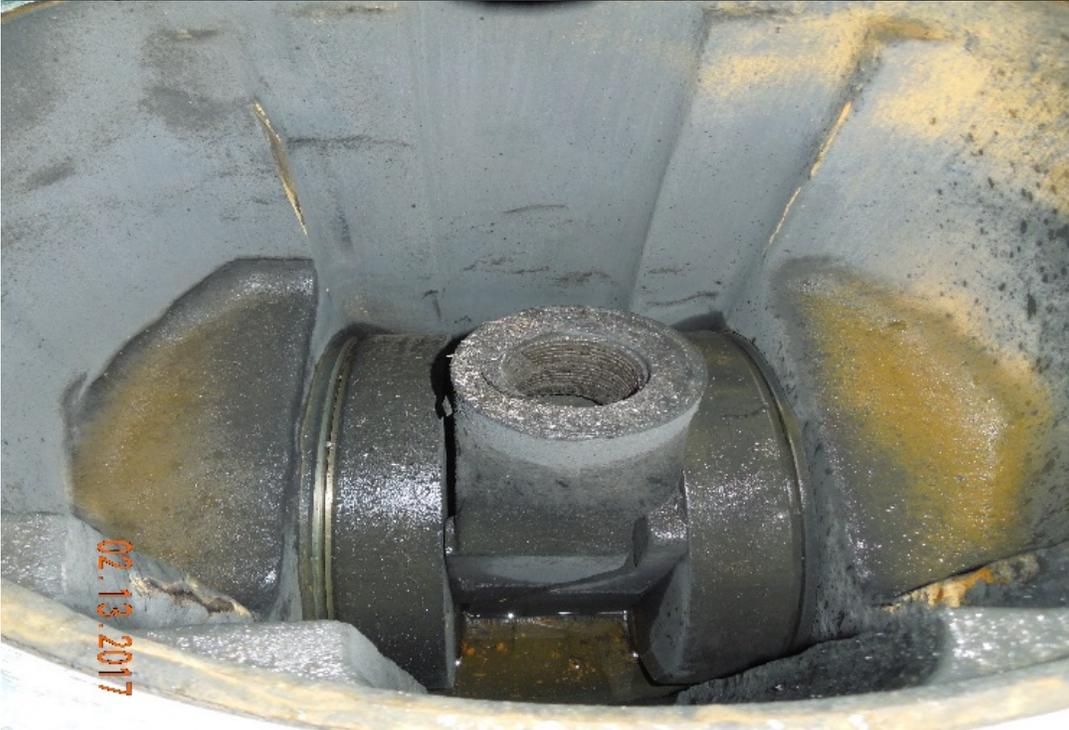
On February 11, 2017, the Unit 2 HPCS injection valve stem was found to be separated from the upper wedge/disc assembly during a fill and vent activity<sup>1</sup>. Prior to the failure, the valve had successfully passed a local leak rate test where the valve had cycled successfully several times. Valve disassembly and inspection revealed the wedge pin had sheared and the valve stem threads were damaged. This valve was an Anchor/Darling 12 inch Double Disc Gate Valve (ADDDGV) and was included in those valves associated with the Flowserve and Browns Ferry Part 21 reports submitted in 2013 (ADAMS ML13008A321 and ML13064A012). The licensee was addressing the Part 21 reports by using industry guidance provided by the Boiling Water Reactor Owners Group (BWROG) prior to the failure. Following the identification of the separation, the licensee redesigned and repaired the failed Unit 2 HPCS Injection valve.

Figure: As Found Pictures of Failed Unit 2 HPCS Injection Valve Stem to Wedge Connection
