Part 21 (PAR)

Event # 52762

NOTIFICATION UNDER 10 CFR PART 21 OF BETTIS BRAND SEISMIC QUALIFIED G SERIES SPRING RETURN ACTUATORS

Re: Notification under 10 CFR Part 21 of Bettis Brand Seismic Qualified G Series Spring Return Actuators

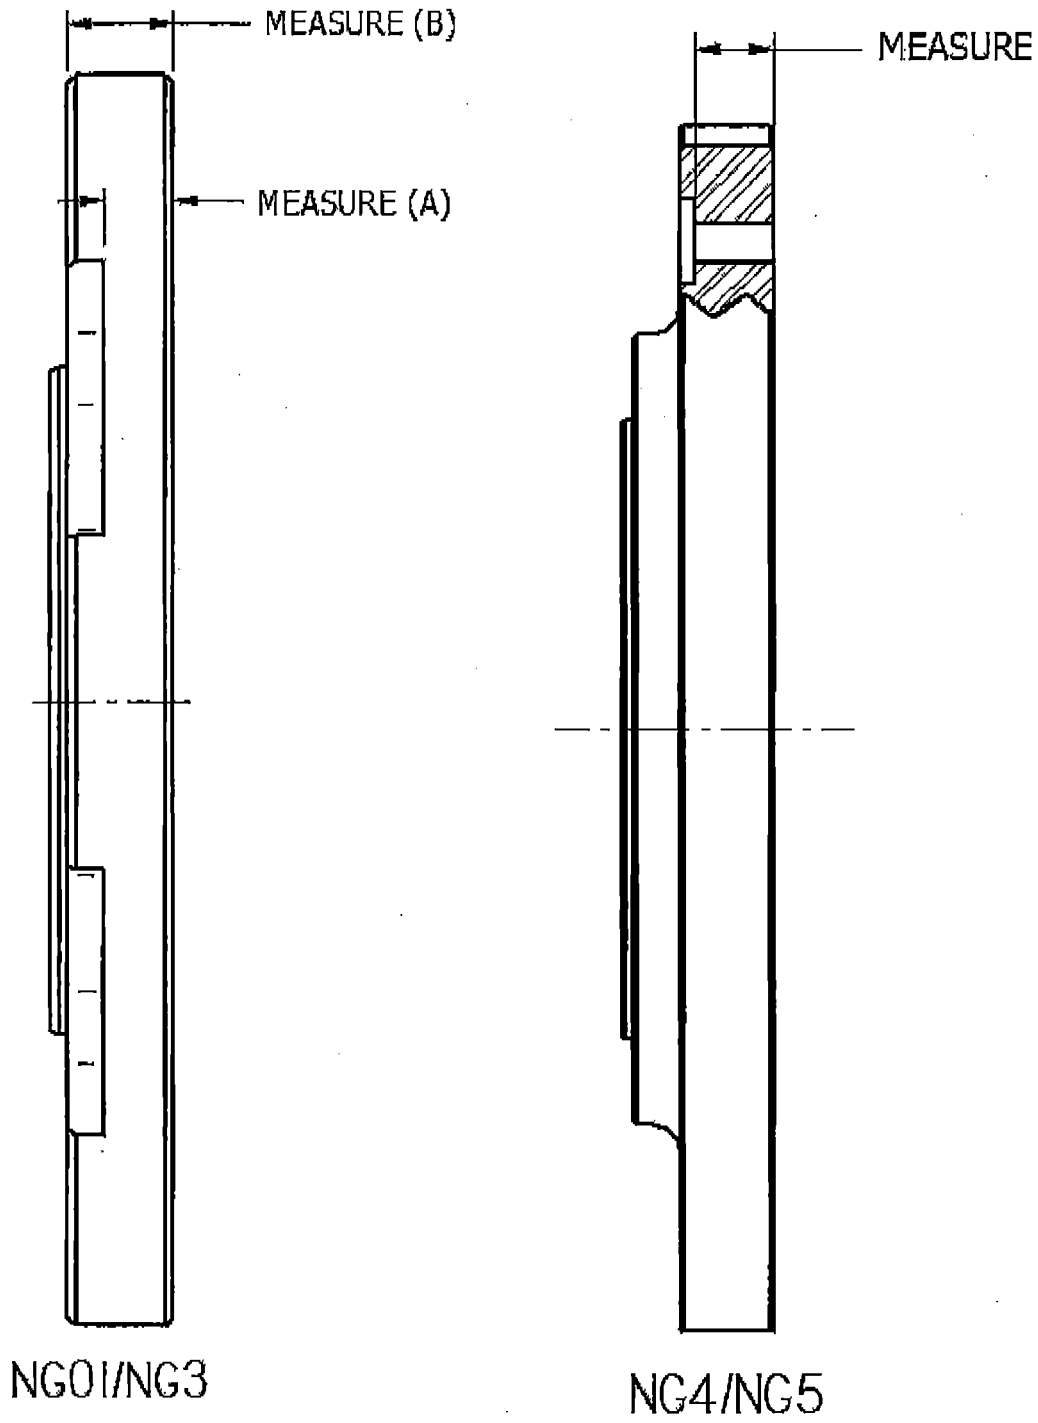
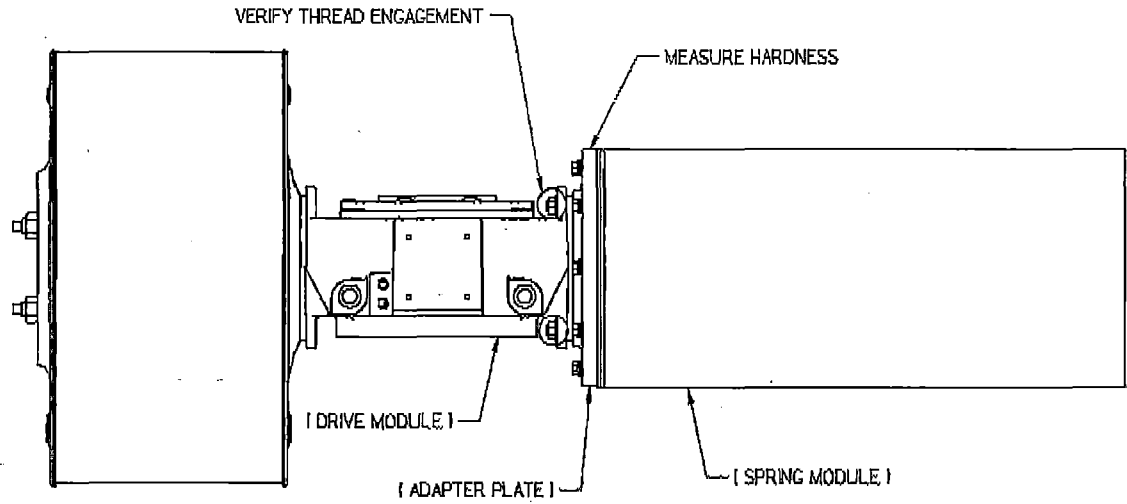
FIGURE A

Certain measurements should be taken to remedy the inspection nonconformance. All measurements may be taken in situ with the actuator assembled to the valve. Please refer to Figure A (attached) depicting the feature to be measured. The numbered measurements in Figure A correspond to the numbered measurement inspection procedure below. Table 1 provides measurement values for reference. Remedial inspection recommendations are to:

1. Confirm the thickness of the plate at the point where the bolt head & washer engage the flange surface. This location may be a milled flat section or counter sunk hole depending on the actuator size.
2. Verify full thread engagement for nuts installed on bolts for the housing flange.
3. Perform hardness testing on a small area on the outside diameter of the adaptor plate. The paint will need to be removed at the point of hardness testing.

Should the adaptor plate fail to meet the above specifications, please contact us promptly.
