SUBJECT: LER 87-003-00: on 870320, five containment atmosphere control inboard isolation valves closed due to fuse blowing in control power circuitry. Caused by shorted rectifier to one valve. Personnel isolated fault & replaced fuse. W/870420 ltr.

FACILITY NAME (1) Susquehanna Steam Electric Station - Unit Two	DOCKET NUMBER (2) 0 5 0 0 0 3 8 8	PAGE (3) 1 OF 0 4
--	--	----------------------

TITLE (4)
Five Containment Isolation Valves Close Due to a Blown Fuse

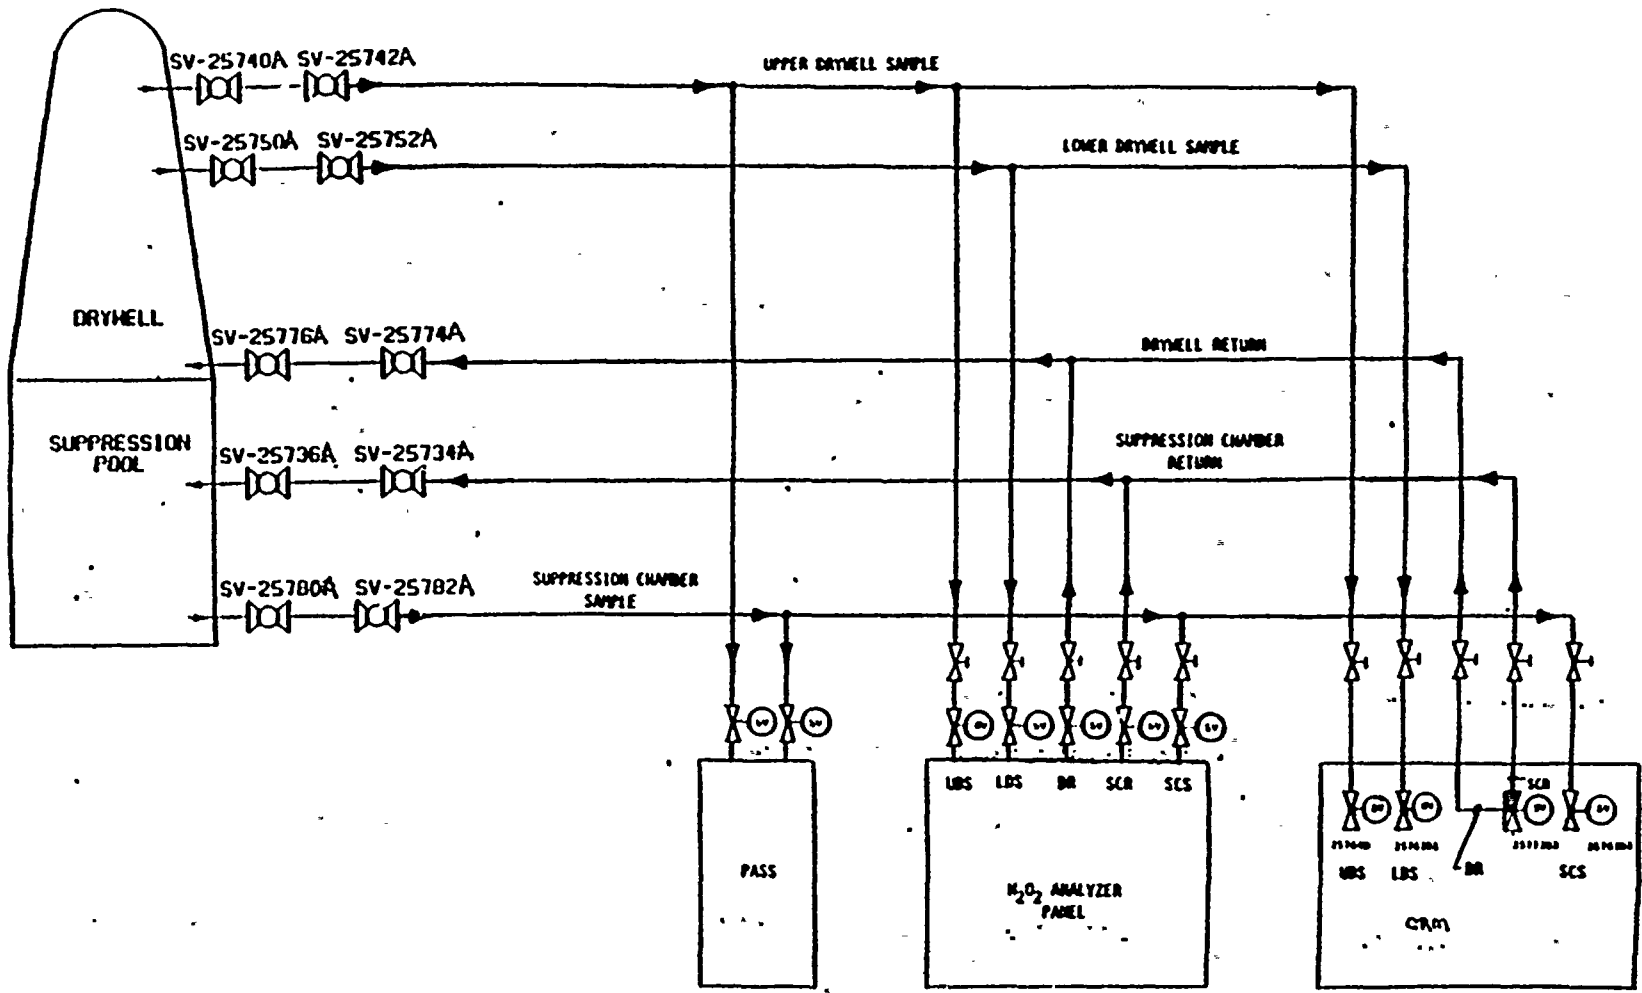
On March 20, 1987, at approximately 1230 hours, five Loop "A" Containment Atmosphere Control (EIIS Code: IK) inboard isolation valves closed due to a fuse blowing in the control power circuitry. The valves which closed are identified as:

<u>Valve ID#</u>	<u>FUNCTION</u>
SV-25740A	UPPER DRYWELL SAMPLE
SV-25750A	LOWER DRYWELL SAMPLE
SV-25776A	DRYWELL RETURN
SV-25736A	SUPPRESSION CHAMBER RETURN
SV-25780A	SUPPRESSION CHAMBER SAMPLE

Figure 1 shows the relationship between these valves and the Post Accident Sampling Station (EIIS Code: IP), H₂O₂ Analyzer (EIIS Code: IK) and the Containment Radiation Monitoring System (EIIS Code: IL). The blown fuse interrupted power to the valves' solenoids causing them to close to their fail-safe position. Prior to, and throughout, the event the unit continued to operate at or near 100% rated thermal power.
