SUBJECT: LER 87-004-01: on 870203, HPIS isolated. Caused by technician mistakenly setting RWCU switch in test position while performing Surveillance Procedure SI-152-205. Switch reset to normal position. W/870422 ltr.

LICENSEE EVENT REPORT (LER)

FACILITY NAME (1) Susquehanna Steam Electric Station - Unit One	DOCKET NUMBER (2) 0 5 0 0 0 3 8 7	PAGE (3) 1 OF 0 4
--	--------------------------------------	----------------------

TITLE (4) The High Pressure Coolant Injection System Isolates Due to An I&C Technician Bypassing the Incorrect Isolation Logic During Surveillance Testing.

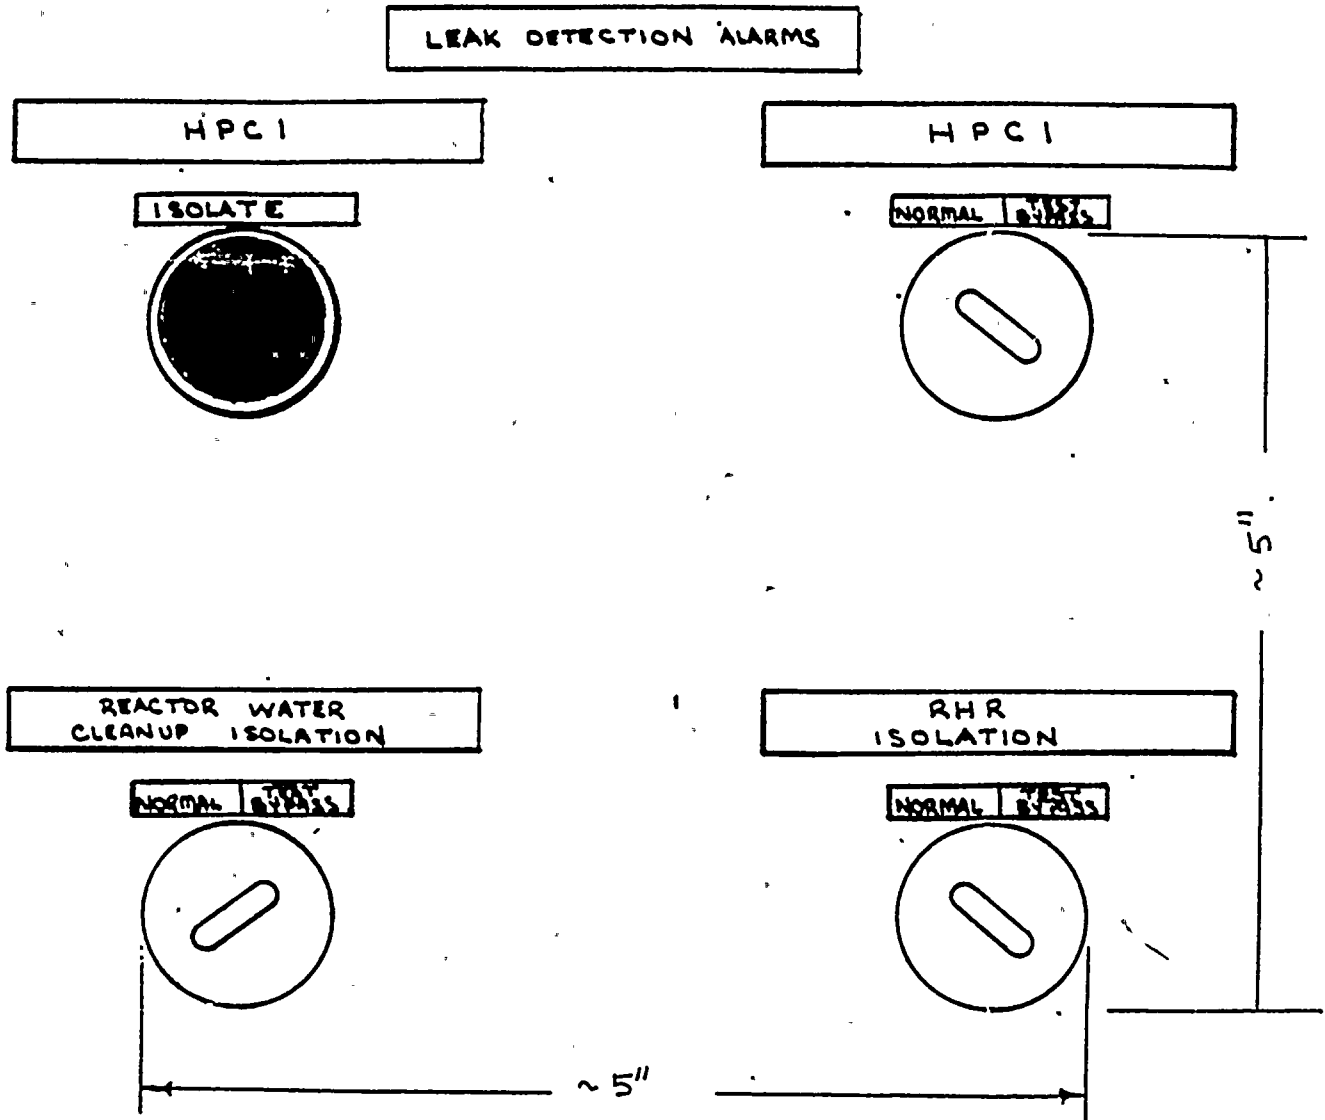
FIGURE 1

The HPCI isolation was caused by an I&C technician bypassing the Reactor Water Cleanup (RWCU) (EIIS Code: CE) isolation logic instead of the HPCI isolation logic. Figure 1 shows the arrangement of the key switches. The technician performing the surveillance read the label for the HPCI manual isolation pushbutton and then inserted the key into the RWCU key switch located directly beneath the pushbutton. The technician failed to notice the label identifying the key switch was for the RWCU system.

A review of the panel layout revealed that the position of the HPCI test switch is non-standard and that this contributed to the technician choosing the RWCU switch. Usually system related switches are located beneath one another. On this particular panel the HPCI TEST/BYPASS switch is situated to the right of the HPCI manual isolation pushbutton while the RWCU TEST/BYPASS switch is located beneath the HPCI pushbutton.

Immediate corrective action included removing the trip signal, resetting the RWCU key switch to the NORMAL position and restoring HPCI to operable status. To prevent recurrence a caution has been added to the surveillance procedure, prior to the bypass step, which explains the switch layout is non-standard.
