May 24, 2017

Donald C. Cook Nuclear Plant Unit 2  
2016 STEAM GENERATOR TUBE INSPECTION REPORT

### Unit 2 2016 Steam Generator Tube Inspection Report

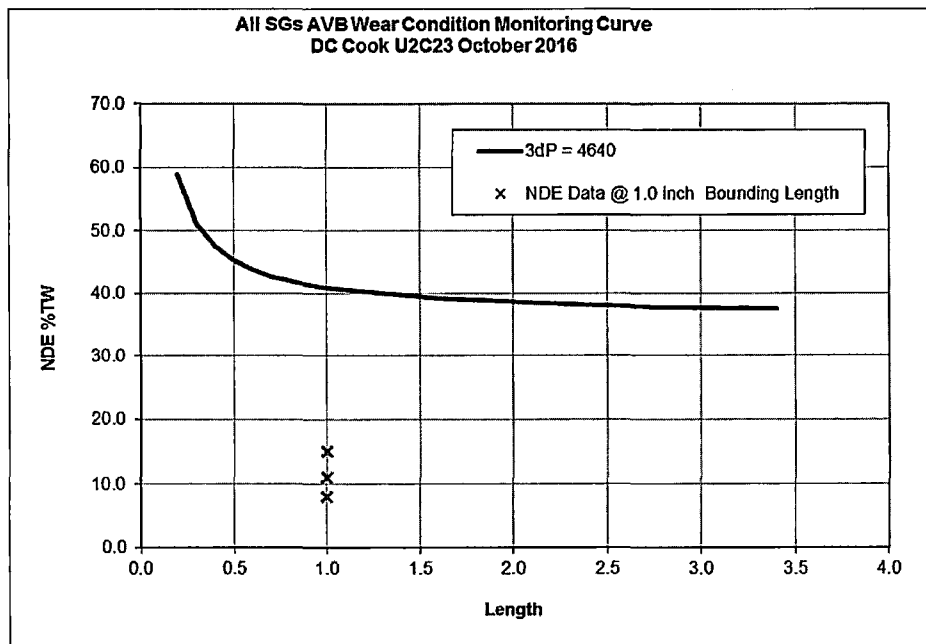
**ANTI-VIBRATION BAR WEAR  
CONDITION MONITORING LIMIT  
ETSS 96004.1**

A total of three AVB wear indications were reported. Two of the indications were located in SG 22 and one was located in SG 23. The SG 22 indications were new and were sized at 8% TW and 11% TW. The indication in SG 23 was previously reported and was found to have grown from 11% TW in the previous inspection to 15% TW in 2016. All of the affected tubes were left in service.

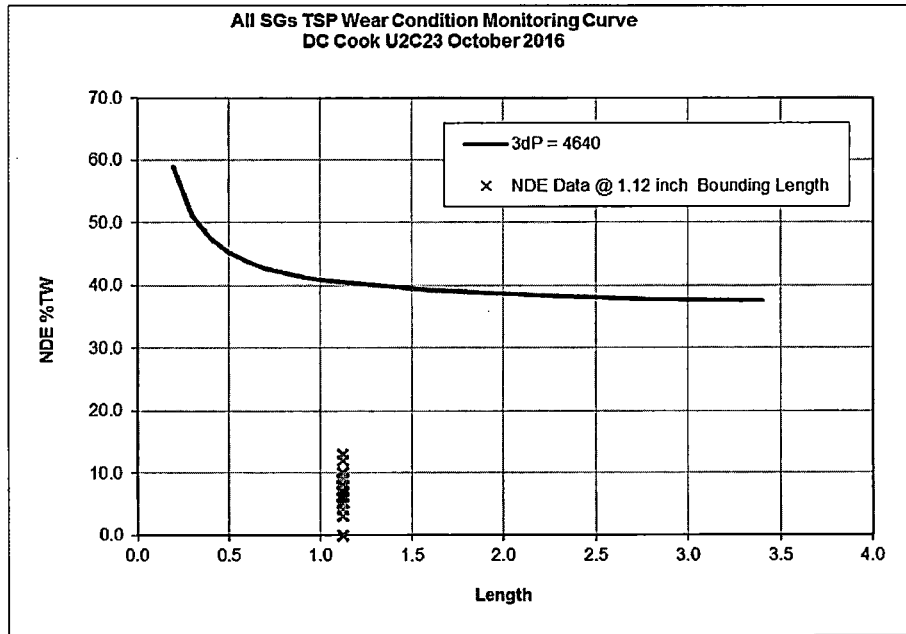
**TUBE SUPPORT PLATE WEAR  
CONDITION MONITORING LIMIT  
ETSS 96004.1**

TSP wear was detected in three of the four steam generators as noted in the above table. Of the 79 total indications, 39 were new and 40 were repeat indications. All of the indications were

≤ 20% TW with the largest being 13% TW. All of the TSP wear indications were returned to service.

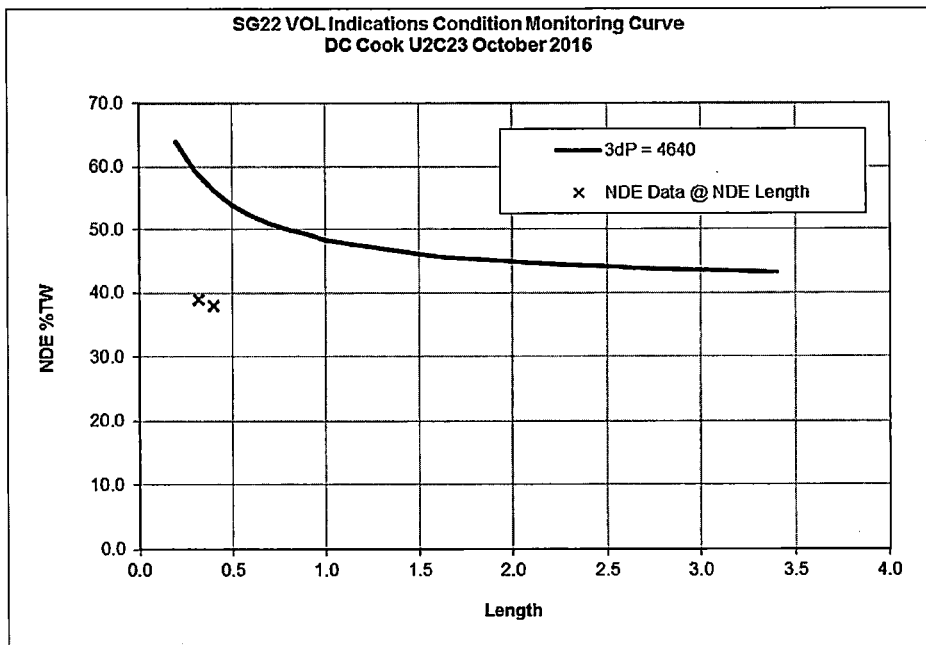
**VOLUMETRIC CONDITION MONITORING LIMIT  
ETSS 27904.1**

Both indications were sized using +Point™. The most appropriate Electric Power Research Institute (EPRI) technique was determined to be Examination Technique Specification Sheet (ETSS) 27904.1 based on the flaw shape. The indication in tube R46/C62 has a maximum depth of 39% TW while the indication in tube R47/C57 had a maximum depth of 38% TW.

Neither of the two indications exceeded the tech spec plugging limit of 40% TW or the condition monitoring limit. The indications did not meet any criteria that would require plugging; nevertheless, both tubes were plugged and stabilized.

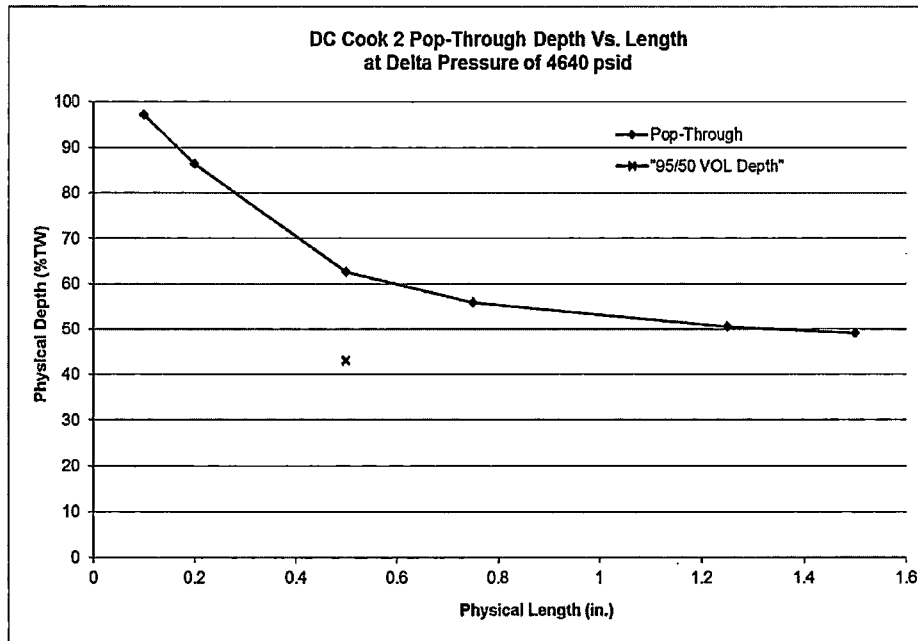
**POP-THROUGH CURVE  
FOR LARGEST VOLUMETRIC INDICATION**

If the volumetric indications are treated as a form of wear-like indication, the same methodology applies, thus the leakage integrity is also demonstrated by the volumetric curve below. Since the volumetric indications resemble an elliptical patch of degradation, leakage due to pop-through was also considered. That is, when considering the worst case accident differential, the largest volumetric indication continues to remain bounded by the pop-through curve at a bounding 0.5 inch length as illustrated in the last figure, thus confirming leakage integrity is satisfied for both volumetric indications.
