COMMONWEALTH EDISON COMPANY (DRESDEN 2)  
DOCKET NO. 50-237  
CORE SPRAY NOZZLE CRACKS

SUMMARY OF CORE SPRAY INFORMATION

PRELIMINARY UT RESULTS - DRESDEN 2  
CORE SPRAY "A" LINE

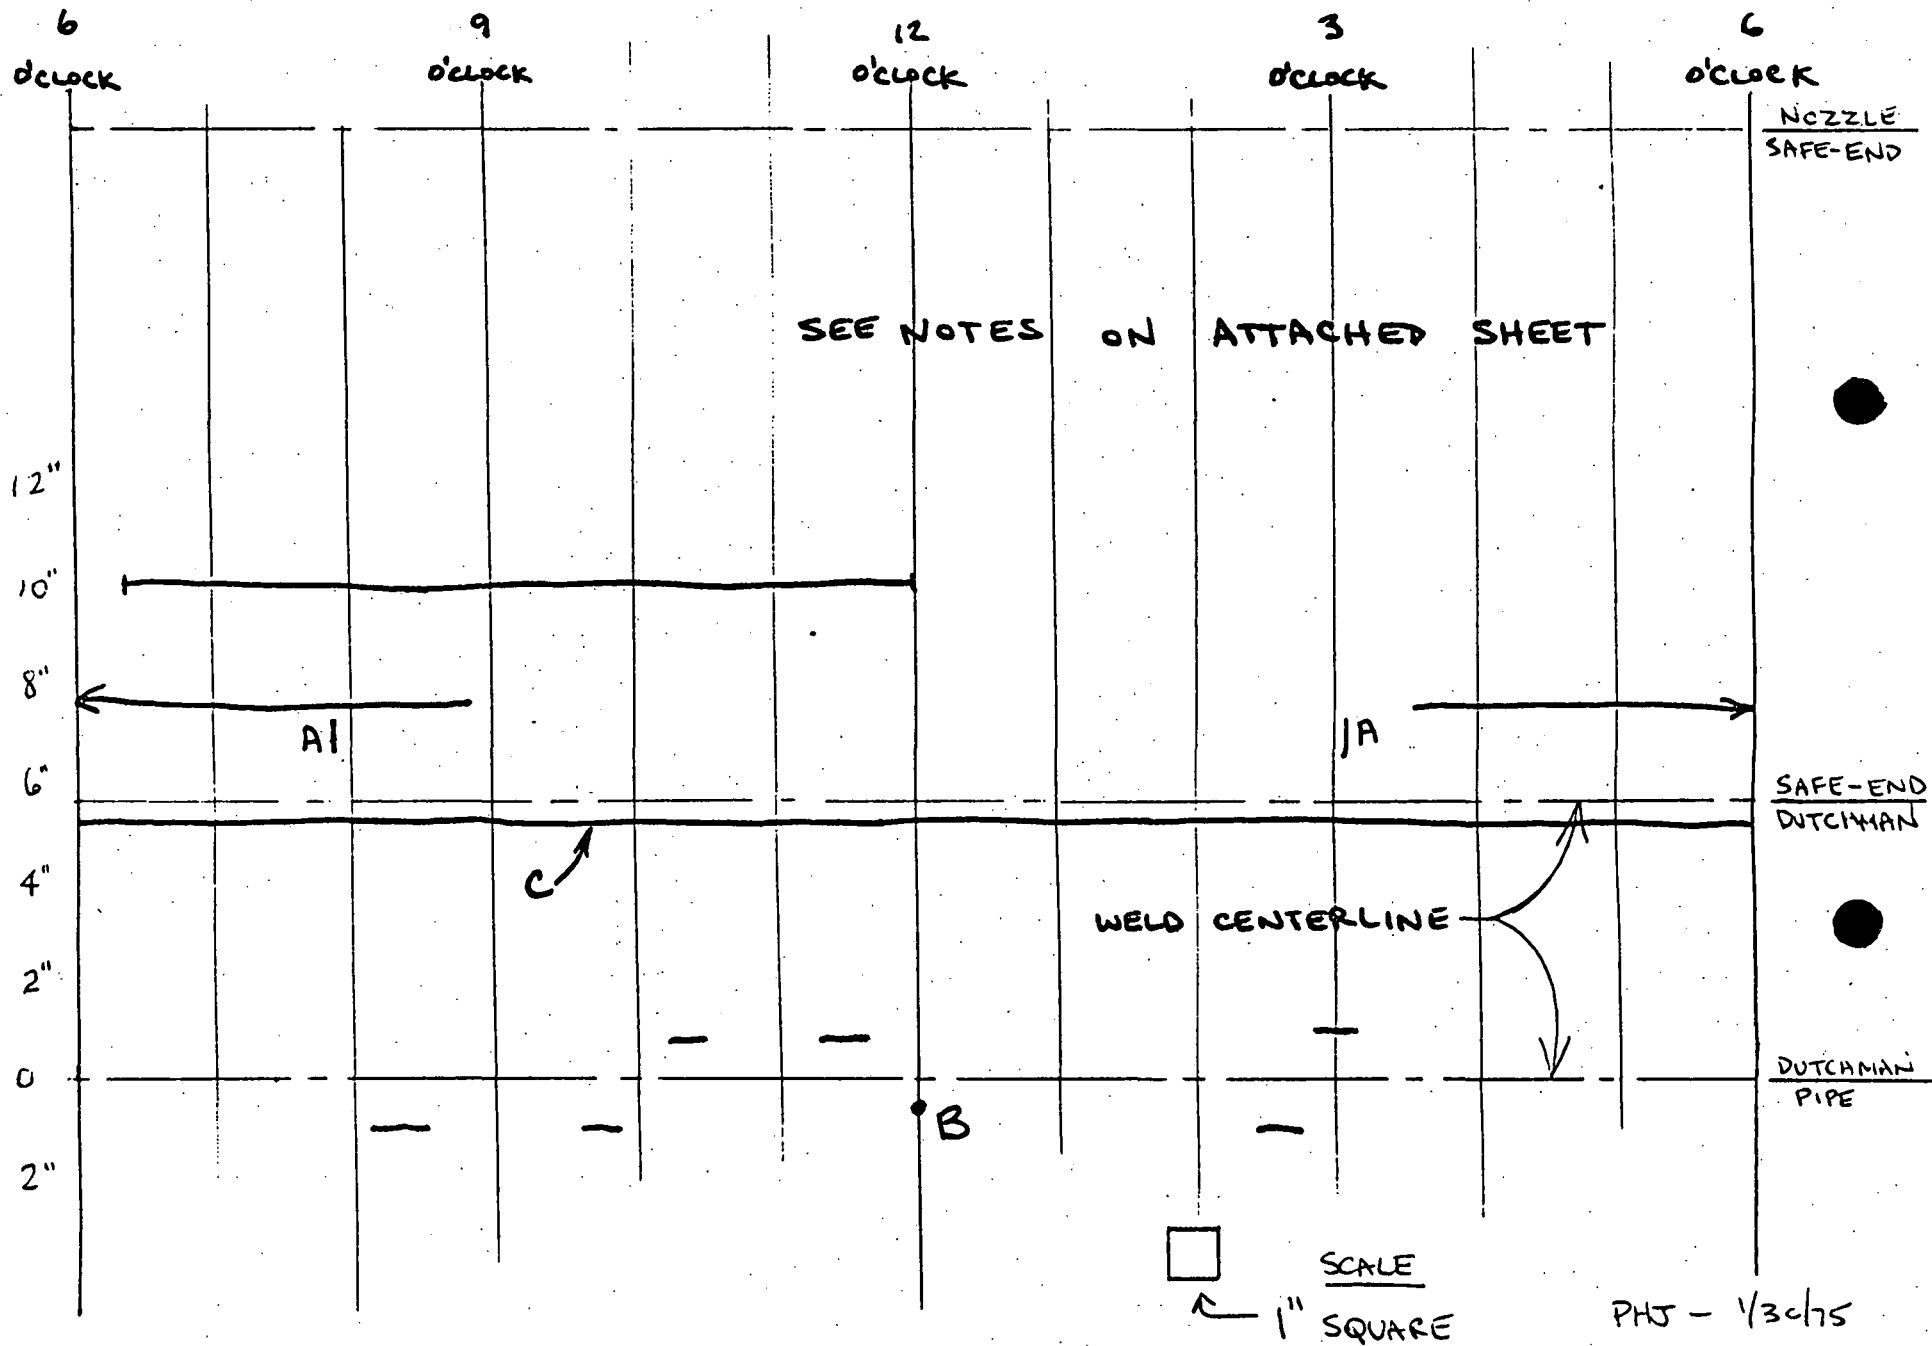
1. EVALUATION OF UT RESULTS STILL IN PROGRESS. LICENSEE PLANS TO USE RADIOGRAPHY TO ASSIST IN CLASSIFICATION.
2. ALL INDICATIONS WERE  $>100\%$  DAC EXCEPT ONE AT  $80\%$ . END OF INDICATION AS SHOWN ON SKETCH REPRESENTS  $20\%$  DAC. (i.e., INDICATIONS OR PORTIONS  $<20\%$  DAC NOT SHOWN).

3. UT PERFORMED ON 1/29/75 BY MAGNAFLUX, INC.
- ★ 4. SAFE END-DUTCHMAN WELD WAS MACHINED AFTER WELDING, MAKING ITS PRECISE LOCATION DIFFICULT. IT WAS INITIALLY THOUGHT TO BE ABOUT 8" FROM DUTCHMAN-PIPE WELD (EASILY VISIBLE). FERRITE SCAN PERFORMED 1/30/75 SHOWED SAFE-END-DUTCHMAN WELD TO BE ONLY  $5\frac{5}{8}$ " FROM DUTCHMAN-PIPE WELD.

5. SPECIFIC INDICATIONS:
  - A. TWO LONGITUDINAL CRACKS PREVIOUSLY REPORTED, CONFIRMED BY UT. IN VIEW OF NOTE 4, THESE ARE LOCATED IN SAFE-END. UT SHOWED LENGTH OF CRACKS AT I.D. TO BE ABOUT THE SAME AS AT O.D.

- B. PINHOLE PREVIOUSLY OBSERVED TO BE LEAKING. NOT SEEN ON UT.
  - C.  $360^\circ$  INDICATION, CONSISTENTLY "HEALTHY" SIGNAL. SHALLOW INDICATION, POSSIBLY DUE TO GEOMETRY.

- D. OTHERS AS SHOWN - DEPTH INDICATED ON SOME. EVALUATION STILL NOT COMPLETED.
