DRESDEN NUCLEAR POWER STATION

Supplement A to Special Report No. 18

Dresden 2/3 Safety Valve Investigation

DRESDEN SAFETY VALVE ANALYSIS

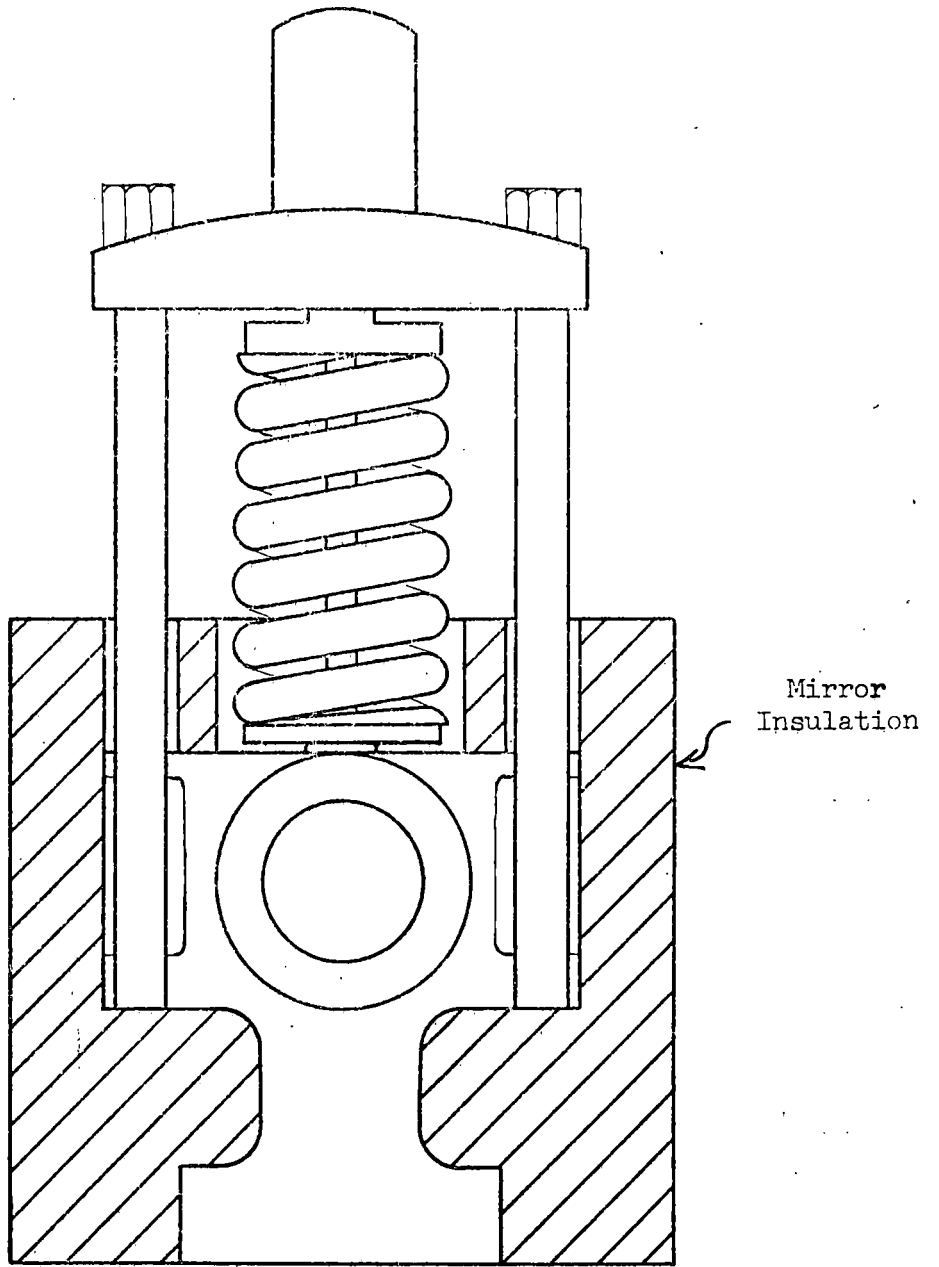
Figure 1
Safety Valve Insulation

In actuality, these valves are operating in an environment whose temperature is approximately 185 (°F). The safety valves are mounted on the main steam lines whose temperature is approximately 550 (°F). In most applications, these valves are not insulated. The Dresden Valves are insulated up to the second coil of the safety valve spring. See Figure (1).

Thermocouples installed on a typical insulated safety valve at Dresden indicated a temperature on the spring surface of 250 (°F), near the lower spring washer. Tests have shown that removal of the insulation results in a spring temperature equal to the drywell environmental temperature, about 150 - 180°F. A program of testing safety valve springs at Commonwealth Edison's Technical Center at Maywood was initiated. This program involved testing of these springs under simulated service conditions, and revealed the following.

The insulation on the safety valve bodies at Dresden Units II and III and Quad Cities Units I and II is capable of causing, in the worst case, a reduction of popping pressure by approximately 90 psi due to safety valve spring relaxation and yoke rod expansion.

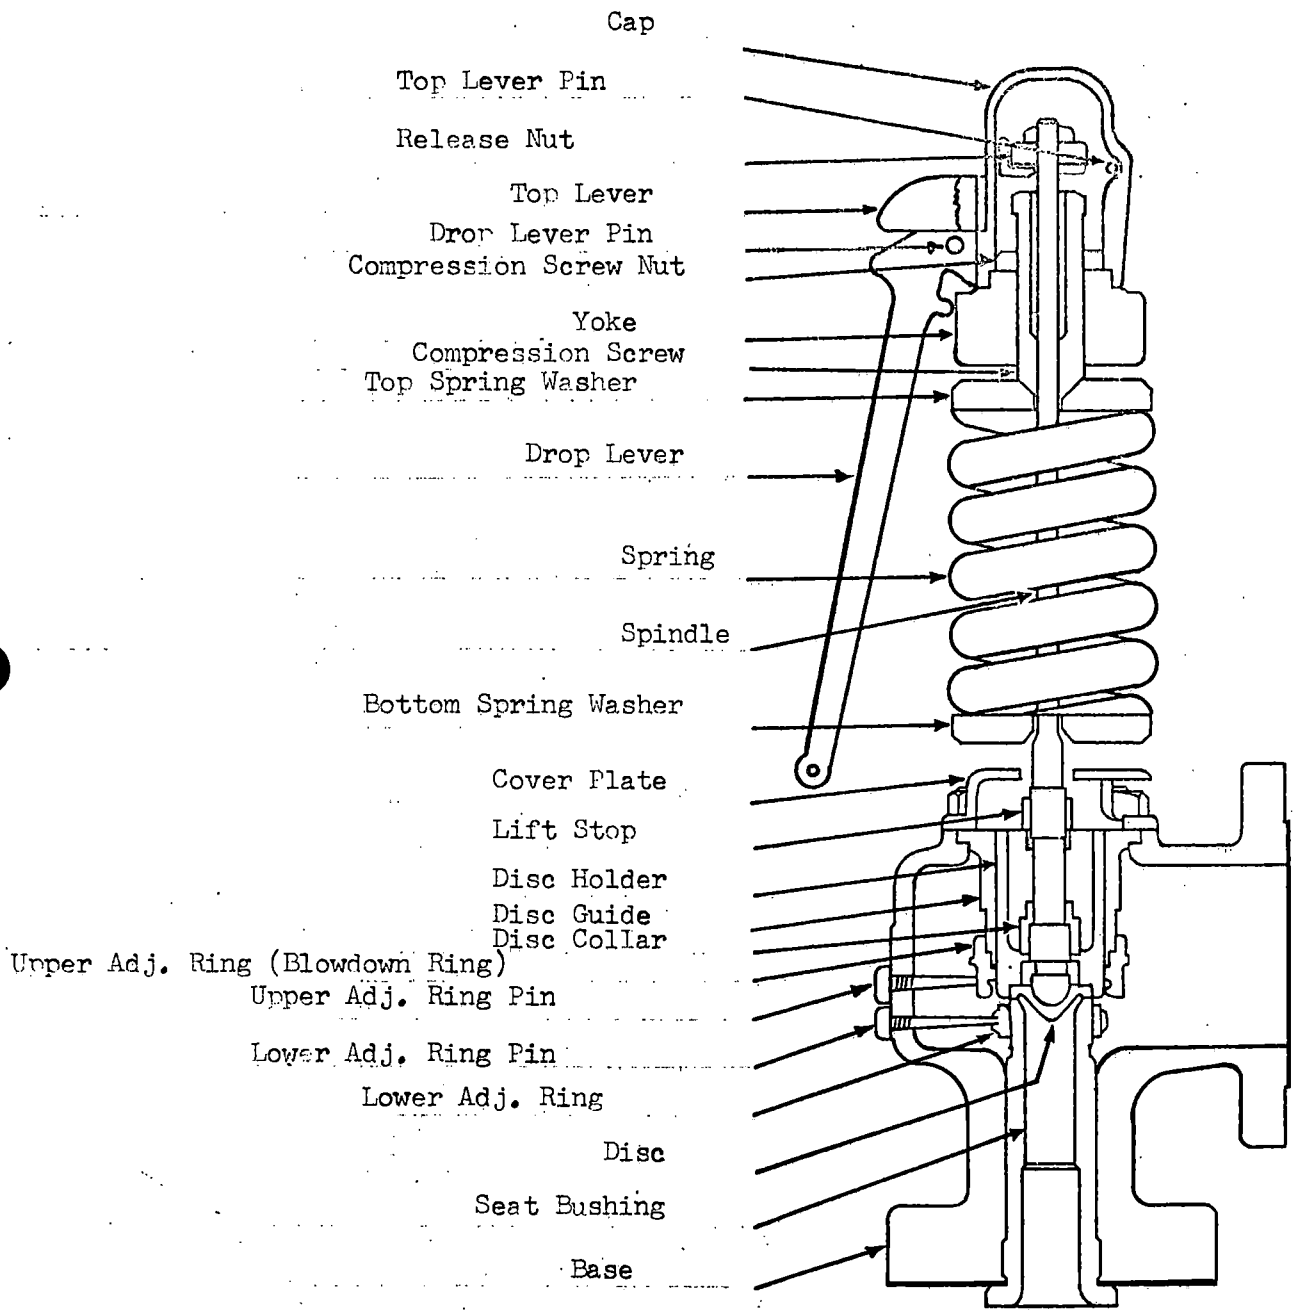
Figure 2
Safety Valve Schematic

The design of this valve was slightly different from that of the Dresden valve in that it had a solid casting up to the spring compressor nut instead of the two yoke rods and yoke configuration (see Figure 2). It is believed that the shock mechanism which caused this valve to discharge was the vibration of the spring and the spindle rod which presses on the disc. (See discussion in section III D).

In the Dresden valve the same type spindle rod is used in addition to the less stable yoke and yoke rod configuration. Thus it can be expected that the Dresden valve would have a greater shock sensitivity.

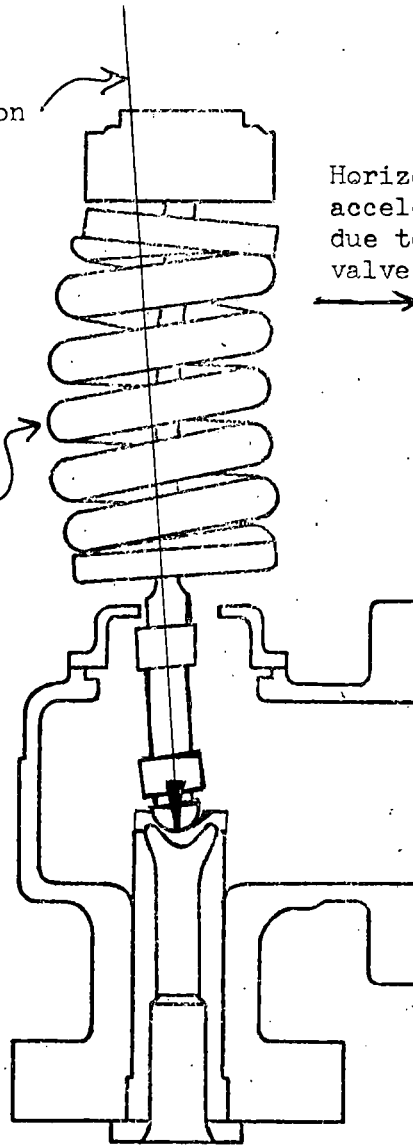
When a shock (horizontal acceleration) is imposed on the safety valve, the inertia of the spring will tend to increase this bending load on the spindle. As the spindle deflects under the increased load, the resultant force exerted by the spindle on the valve disc deviates farther than normal from the vertical axis of the disc thus decreasing the downward force on the disc and causing it to pop at a lower pressure than it is set for. See Figure 3 for a graphic representation of this phenomena.

Resultant force of
spring on disc under
acceleration condition

Horizontal
acceleration component
due to electromatic
valve actuation

Inertia of spring
causes bending of
spring and spindle

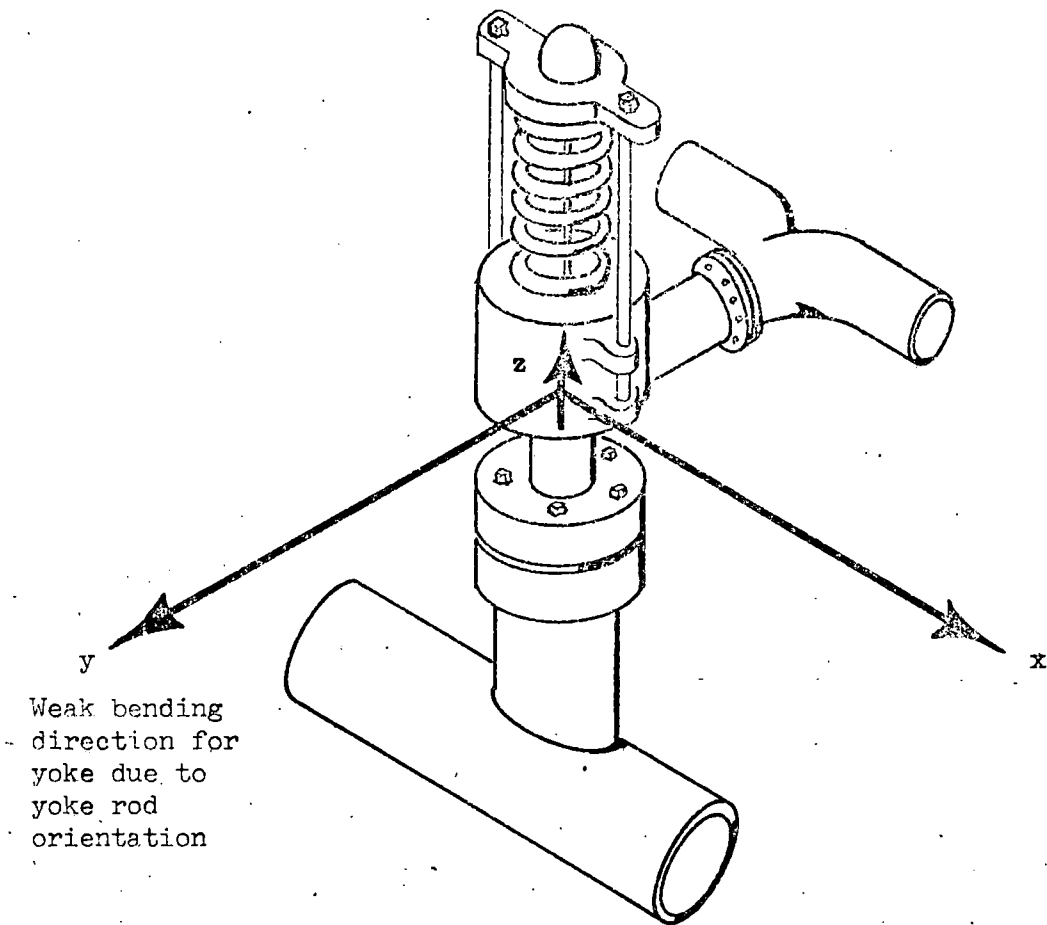
Figure 4

Recently, during tests were performed at Quad Cities Unit II; accelerations on the order of 30 G's were measured on the top of the valve spindle in the direction perpendicular to the plane of the yoke rods, see Figure 2, when an adjacent electromatic relief valve was manually actuated.

Test Title	Valve Body Accelerations in G's			Top Spindle Accelerations in G's		
	x	y	z	x	y	z
Isolated Reactor (1,000 psi)	-	-1.7	-20	-16	-28.5	-5
Unisolated Reactor (1,000 psi)	-	-2	-25	-17	-31.5	-1.6

Accelerations resulted from operation of an electromatic relief valve adjacent to the safety valve instrumented.

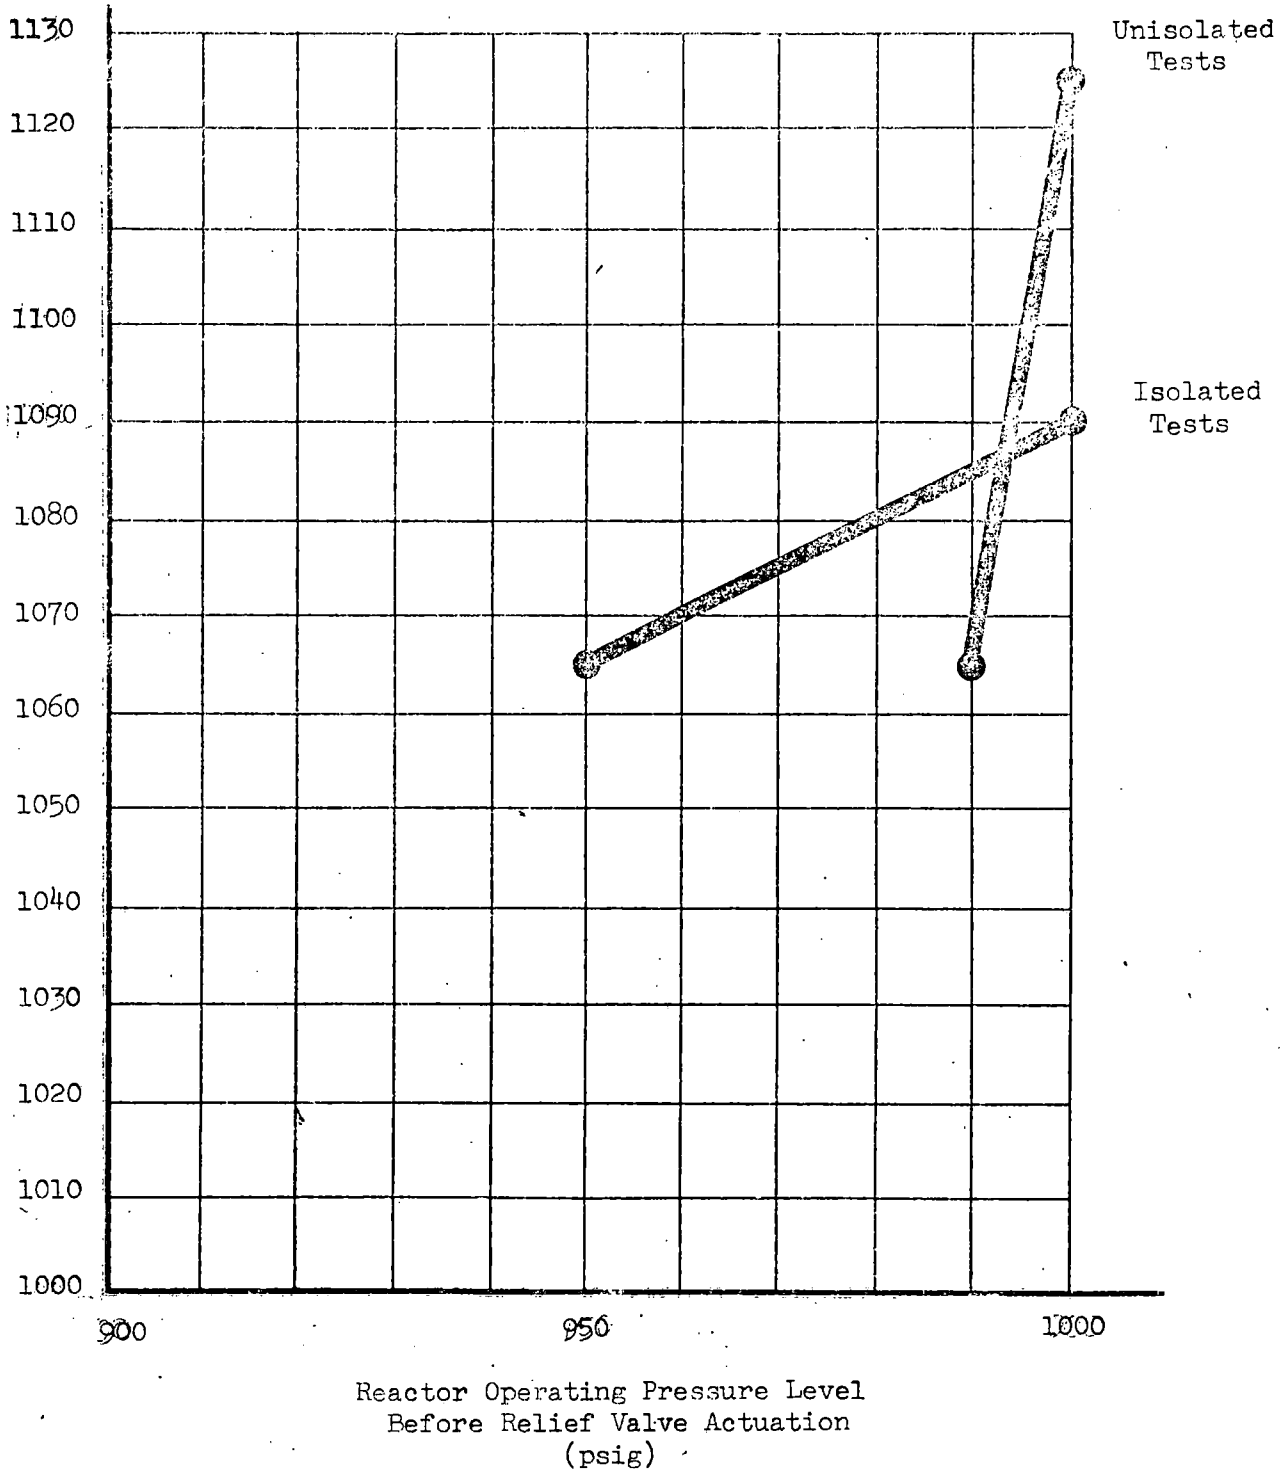
Figure 5

Recent tests at Quad Cities Unit II on an instrumented safety valve in service, indicate that actuation of an electromatic valve adjacent to a safety valve on the same main steam line with the reactor isolated (mainsteam isolation valves closed) caused on opening, pressure pulses 125 psi above the main steam line pressure before actuation. This test was performed at 1000 psi. Data at 990 psi where a pulse of approximately 75 psi above operating was measured, indicate that the higher the initial pressure in the main steam line before electromatic valve actuation, the higher the pressure pulse that the safety valve on the same line will experience. These data also indicate that this pressure pulse magnitude is a steeply rising function of initial steam pressure in the main steam line before actuation. Similar results were obtained although smaller in magnitude for the unisolated tests. Figure 6 shows these plots of pulse heights versus operating level.

It is difficult to calculate the energy in the pressure pulse curves and the response of the safety valve to these pulses, but the potential for premature actuation on a high pressure pulse can be readily visualized.

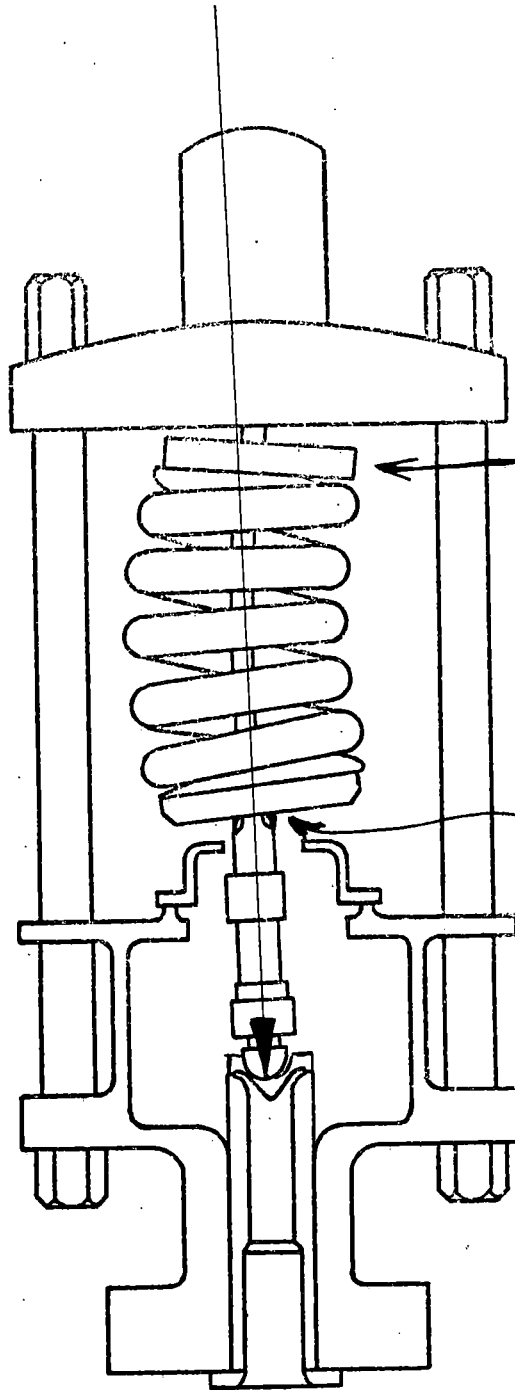
Figure 6
Safety Valve Spring Force Components

The bending of the spindle further increases the deviation of the resultant force exerted by the spindle on the disc from the perpendicular axis of the disc. Since the resultant force of the steam on the disc is always colinear with the perpendicular axis of the disc, the deviation of the spindle force decreases the opposing force against the disc exerted by the spring.

Tilting of upper
spring washer

Bending of spindle due
to eccentric spring load
on lower washer lowers
resultant force acting
down of valve disc.

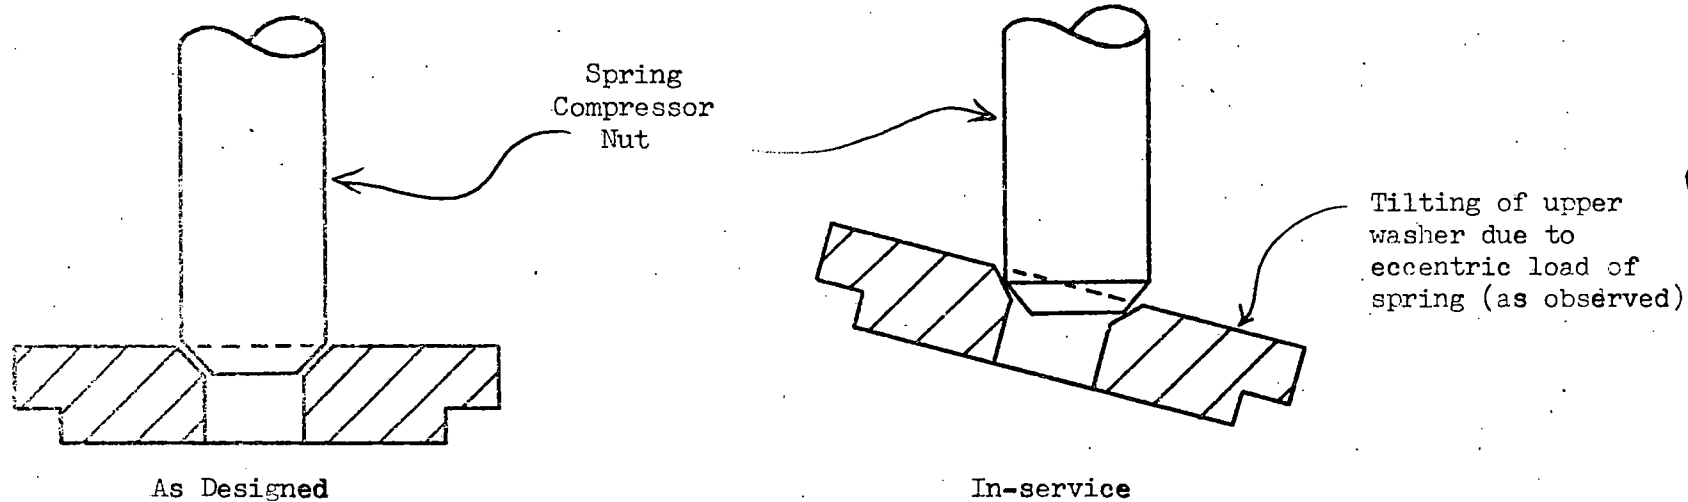
Figure 7

There are two ramifications of the eccentric loading that the spring exerts on the spindle and the spring washers. One involves the tilting of the upper and lower spring washers which involves a lowering of the magnitude of the load applied by the valve spring on the spindle. The other involves a bending of the spindle which leads to a reduction in the spring load applied to the valve disc because of the shift of the resultant force applied by the spring through the bent spindle to the valve disc. (See Figure 7) These two ramifications are discussed separately below.

The upper spring washer mates with the spring compression nut in the yoke on a conical seating surface. This surface should prohibit tilting of the washer relative to the compression nut, but as previously stated the upper washer, as observed, was tilted. This indicates that the nut material is incapable of sustaining the eccentric load which the spring applies to the washer, See Figure 8.

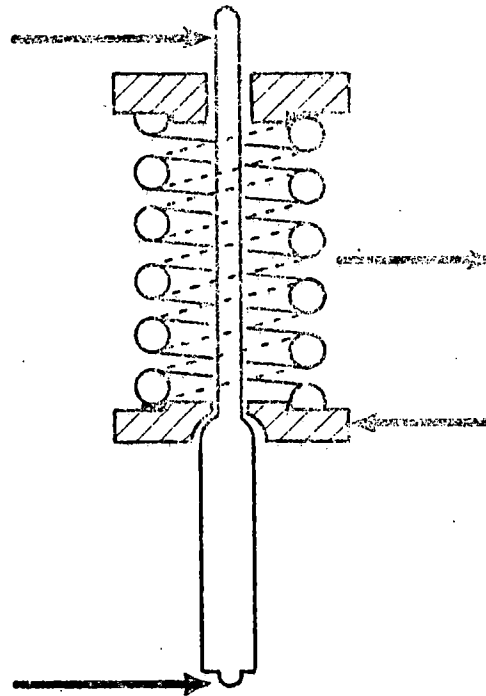
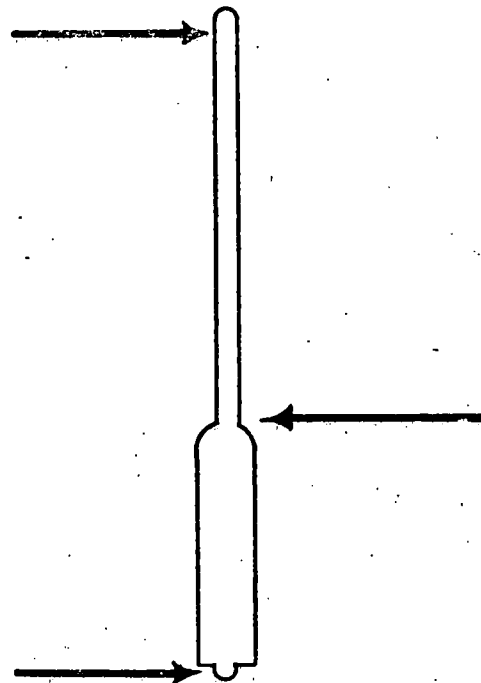
Figure 8

The safety valve spring is connected to the safety valve body at two points, the upper and the lower spring washers. Acceleration of the valve body in the above indicated direction causes an inertial loading of the spring on the valve body components through the two spring washers. The upper washer is connected to the compression nut which is rigidly mounted in the yoke. The lower spring washer however is held by the safety valve spindle. As previously stated the region where the lower spring washer rests on the spindle contains a stress concentration configuration. Considering the spindle to behave as a vertical beam, subjected to a large inertial load at a stress concentration, plastic deformation (bending) is highly probable at this point when the valve body is accelerated, See Figure 9.

Acceleration of
valve body

Inertia load of
spring on lower
spring washer

Inertial load of
spring transmitted
through lower spring
washer to spindle
