EXHIBIT 1, CONTAINING EVALUATION OF OPERATIONAL  
DIFFICULTIES.....

# DRESDEN NUCLEAR POWER STATION UNIT 2

Special Report  
of  
Incident of June 5, 1970

DRESDEN 2  
HPCI LINE DAMAGE REPORT

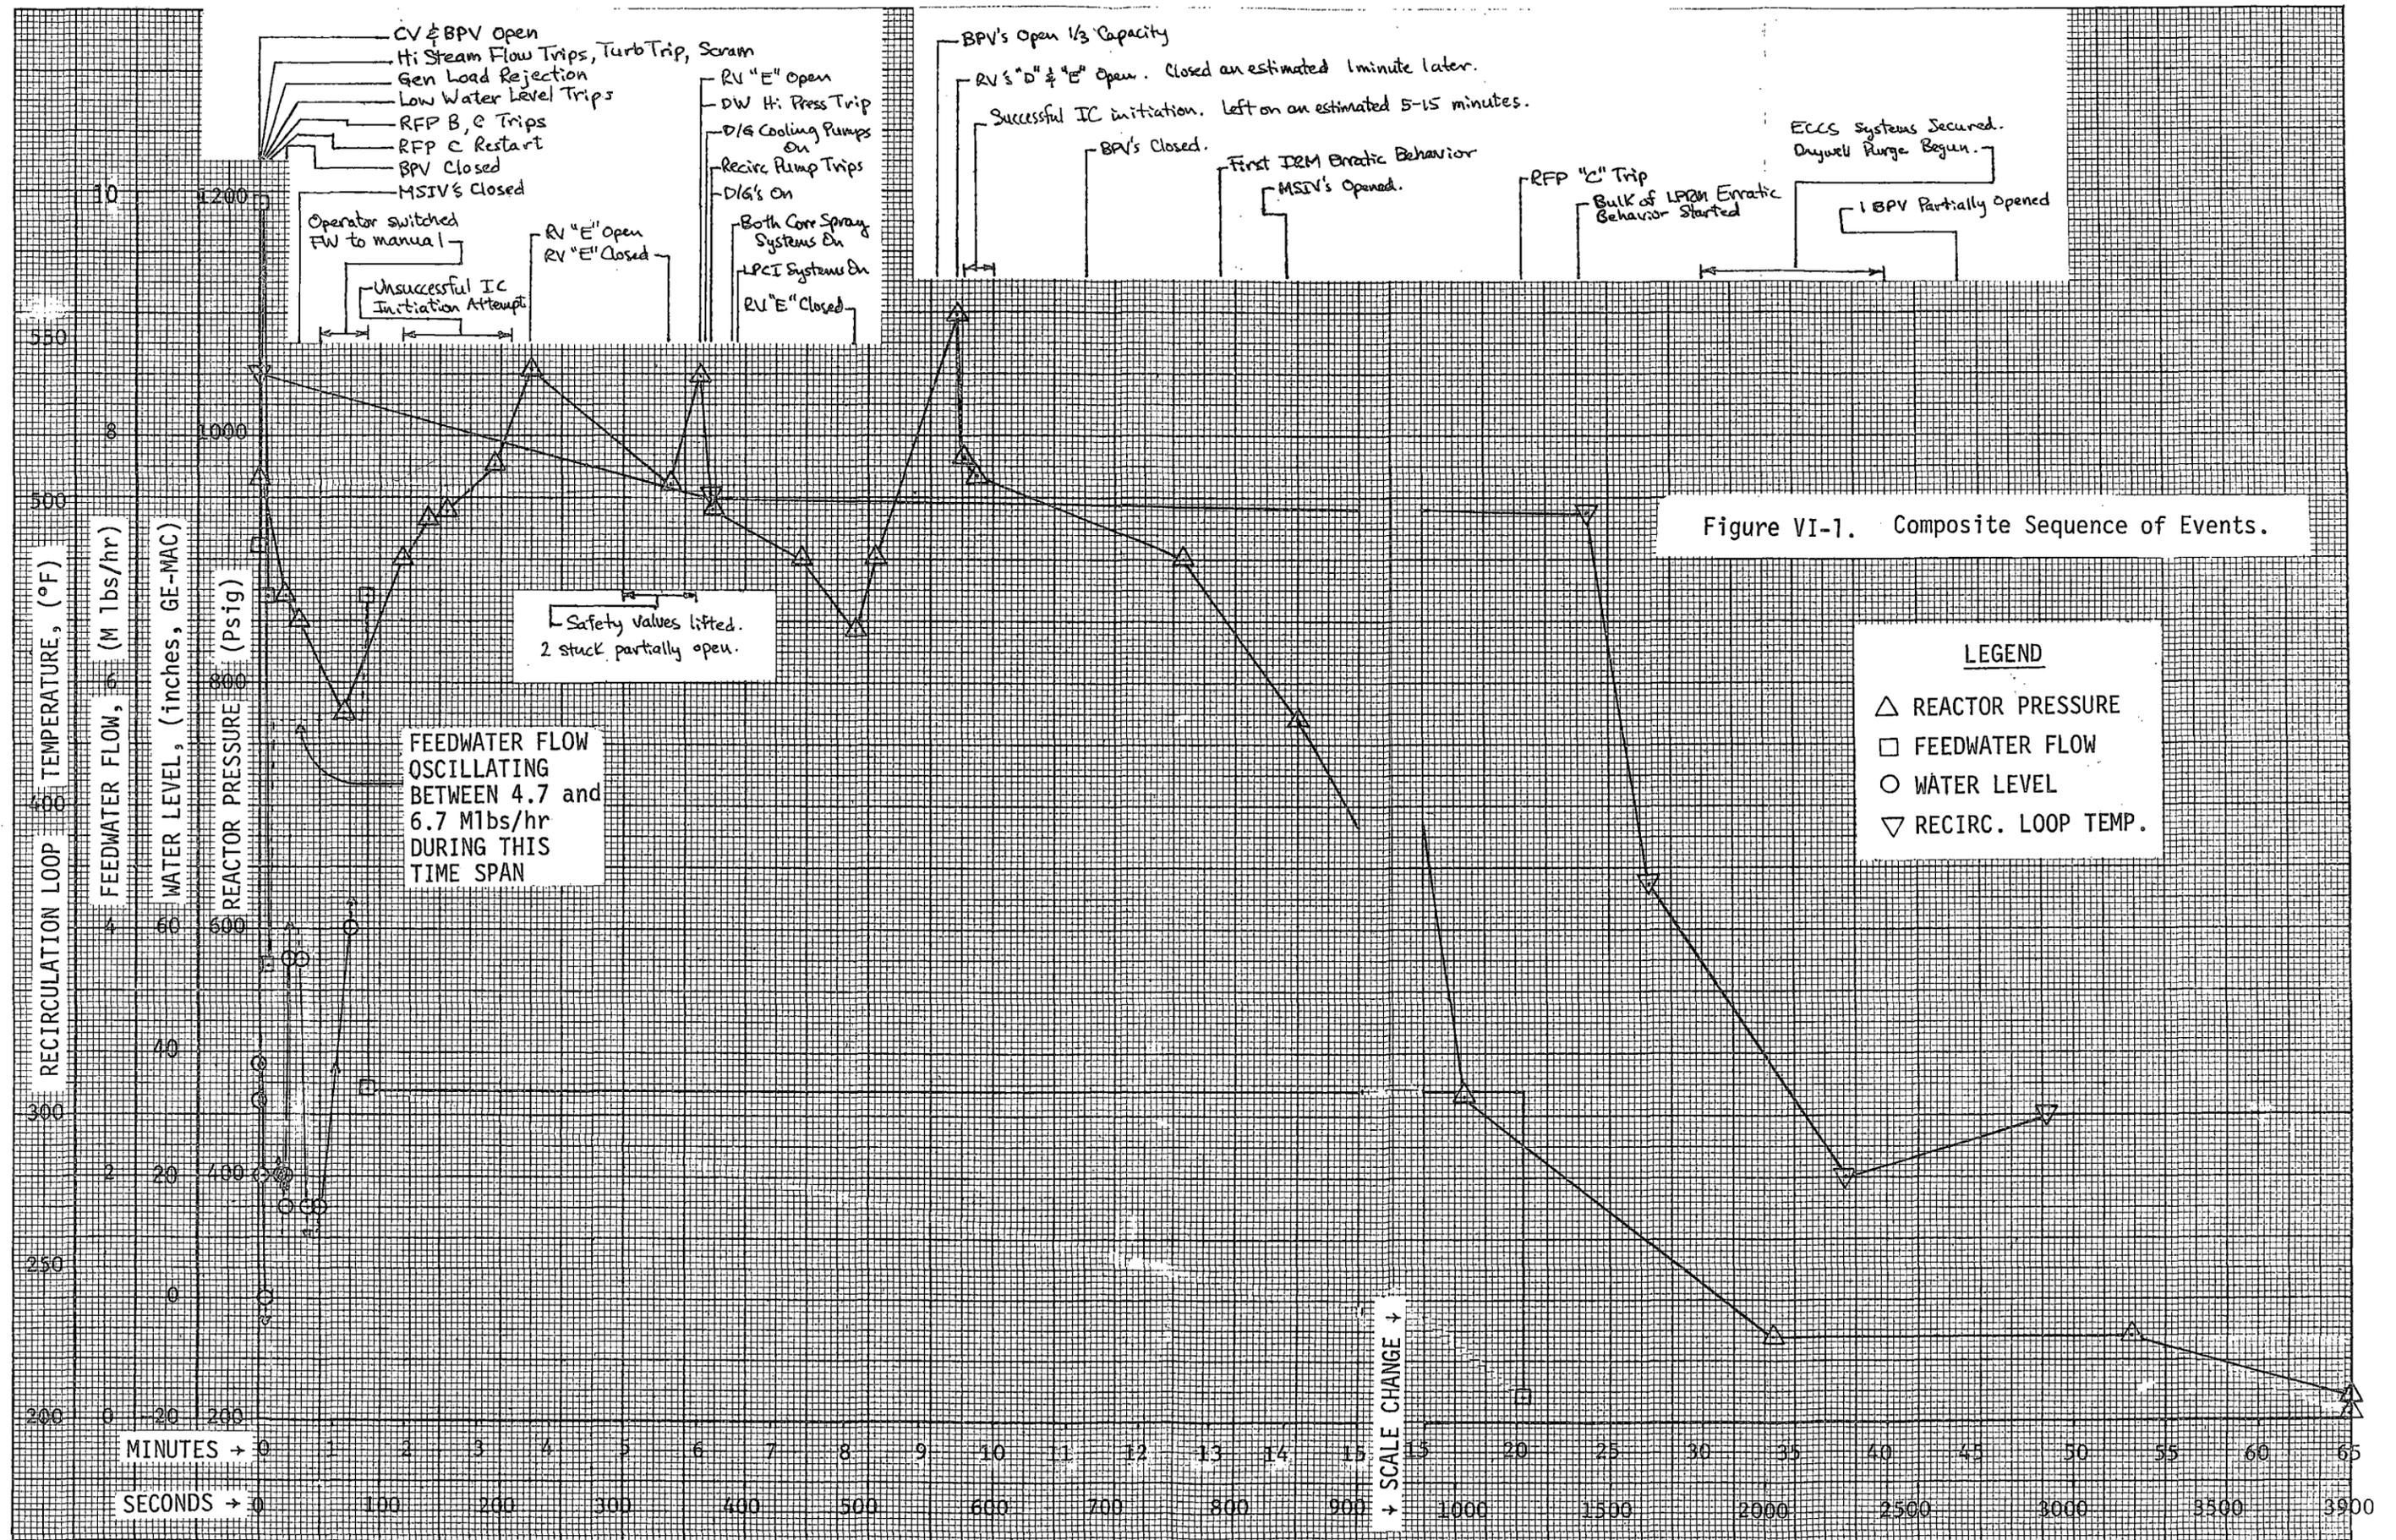
Figure VI-1. Composite Sequence of Events.

The vessel pressure transient during this event has been analyzed based on the initial conditions and the sequence of events which occurred during the transient. The predicted results and the actual recorded data are plotted on Figure VI-1. The following is a discussion of the comparison between the analysis and the data extracted from the recorder charts.

In the analysis, the vessel pressure dropped from the initial value of 985 psia to 970 psia approximately 1 second after the bypass valves opened, at which time turbine stop valve closure and scram was assumed to occur. After closure of the stop valves the pressure increased to 1006 psia at 3 seconds. The bypass valves were assumed to open completely at time zero. The momentary increase in pressure in the analysis after the stop valves closed can be explained by the fact that at this time the 40% bypass capacity is not adequate to remove the decay heat from the reactor core. This pressure increase was not observed in the recorded pressure trace. The early pressure transient is sensitive to the actual precise timing of the valve position changes which could not accurately be determined from the strip chart data. However, this did not significantly affect the subsequent transient analysis.

During the 3 to 22 second-period the bypass valves were fully open and the decay heat was adequately removed, resulting in depressurization of the vessel. During this period, the analysis adequately predicted the depressurization rate as is evidenced by the data obtained from the recorded pressure trace.

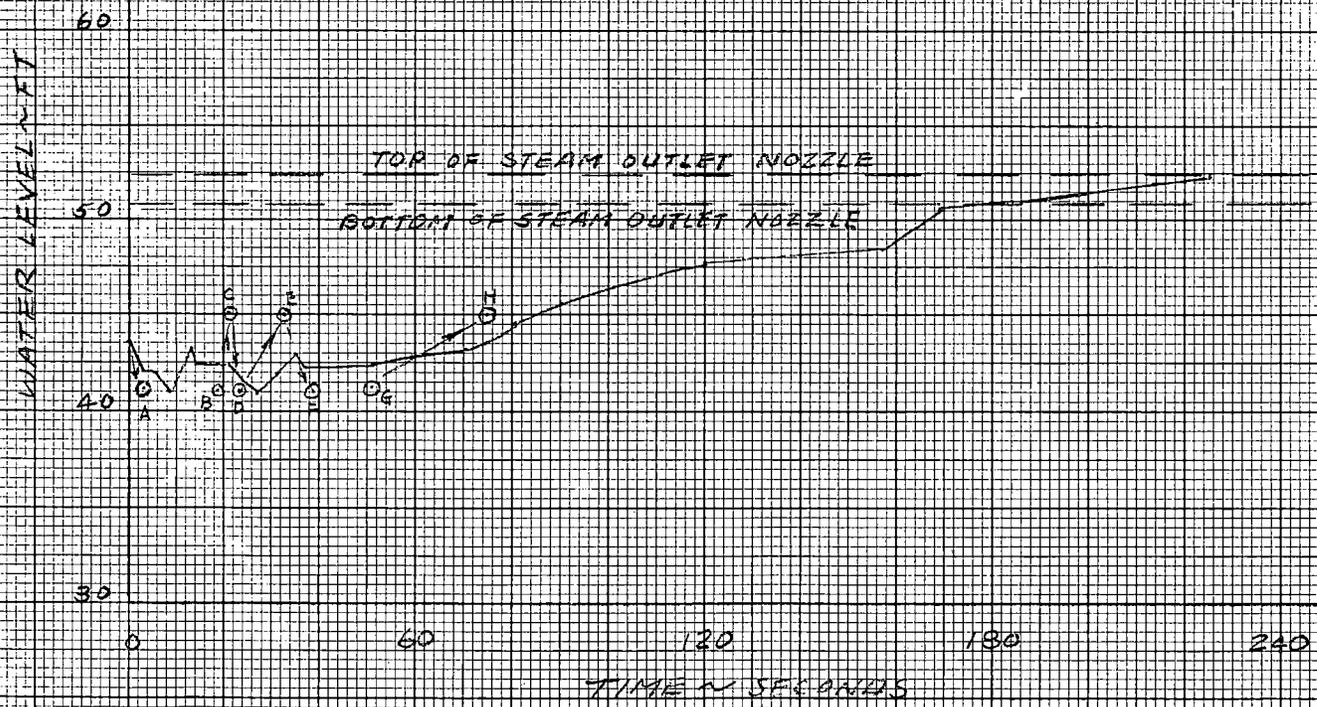
Figure VI-2.

- (a) Pertinent Data. The level and pressure transient used for this analysis are shown in Figures VI-2 and VI-3. Sufficient comparison could be made with available recorded data to verify these transients for times when recorded data was not available.

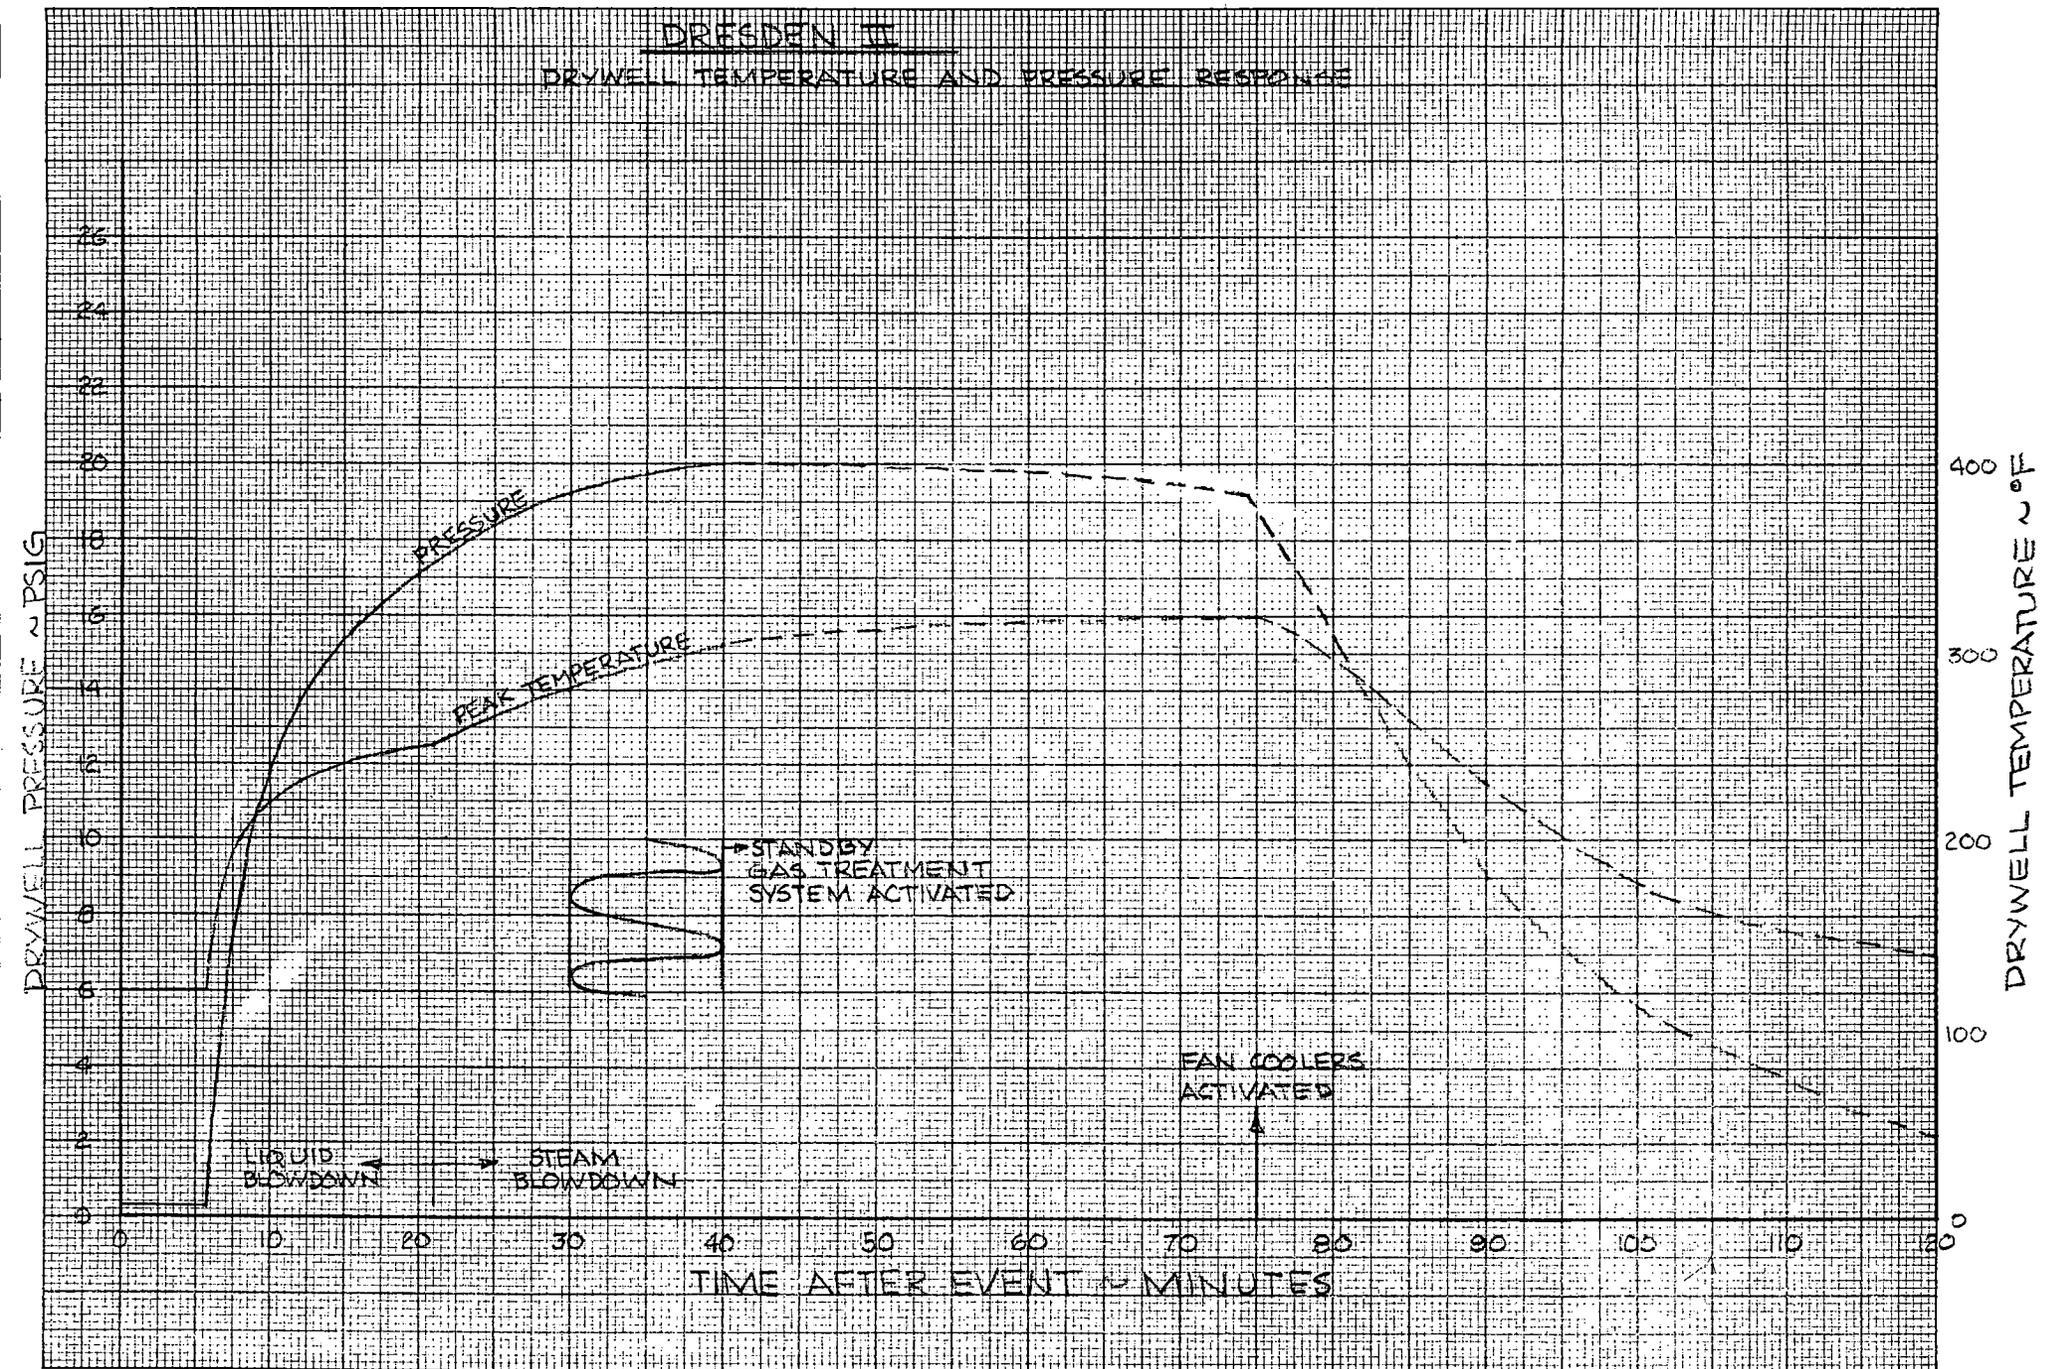
Figure VI-4.

During the time interval of postulated liquid blowdown from the safety valve, the maximum temperature of the jet after expansion was calculated to be 260°F or less depending on the containment pressure. It was during this period that paint was most likely eroded off the drywell wall by the high velocity steam-water mixture. The maximum wall temperature at the localized impingement spots would, therefore, have been close to this temperature, but no higher.
