# DRESDEN NUCLEAR POWER STATION UNIT 2

## Supplementary Information

Special Report  
of  
Incident of June 5, 1970

Commonwealth Edison  
Company

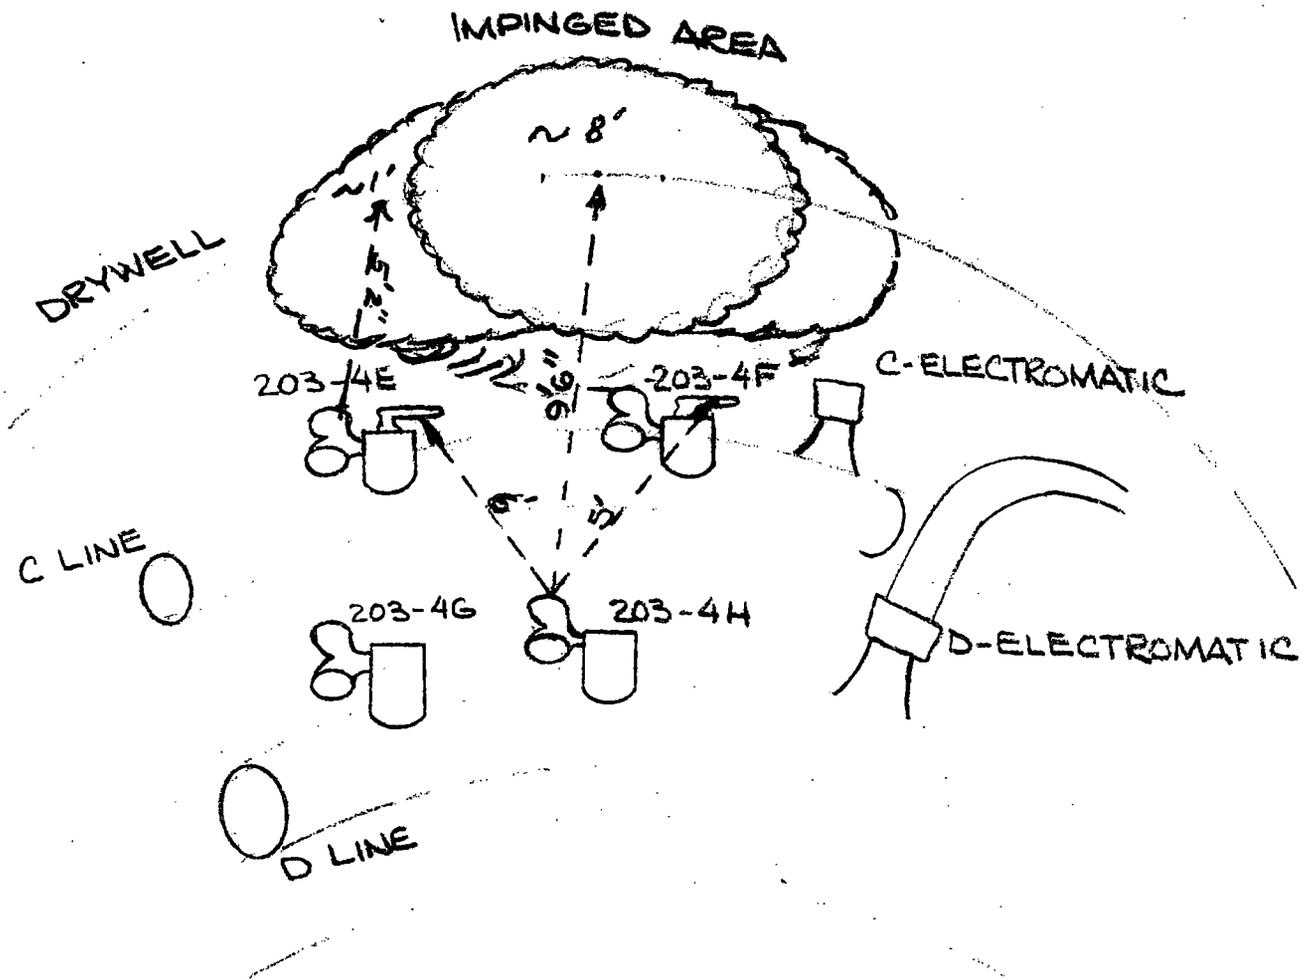
FIGURE 6-1

In the event the original setting is at 200°F for 1220 psig, and the maximum temperature of the spring is 320°F as noted in the June 5 incident report, the set point changes to 1195 psig or a 2% set point change.

In general, the result of impinging fluids is to raise the spring temperature and reduce the set point which tends to be in a safe direction. Also, it is noted that the valve discharges have been rotated at Dresden 2 to assure that impingement will not occur as it did during the June 5 incident.
