U. S. Nuclear Regulatory Commission  
ATTN: Document Control Desk  
Washington, D. C. 20555-0001Edwin I. Hatch Nuclear Plant  
Response to Request for Additional Information Regarding Relief Requests  
RR-16, RR-17, RR-21 and RR-22

**Edwin I. Hatch Nuclear Plant  
Response to Request for Additional Information Regarding Relief Requests  
RR-16, RR-17, RR-21 and RR-22**

**SNC Response to NRC RAI**

**Coverage Plots 2C-1 Vessel to Flange Weld**

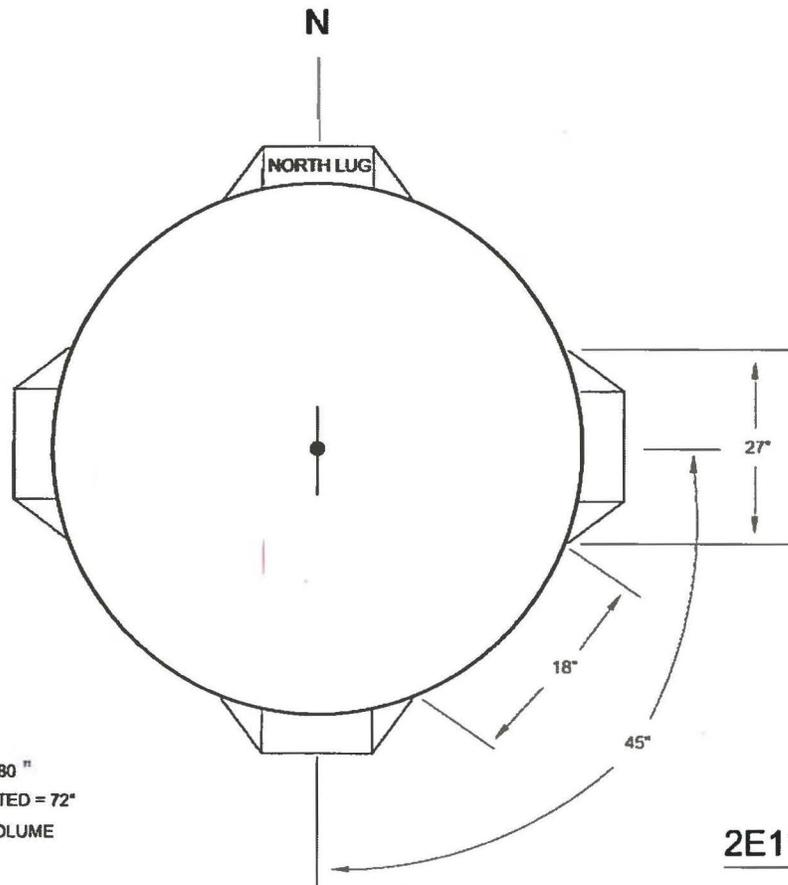
TOP VIEW  
2E11-2HX-A-1 Configuration

5. The staff reviewed the October 17, 1995 submittal identified under Section 8 (Precedents) of RR-21. In this submittal (which corresponds to a similar relief request for the third interval for weld 2E11-2HX-A-1), it is stated that 72% of the required volume was inspected. Please discuss the rationale and basis for the decrease in coverage to 40% during the fourth interval from 72% during the third interval.

Upon review of the initial submittal of RR-5 and the data sheets from the examination, the 72% percent coverage contained in the submittal for 2E11-2HX-A-1 was actually 72" of coverage out of 180" of total weld length, or 40% (72"/180"). The volume calculation has been consistent when comparing examination results. The figure on the next page shows the configuration documented in the data sheets. This error has since been documented in the SNC Corrective Action Program (CAP).

TOTAL EXAM  
TOTAL CIRCUMFERENCE = 180"  
TOTAL INCHES UNOBSTRUCTED = 72"  
 $72 / 180 = 40\%$  OF EXAM VOLUME

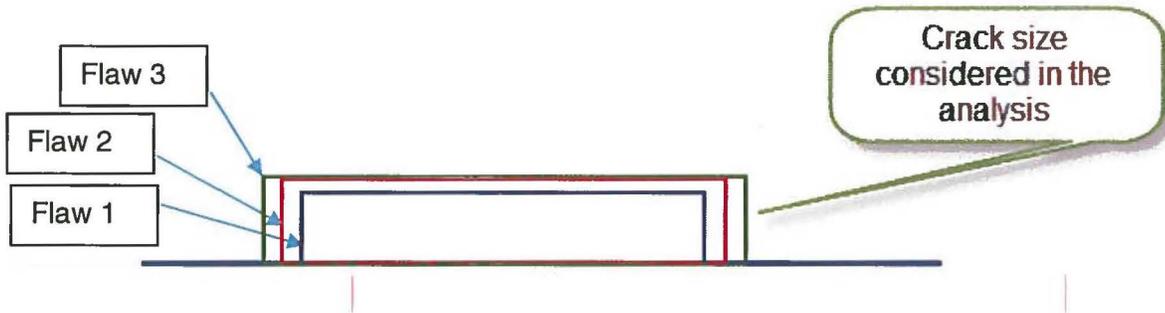
Flaws	Depth (in)	Length (in)	Depth/Length
Flaw #1	0.12	0.75	0.16
Flaw #2	0.18	0.80	0.225
Flaw #3, Assumed Flaw	0.18	0.90	0.20

Since Flaw #2 is larger than Flaw #1, both in the depth and the length directions, only Flaw #2 needs to be considered. Assuming the a/l for Flaw #2 to be 0.2 makes the flaw longer and thus more conservative.

The fatigue crack growth (Section 6.2.4) was performed using an initial crack of depth = 0.18 inch and length = 0.9 inch ( $a/l = 0.2$ ).

For further clarification, ignore  $a/l$ , and only compare the depths and the lengths of the flaws. The flaw assumed for further analysis (Flaw #3) is larger than the observed flaws as shown in the sketch below.

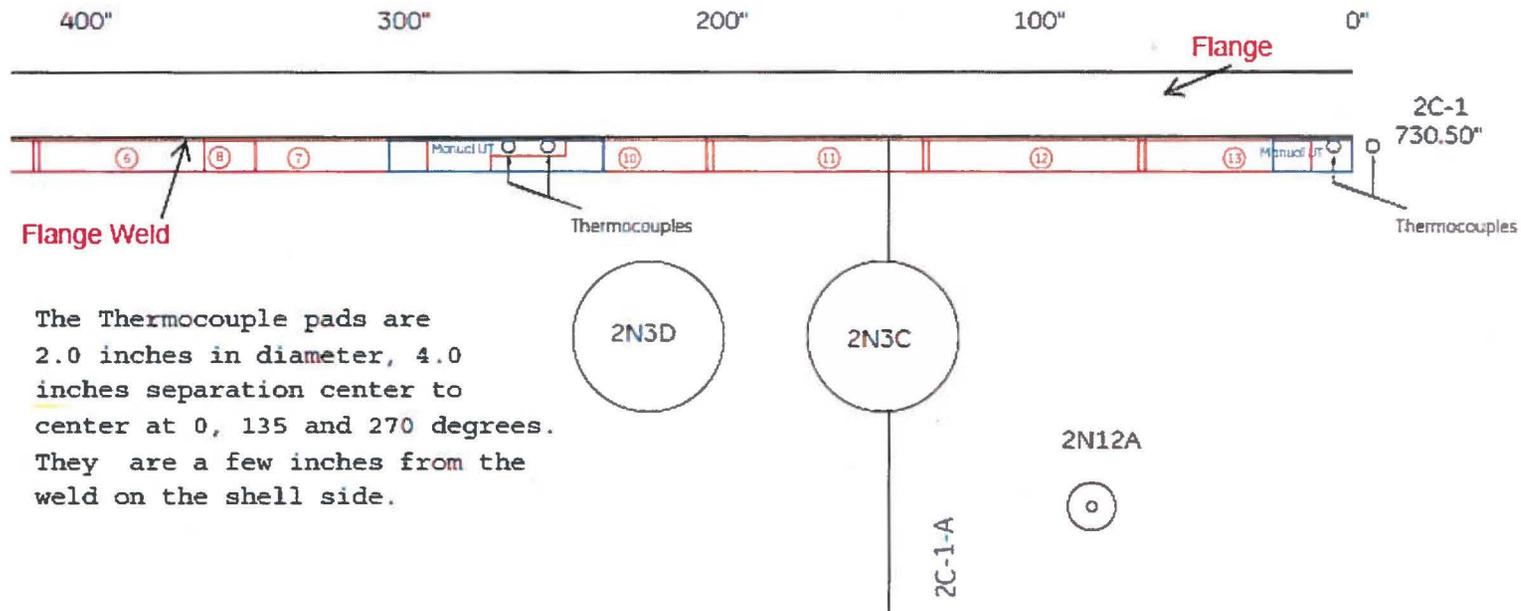
# Coverage Plot 2C-1 Vessel to Flange Weld

The thermocouple pads are 2.0 inches in diameter, 4.0 inches in separation (center to center) at 0°, 135° and 270° on the shell side of the weld. The Attachment to this letter shows an excerpt from the General Electric Hitachi (GEH) nondestructive examination (NDE) report showing approximate placement within the examination area.

The Thermocouple pads are 2.0 inches in diameter, 4.0 inches separation center to center at 0, 135 and 270 degrees. They are a few inches from the weld on the shell side.

In the graphic above, the red boxes with numbered circles indicate automated scan areas. The blue boxes indicate where manual scans were performed in the location of the thermocouples to achieve greater coverage.

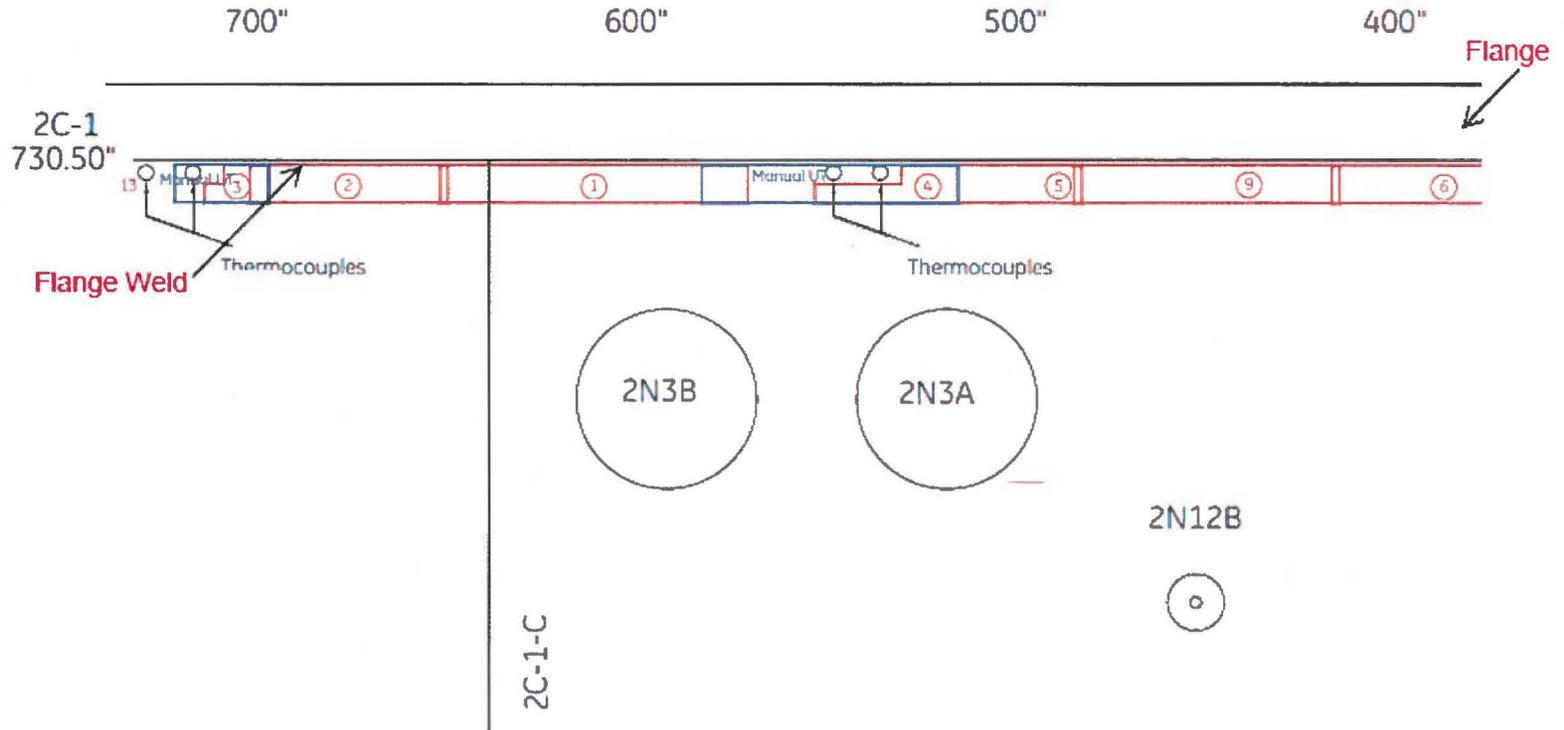
# Coverage Plot 2C-1 Vessel to Flange Weld

In the graphic above, the red boxes with numbered circles indicate automated scan areas. The blue boxes indicate where manual scans were performed in the location of the thermocouples to achieve greater coverage.
