UNITED STATES
NUCLEAR REGULATORY COMMISSION
OFFICE OF NUCLEAR REACTOR REGULATION
OFFICE OF NEW REACTORS
WASHINGTON, DC 20555

NRC INFORMATION NOTICE 2017-03: ANCHOR/DARLING DOUBLE DISC GATE VALVE
WEDGE PIN AND STEM-DISC SEPARATION
FAILURES

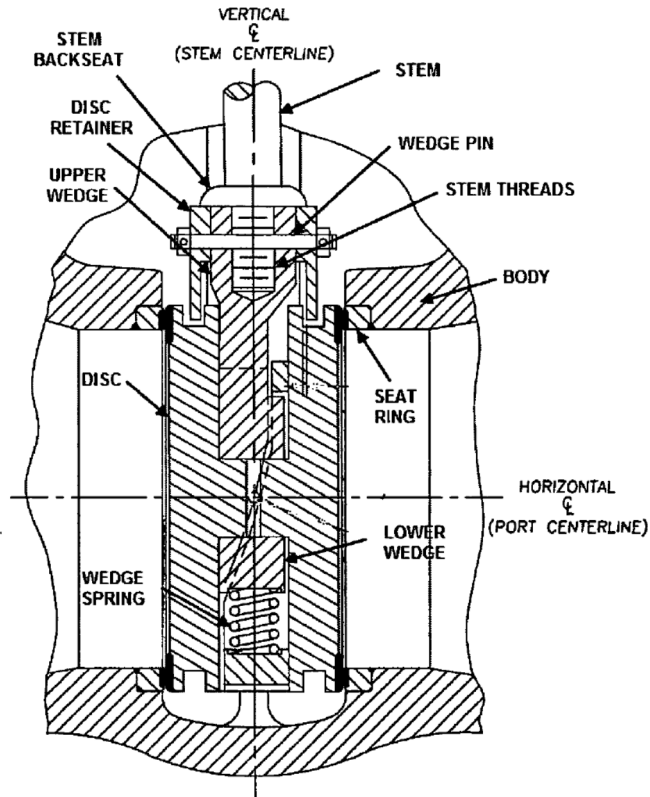
Figure 1 Typical Anchor/Darling DDGV (ADAMS Accession No. ML13064A012)
