Subject: KSV Standby Diesel/Generator
Pennsylvania Power and Light
Unit "B", Crankcase Explosion

REPORT

Pennsylvania Power and Light Company
Standby Diesel/Generator KSV-16-T
Unit "B" S/N 7159
Crankcase Explosion - Sept. 7, 1989, No. 7 Left Cylinder

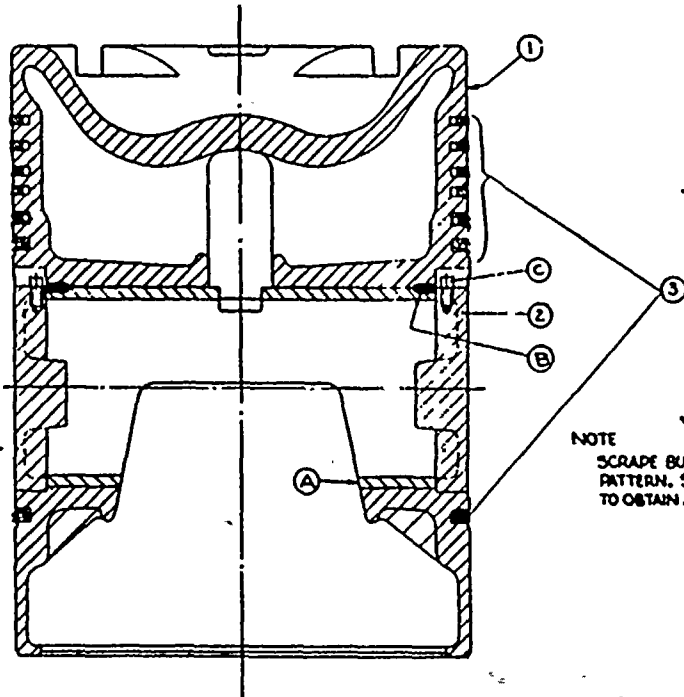
KSV-5-2
Revisic

- 2.5 Both piston pin caps removed from the 7 left piston showed signs of contact with the cylinder liner. The aft end cap evidenced heavy contact. It was reported that upon removal from the cylinder both piston pin caps were found to be below the external surface of the piston. (See attached KSV-5-2 drawing for piston assembly detail).

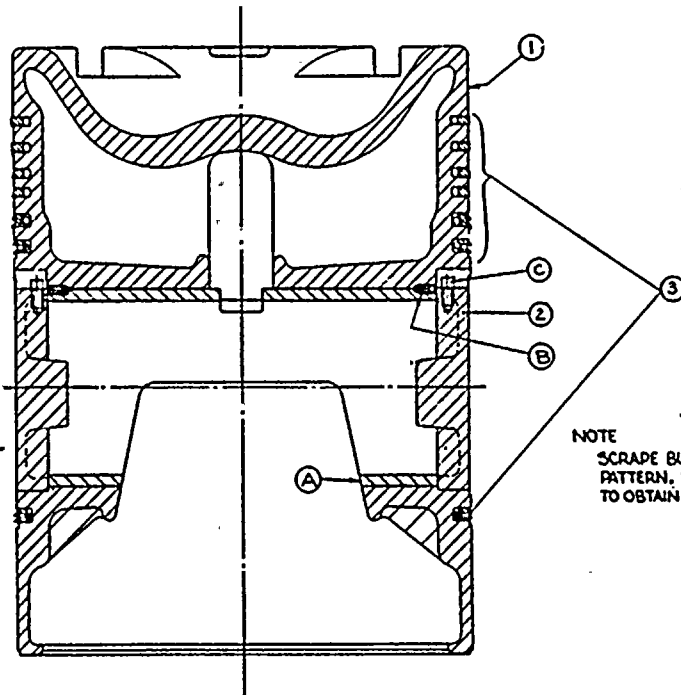
KSV-5-2
Revisic

- 2.5 Both piston pin caps removed from the 7 left piston showed signs of contact with the cylinder liner. The aft end cap evidenced heavy contact. It was reported that upon removal from the cylinder both piston pin caps were found to be below the external surface of the piston. (See attached KSV-5-2 drawing for piston assembly detail).
