U.S. NUCLEAR REGULATORY COMMISSION
REGION I

Report Nos. 50-387/89-37
50-388/89-36

Facility Name: Susquehanna Units 1 & 2

Meeting Topic: Susquehanna Emergency Diesel Generator Crankcase
Explosions of Cooper EDGs

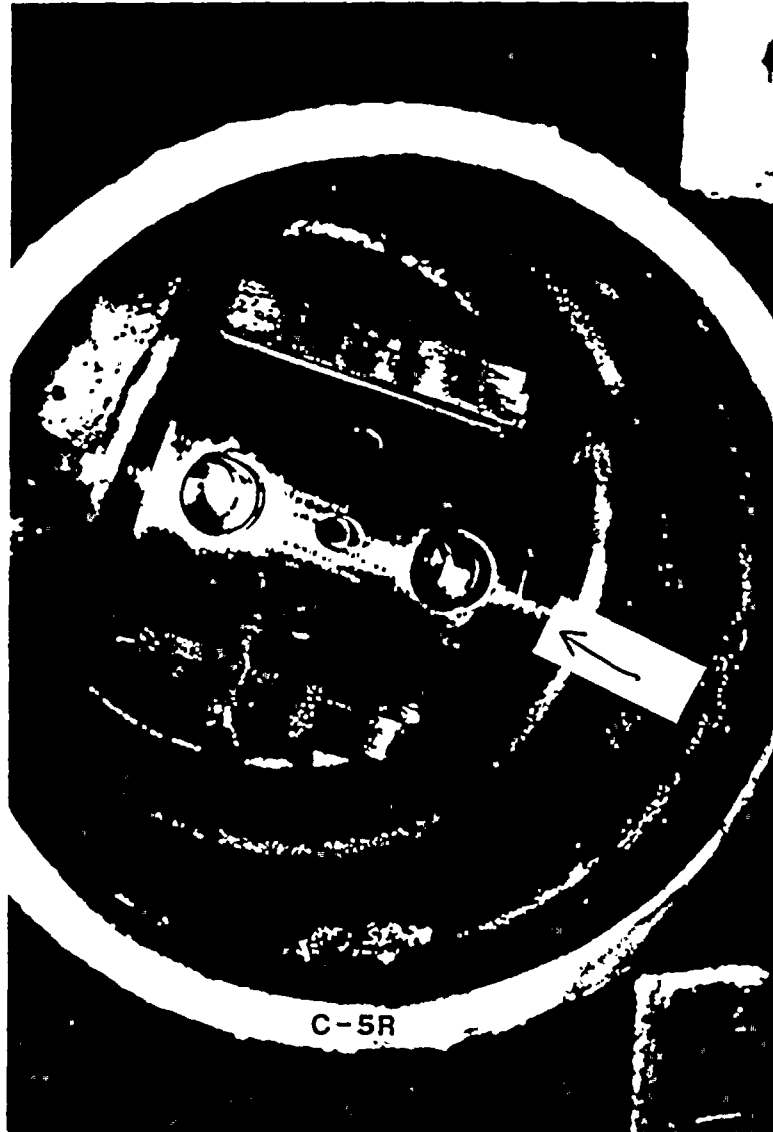
BLUED PIN.

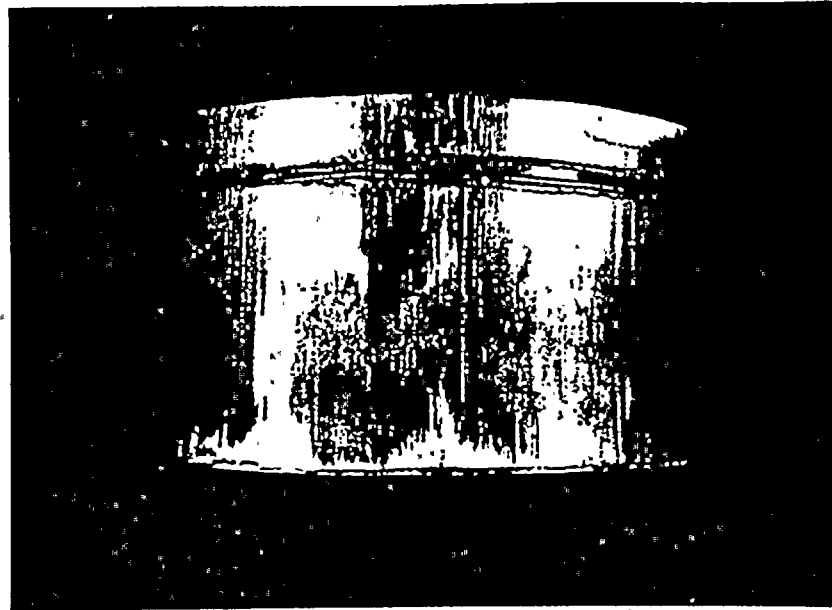
Figure B-1 Picture of the skirt of the B diesel 7L piston showing heavy wear and metal distortion in the lower ring area.

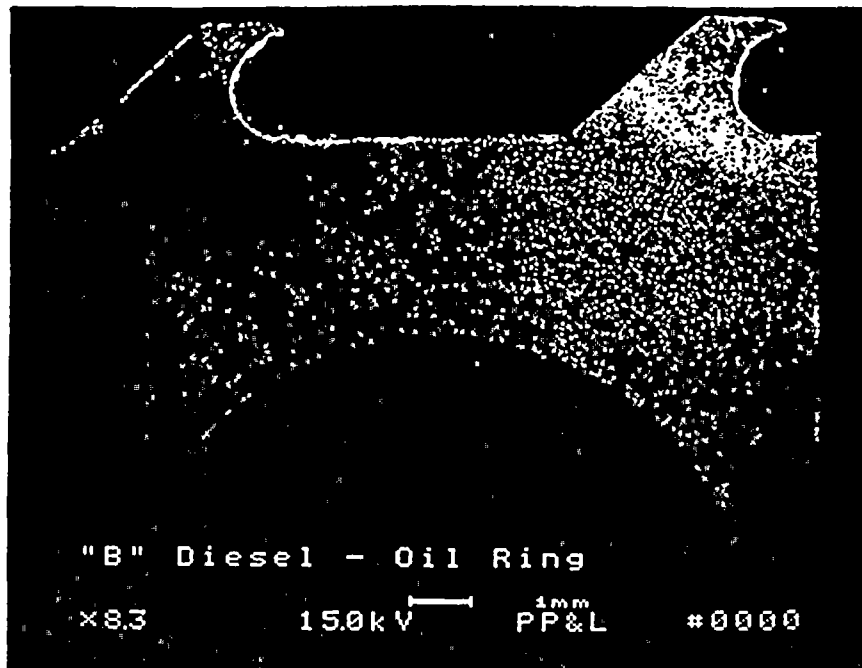
Figure B-12. Cross section of the lower oil ring from the B diesel 7L piston showing the wear and deformation on the two wiper surfaces.

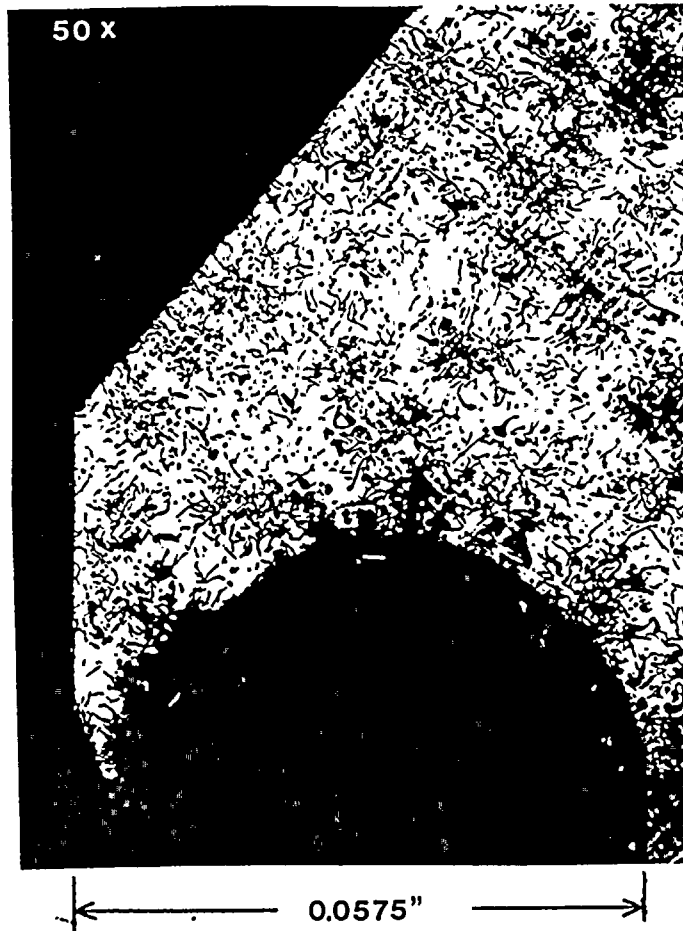
Figure B-13. Picture of oil ring profile at high magnification. To be taken later. Magnified image of oil ring finger from B diesel, 7L piston lower oil ring showing structure deformation and size of the finger.

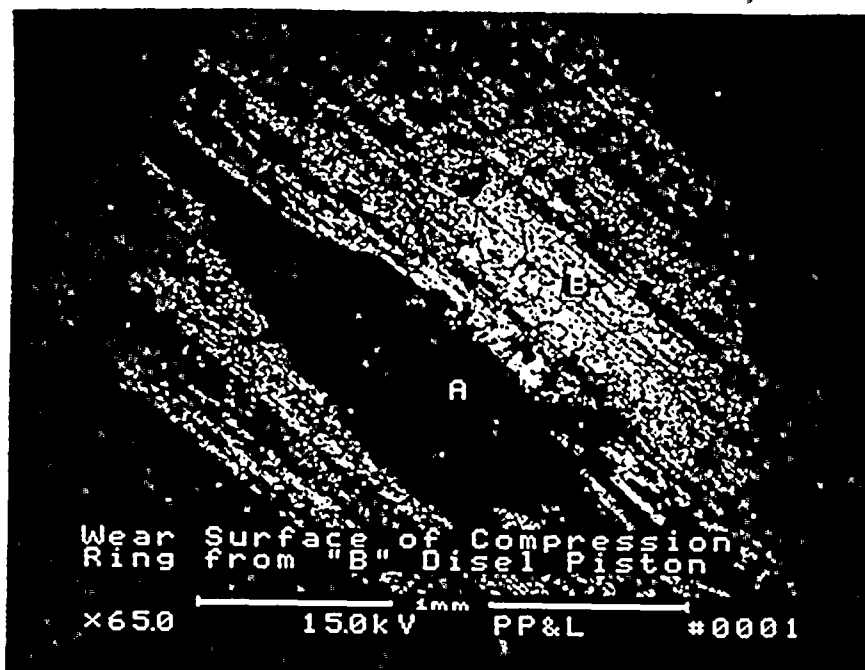
Figure B-15. Smeared metallic deposits found on the #4 compression ring of the B diesel, 7L piston are shown here as the dark gray area labeled 'A'. EDS analysis of area 'A' shows it to contain Cr, Fe, Si(trace) and Sn(trace). Area 'B' shows only Fe with a trace of Cr.

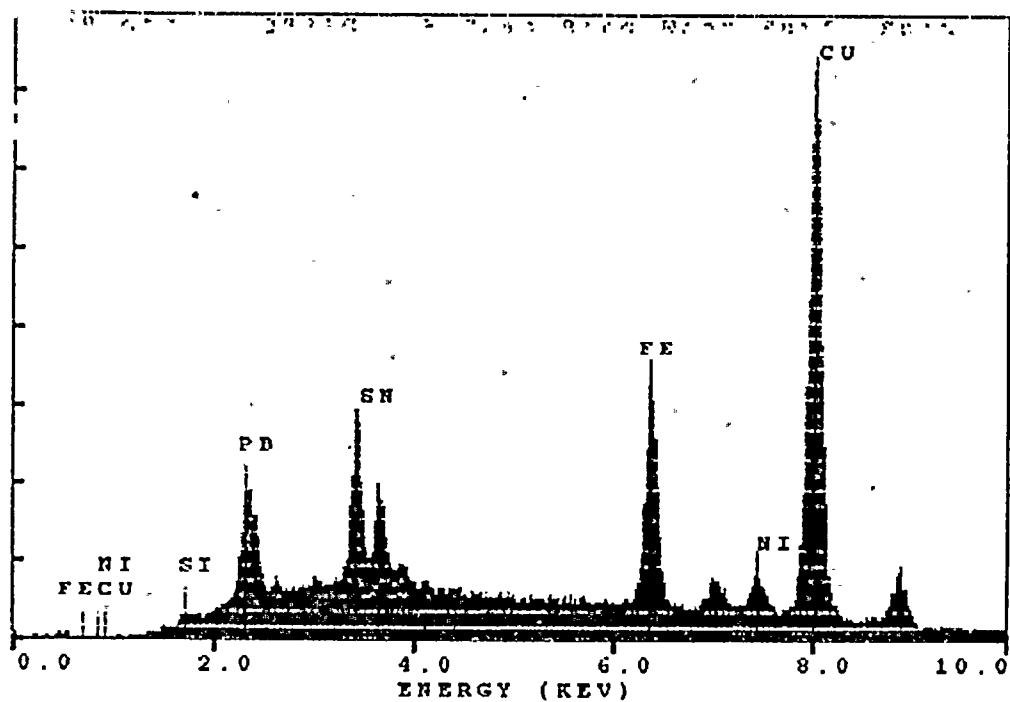
Figure B-17. An unusual spot of foreign material found embedded in the #4 compression ring from the B diesel 7L piston. EDS analysis shows it to contain Cu, Fe, Sn, Pb, and Ni.

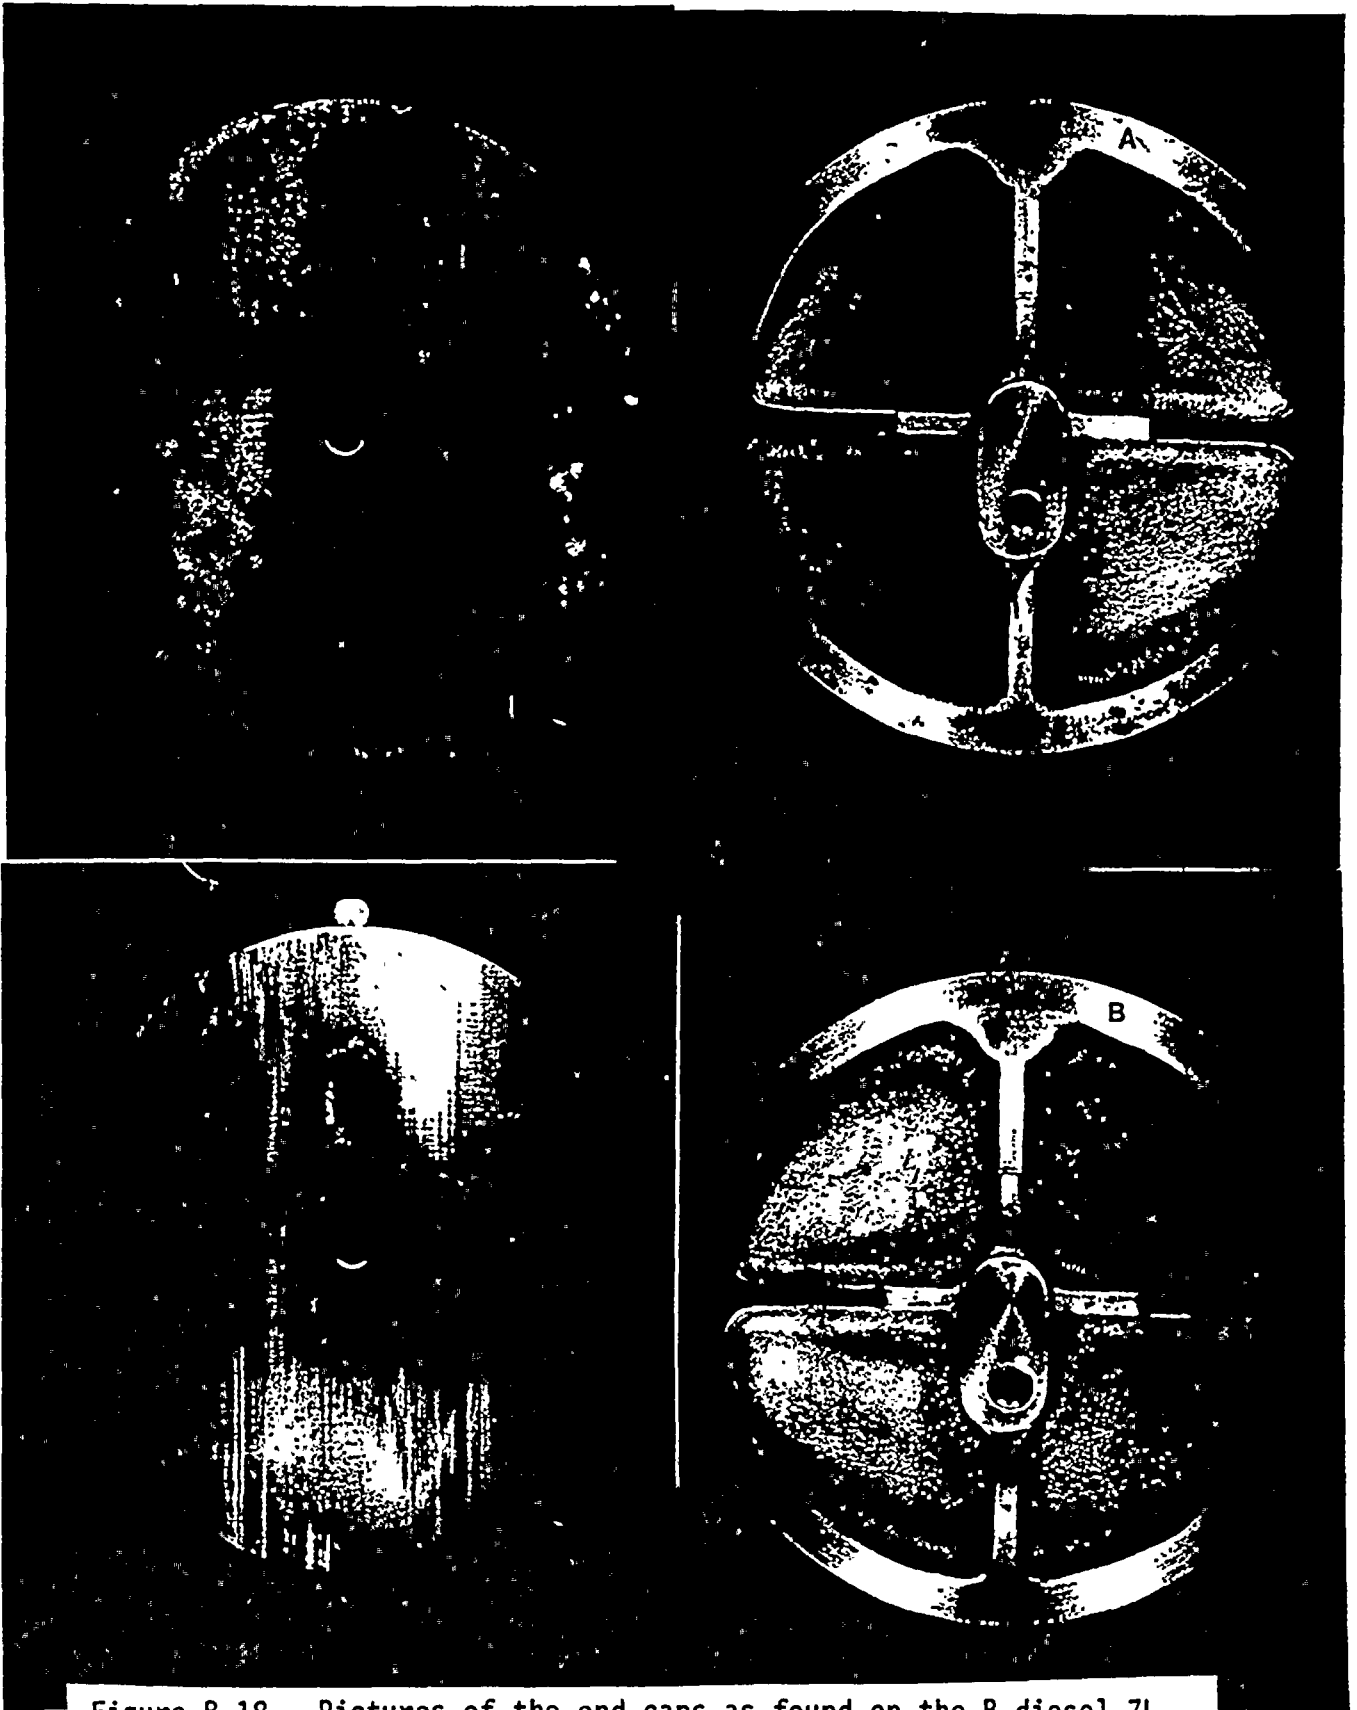
Figure B-18. Pictures of the end caps as found on the B diesel 7L piston showing the scraping and local heating experienced by these parts during the failure sequence.

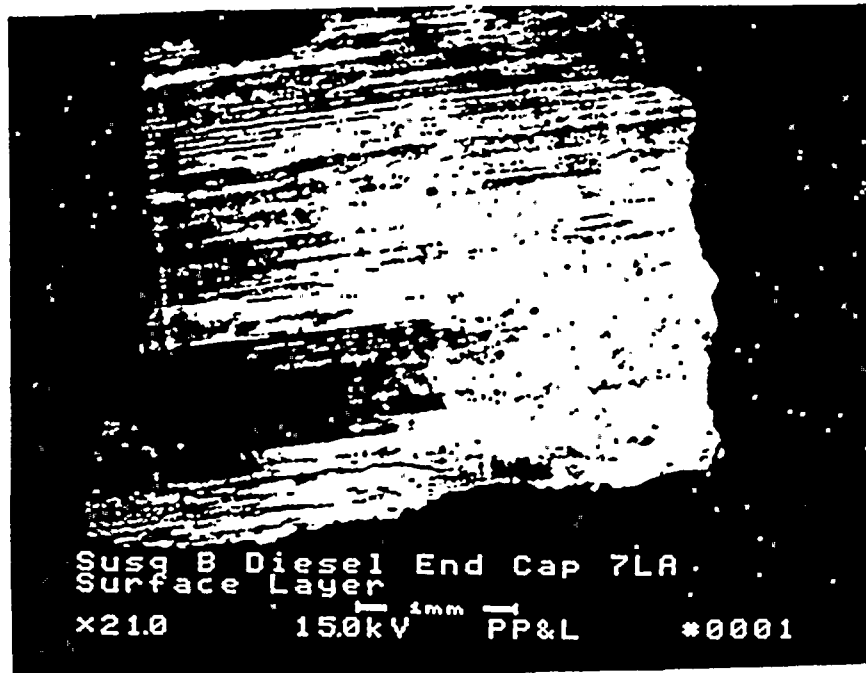
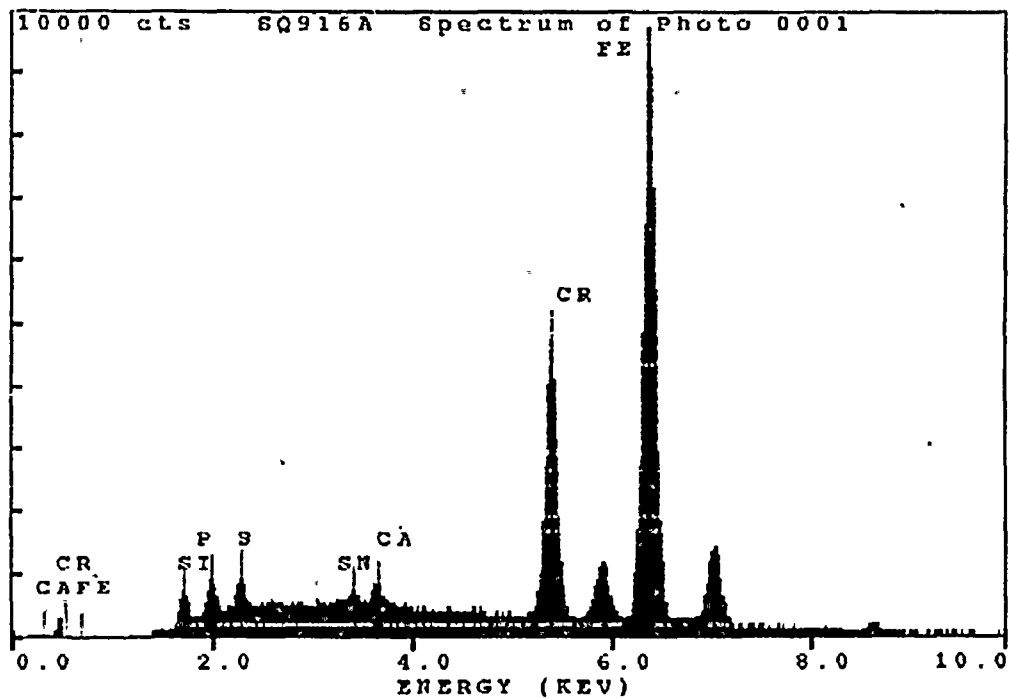
Figure B-19. Picture and EDS analysis of a piece of smeared metal removed from end cap 'A' from the B diesel 7L piston.

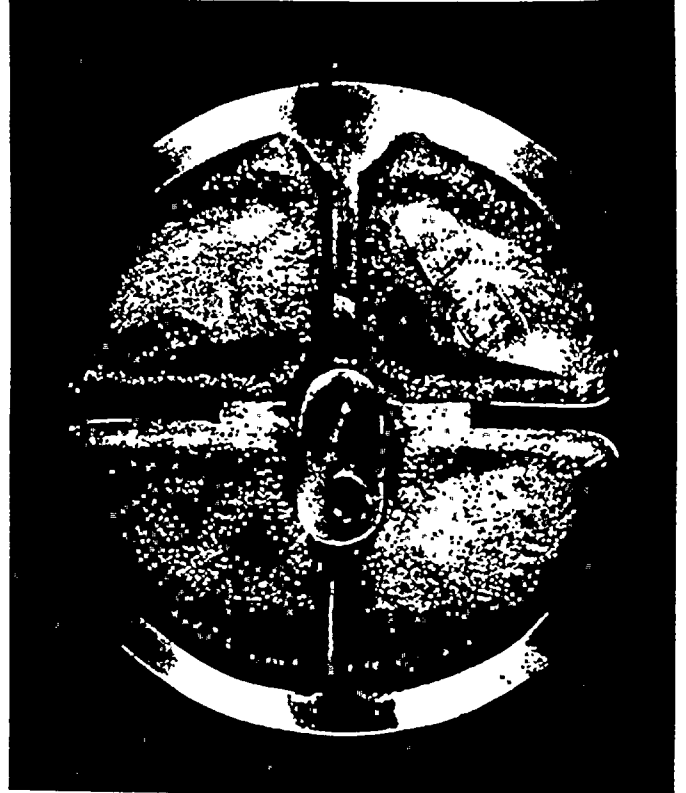
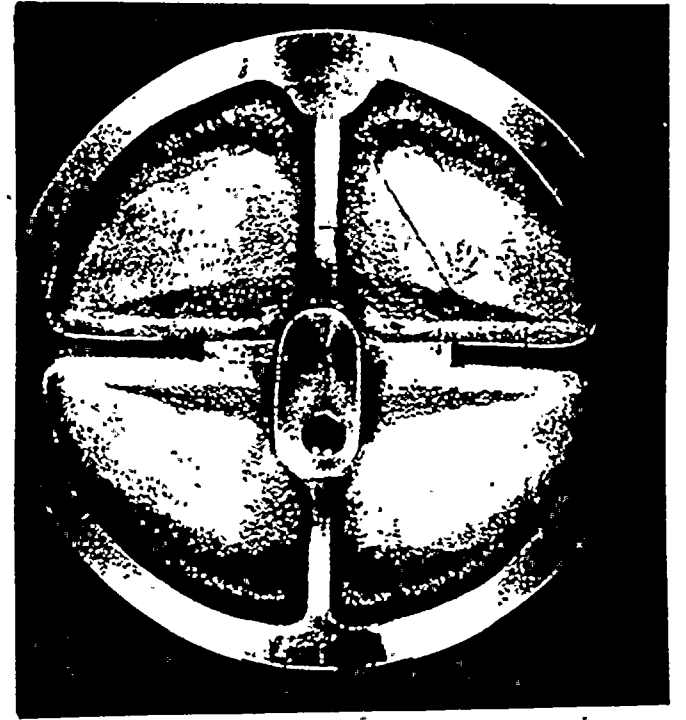
Figure B-21. Abrasion and wear found on the B diesel 7R piston pin end caps.

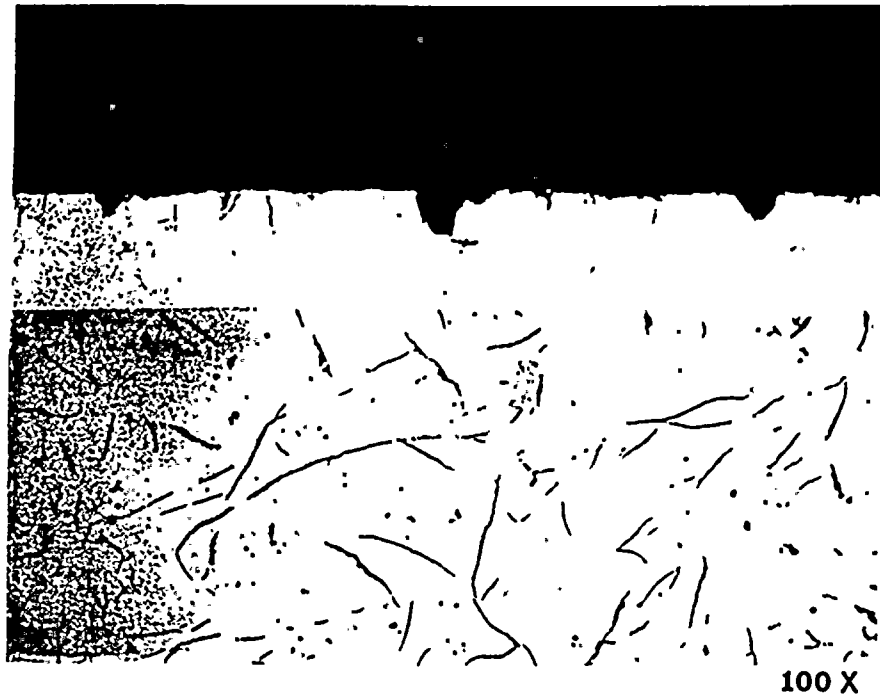
Figure B-27. Transverse cross-sectional views of the thrust side of the B diesel 7L liner 22 7/8 inches from the bottom (piece 'A'). The chromium plating is cracked and some of the pores are filled with metallic particles.

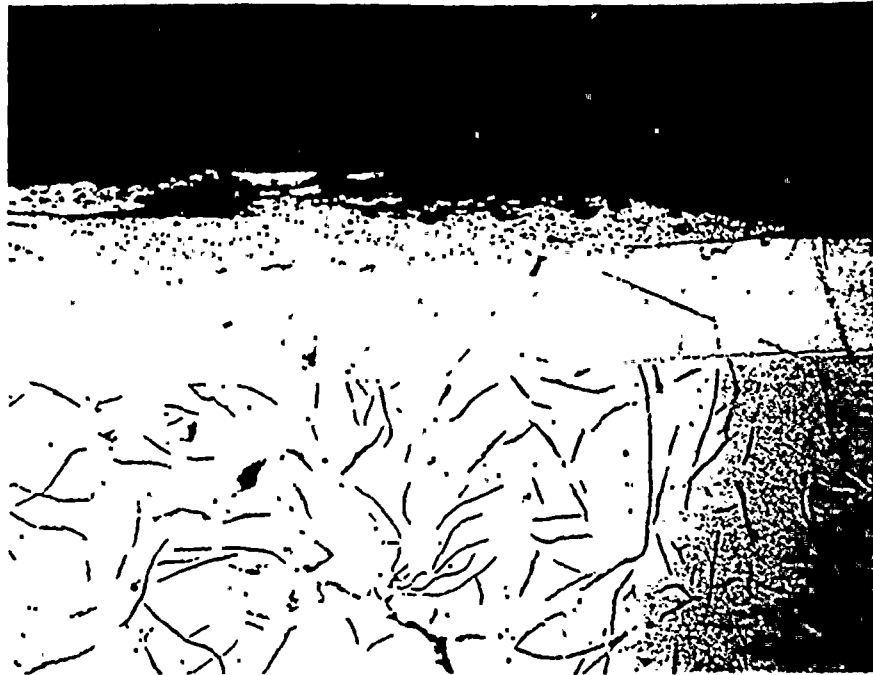
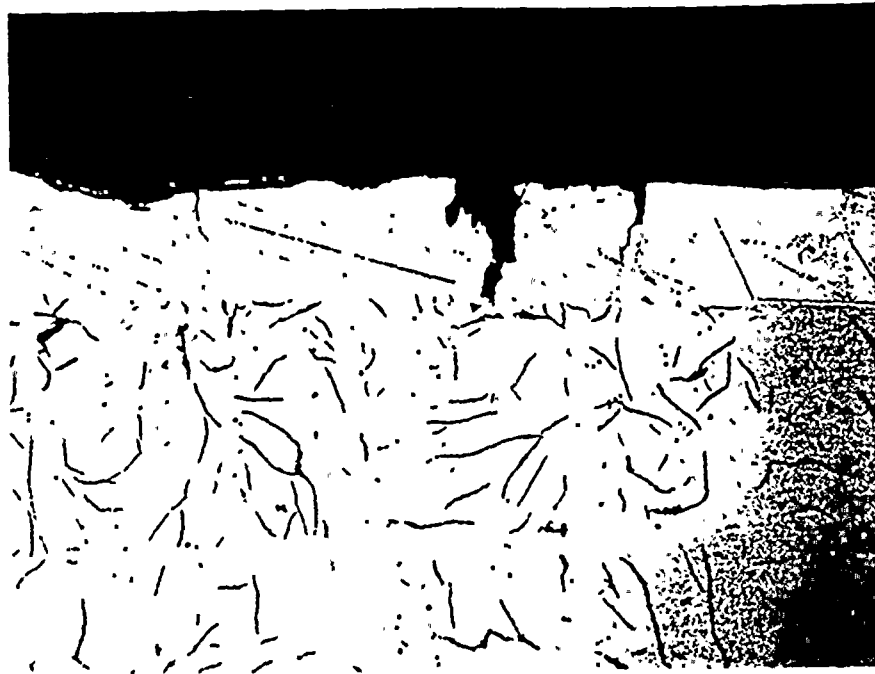
Figure B-28. Longitudinal view of the B diesel 7L liner on the thrust side 11 1/2 inches from the bottom showing metallic deposits, filled pores and cracking in the Cr plating(piece labeled 'B').

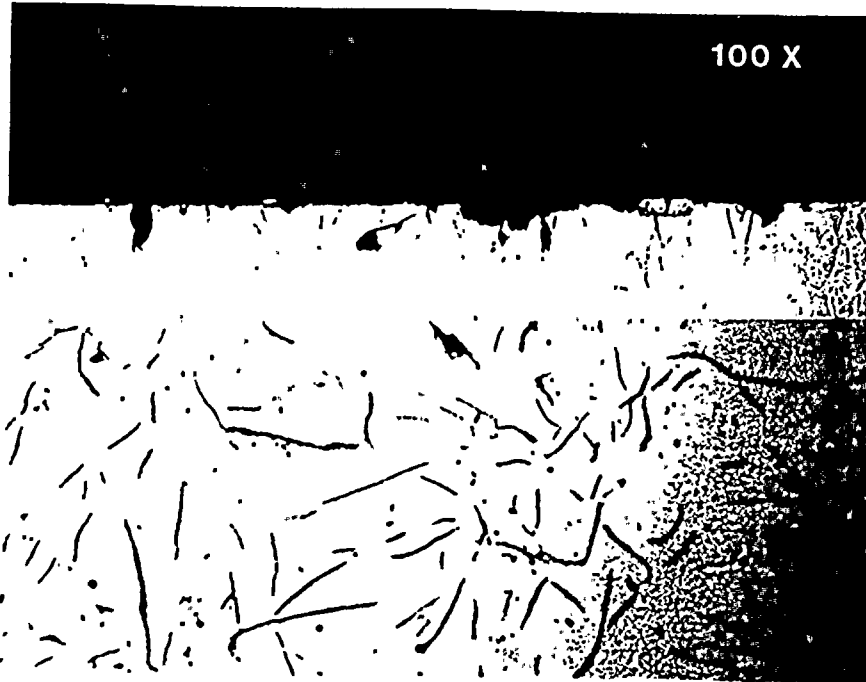
Figure B-29. Longitudinal cross-section (labeled 'C') taken 12 inches from the bottom of the B diesel 7L cylinder liner showing a rough fractured surface with pieces missing and some debris in the pores of the chromium plating layer.

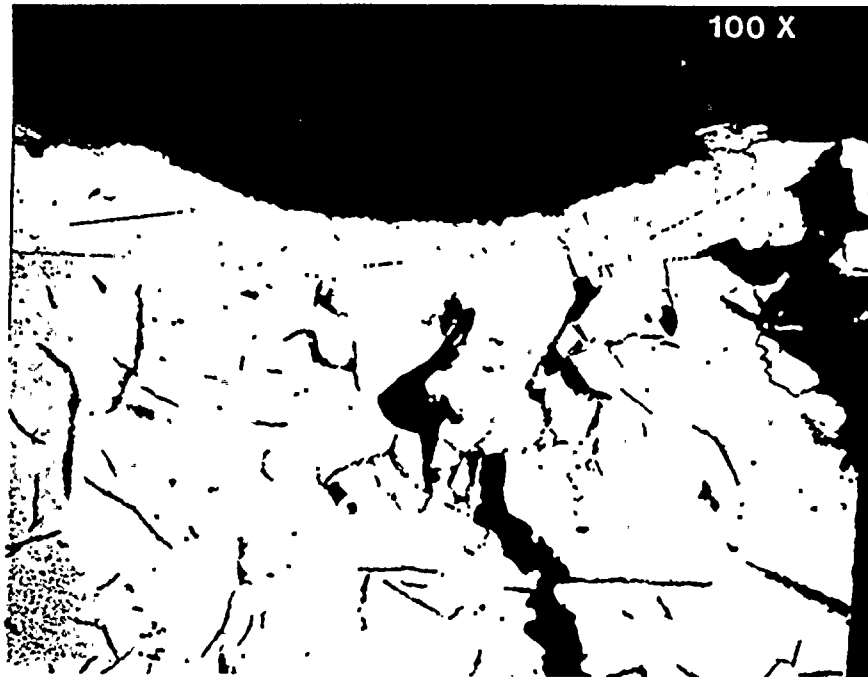
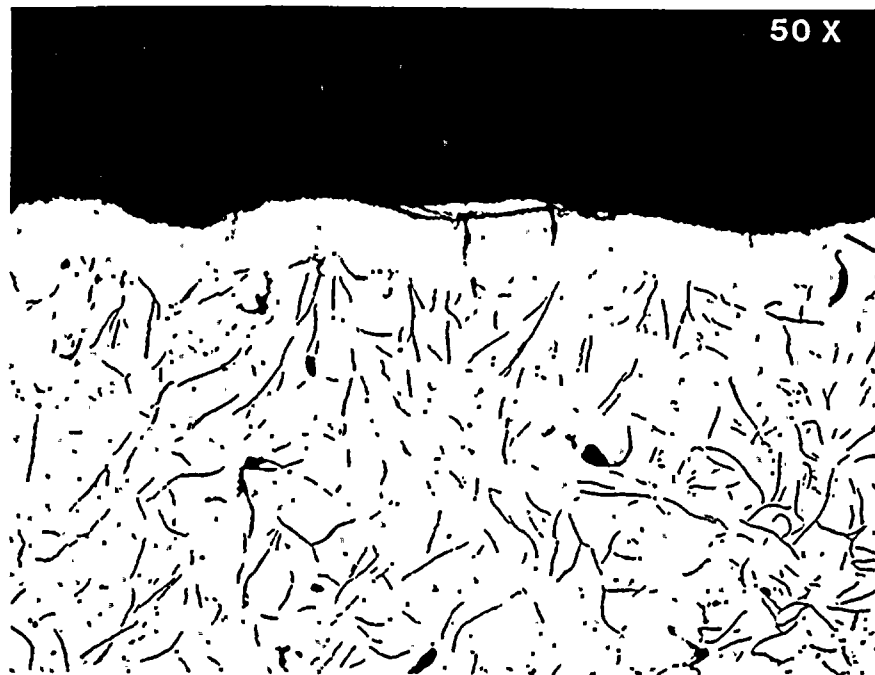
Figure B-30. Transverse cross-section (labeled area 'D') taken 7 1/2 inches from the bottom of the B diesel 7L liner showing depressions in the Cr plating surface, cracking of the base metal casting and deposited metal.

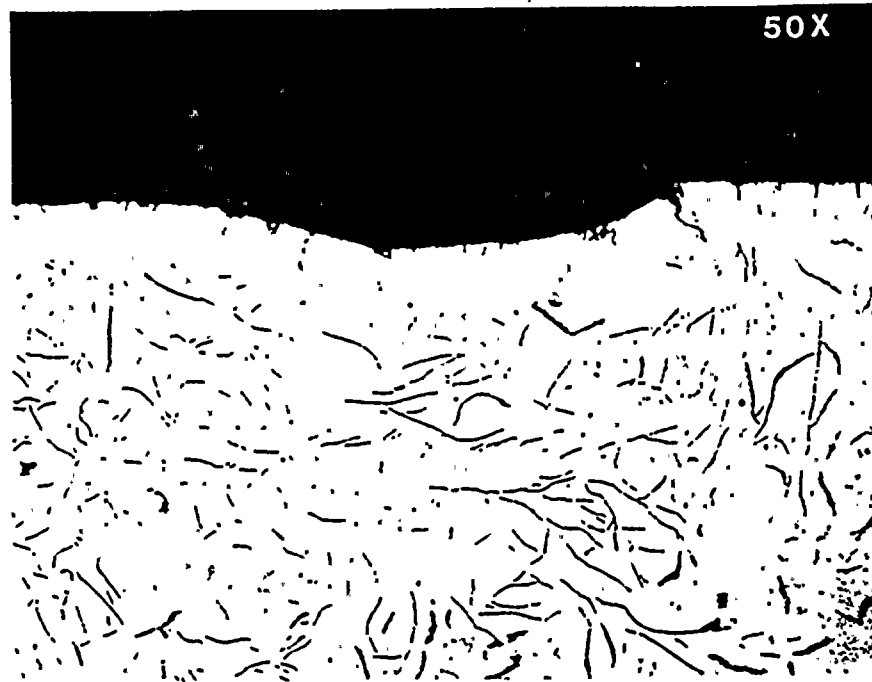
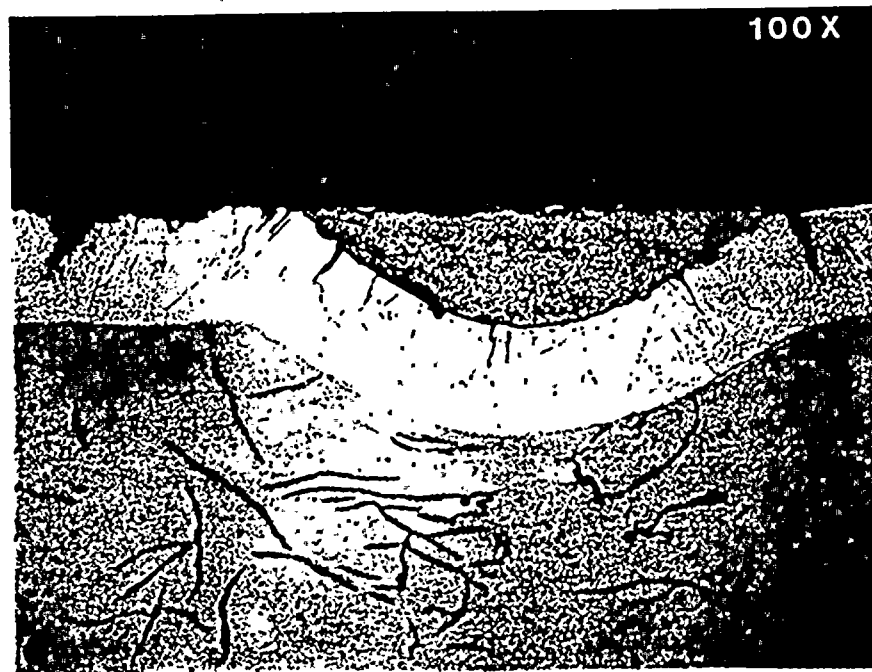
Figure B-31. Transverse cross-section (Labeled area 'E') of the thrust side of the B diesel 7L liner taken 7 1/2 inches from the bottom showing depressions in the Cr plating and deposited metal.

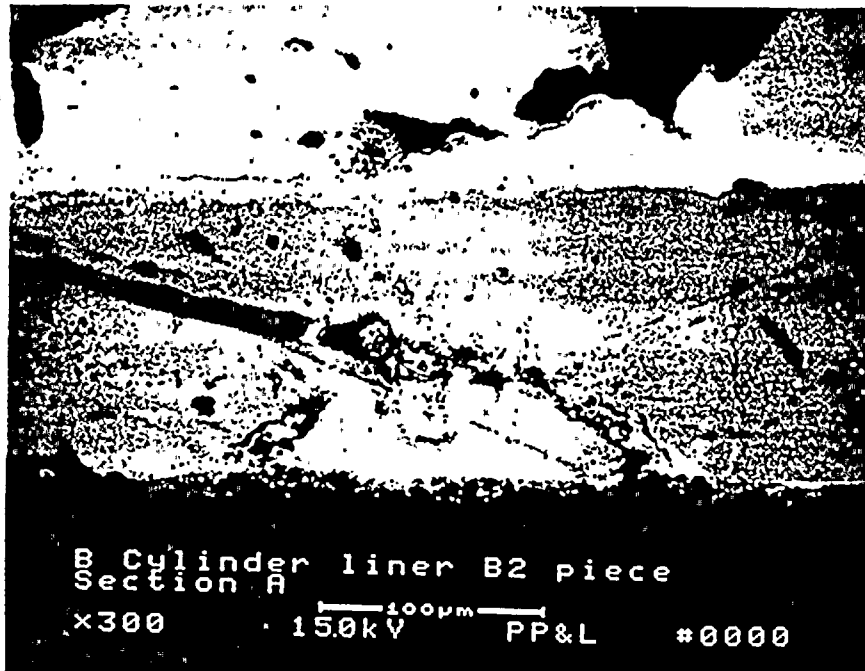
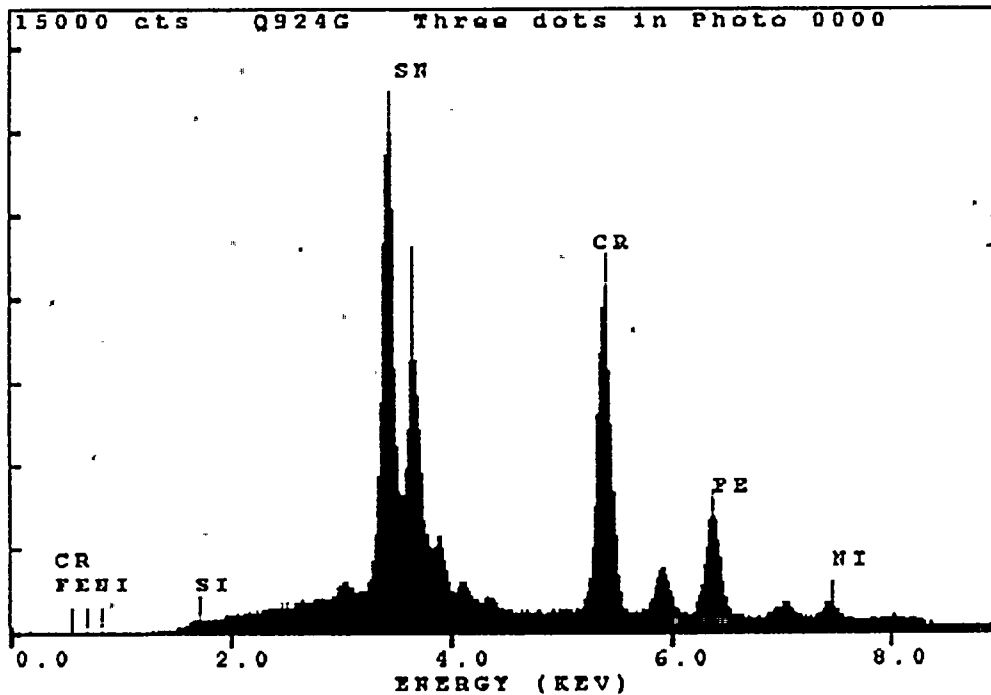
Figure B-34. Longitudinal section of B diesel 7L liner (labeled 'A' of part B-2) showing cracking in the Cr plating surface and the presence of Sn at the Cr-Fe base metal interface.

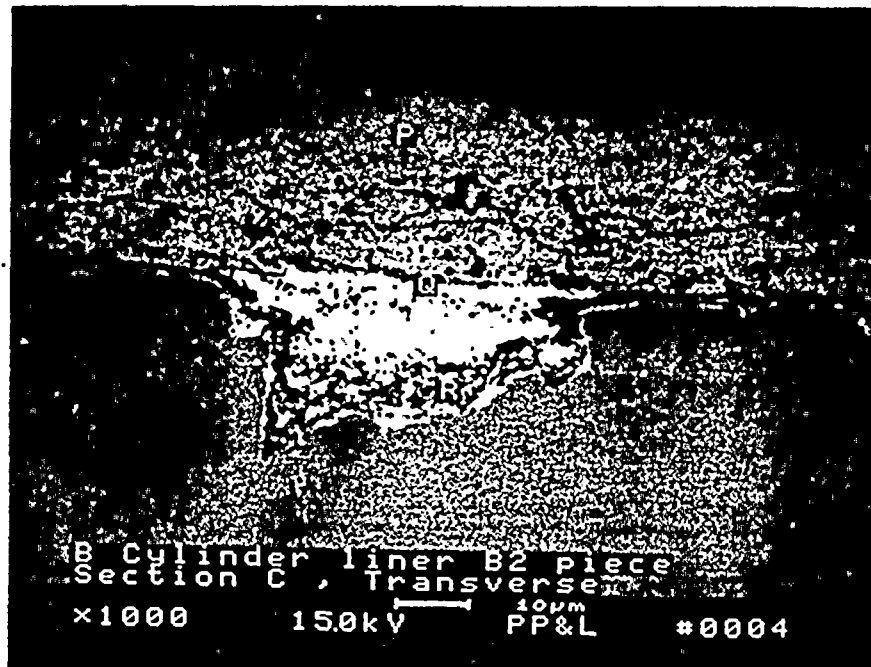
Figure B-35. Transverse cross-section of the B diesel 7L liner (labeled 'C' of part B-2) showing areas of metal buildup and filling of pores with Cr,Sn and Fe.

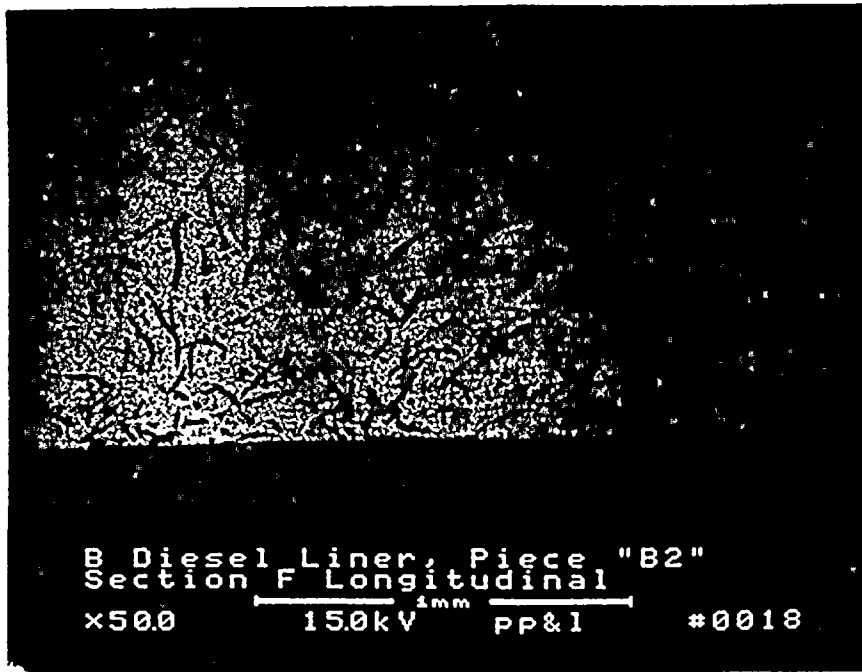
Figure B-38. Longitudinal section 'F' from B diesel liner 7L piece B-2 taken 24 5/8 inches above the bottom. This section does not show any pores filled or otherwise, but does show several cracks through the thickness of the Cr plate.

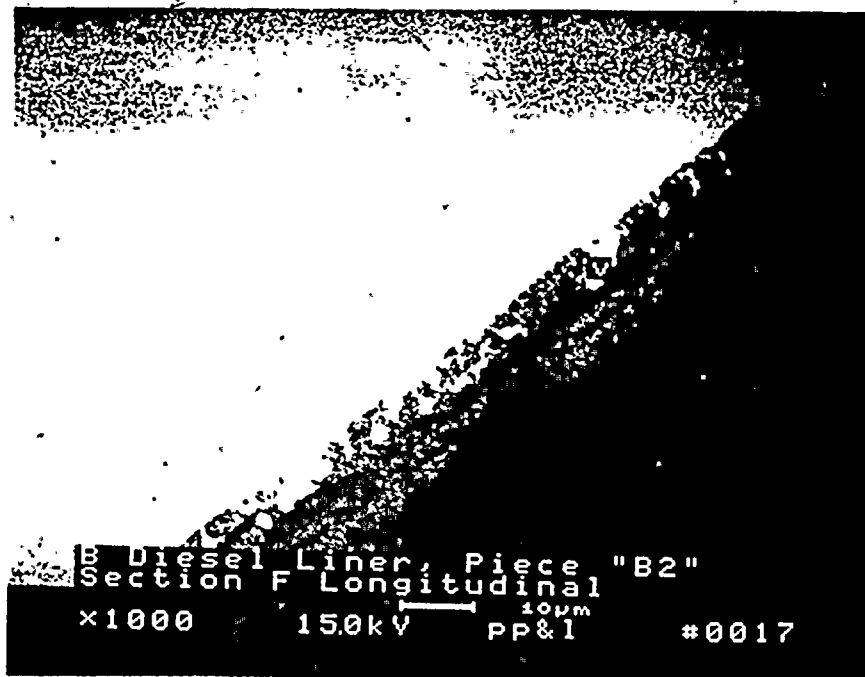
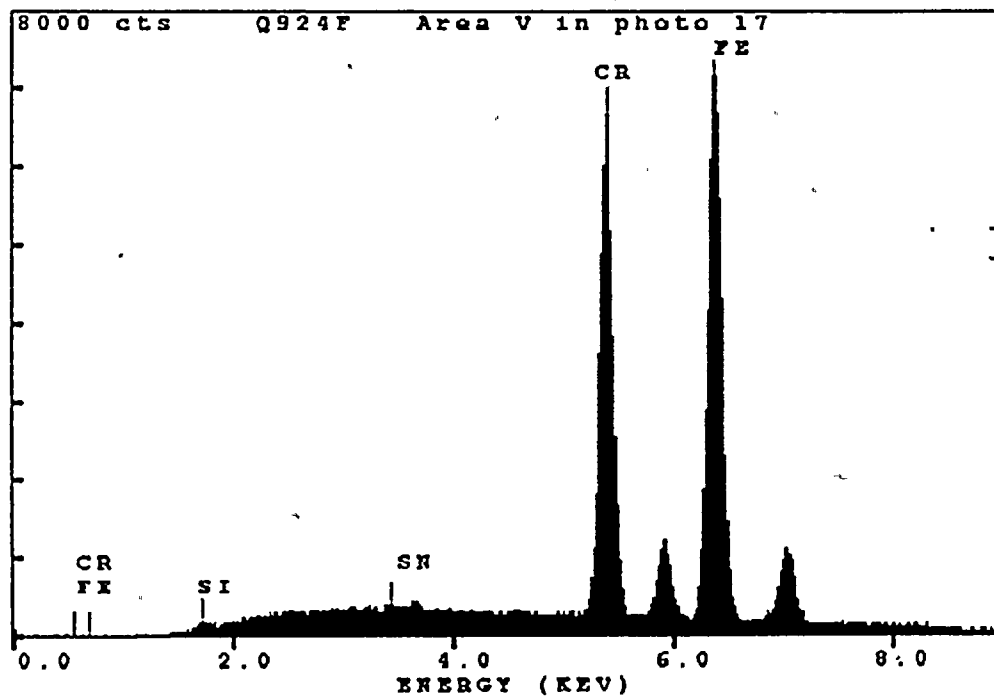
Figure B-39. Longitudinal section of B diesel 7L liner taken from the end cap side 24.625 inches from the bottom showing the layer of deposited metal and the EDS analysis of the lighter grey area.

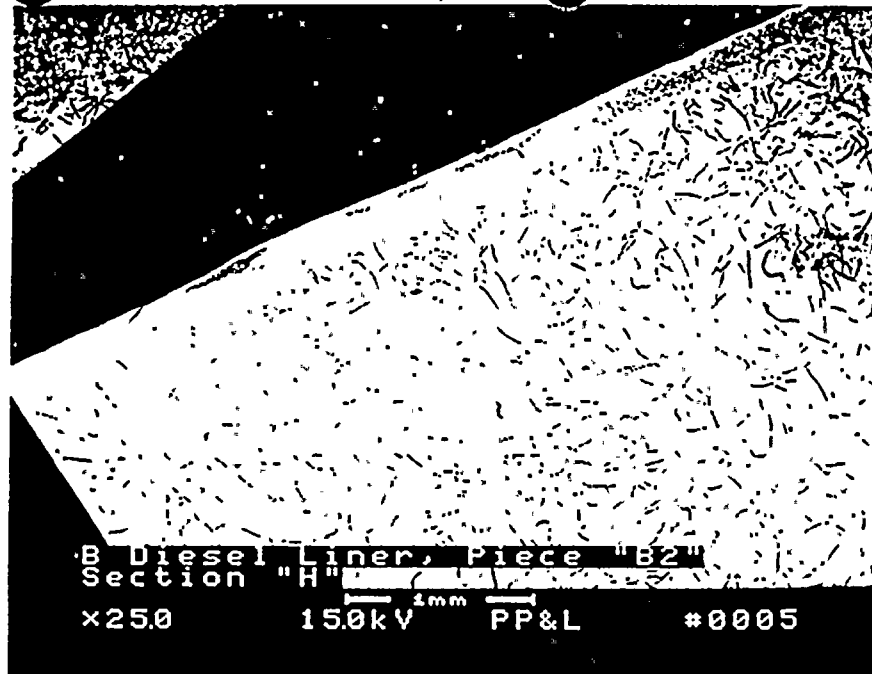
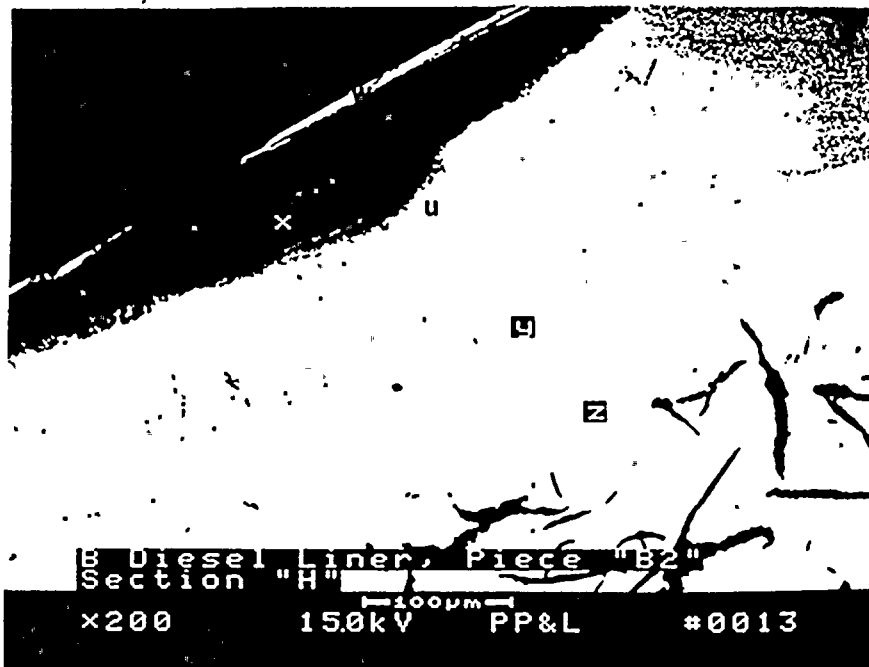
Figure B-40. End cap side of the B diesel 7L liner taken from transverse section H showing damage to the chromium liner and deposited metal. EDS analysis of the various layers are shown in figures B-41 and B-42.

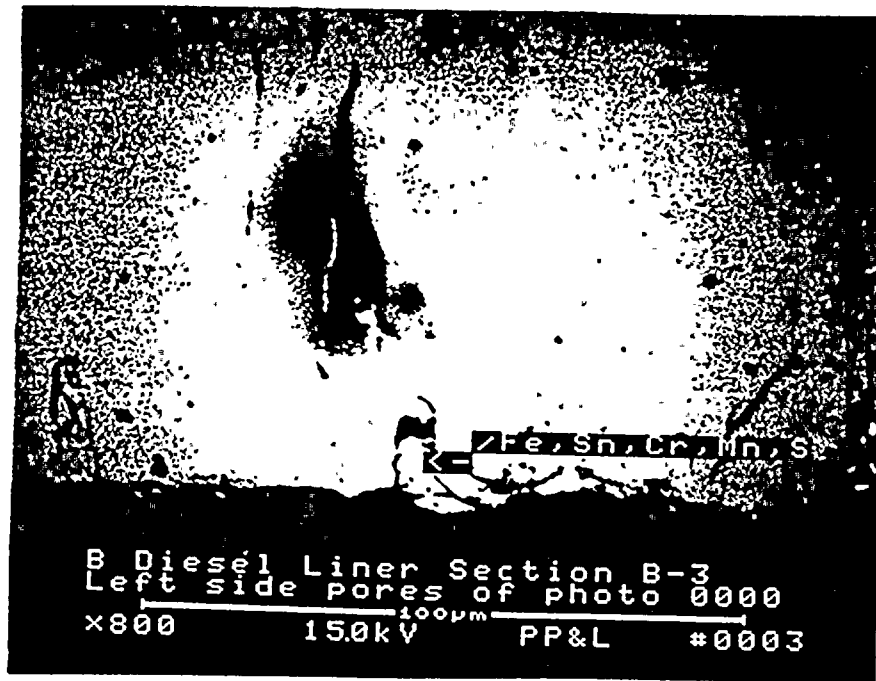
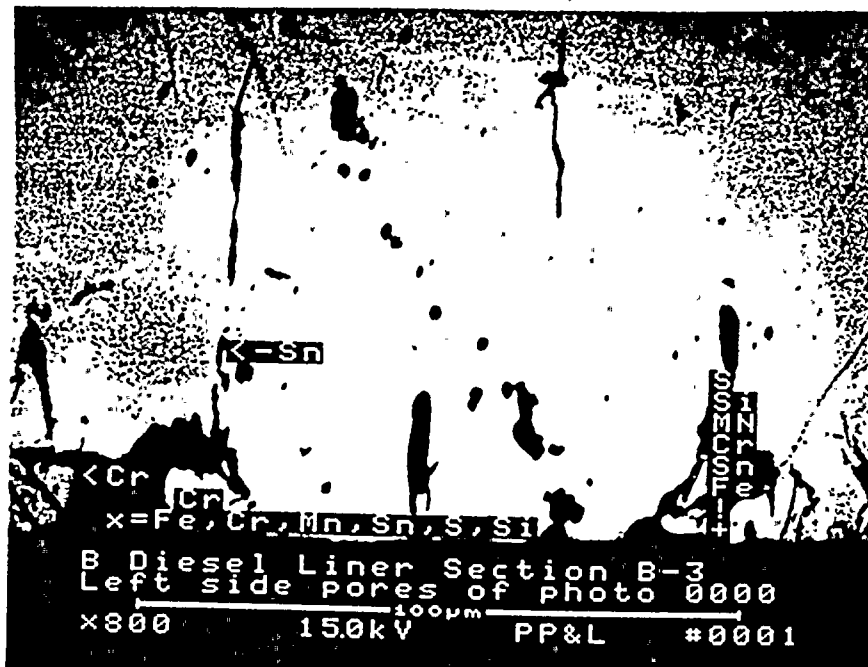
Figure B-55. Another area of pore deposits and elements found present in longitudinal cross-section 'C' part B-3 of the B diesel liner 16.5 inches from the bottom.

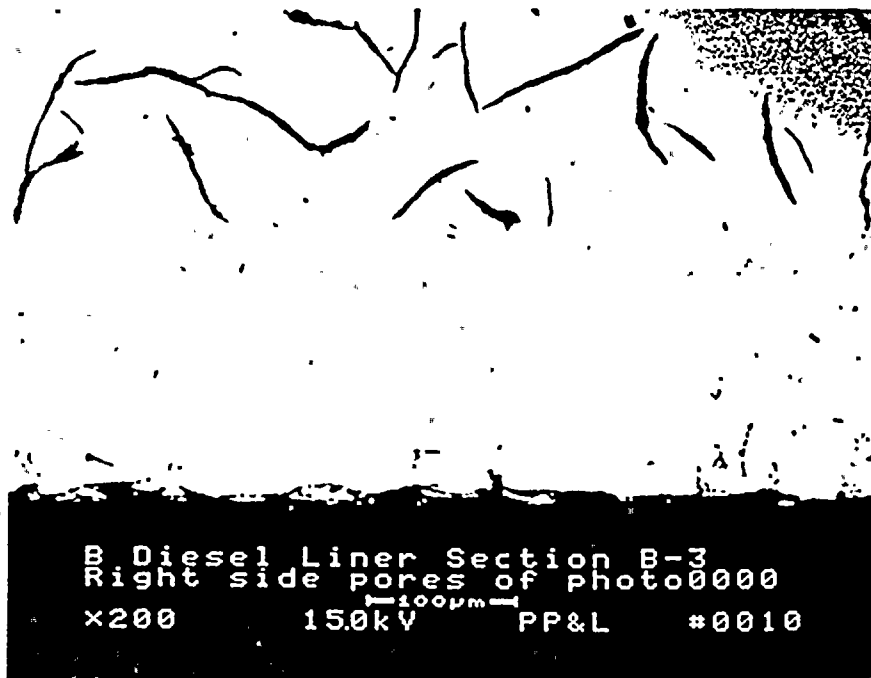
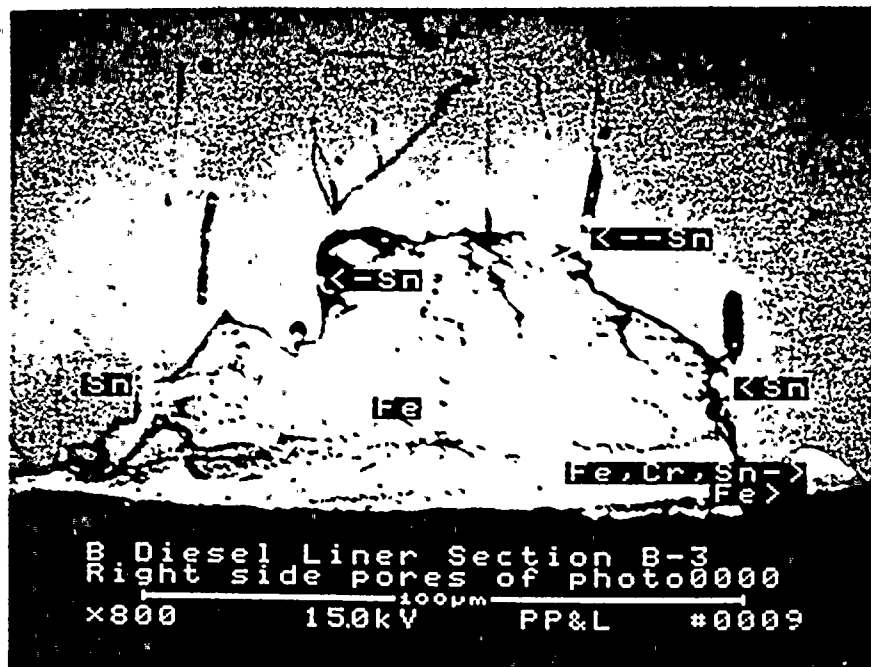
Figure B-56. Various elements and their location found in a pore from the B diesel liner 7L, part B-3, area 'C'.

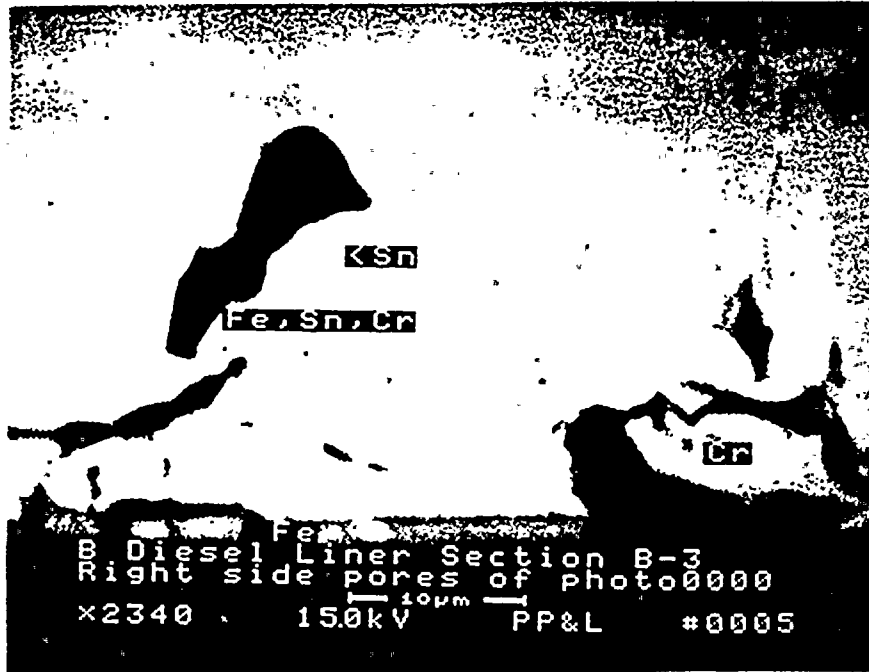
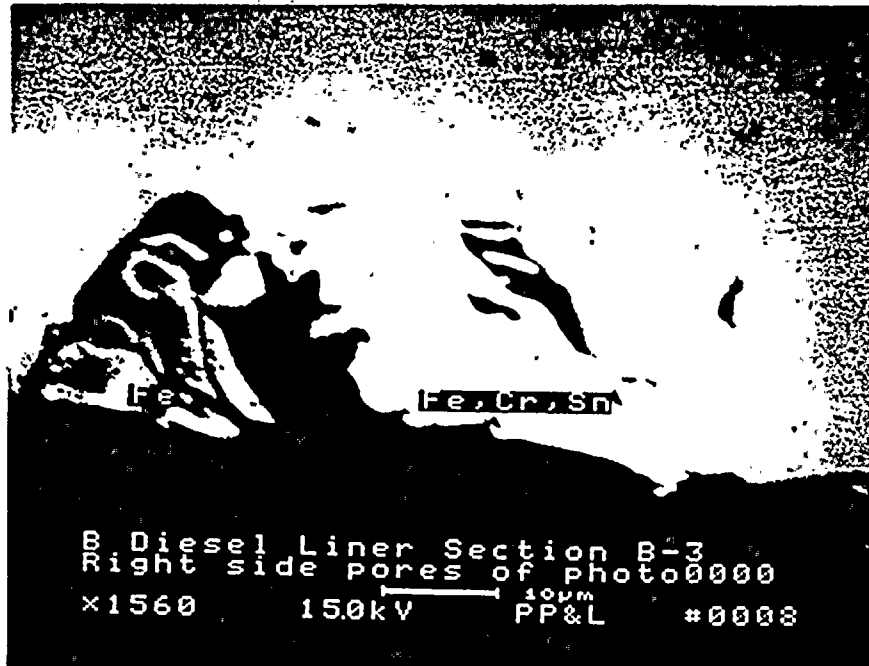
Figure B-57. Elemental contents of two pores filled with metal in the B diesel 7L liner 16.5 inches from the bottom of part B-3, area 'C'.
