SUBJECT: LER 90-007-00: on 900215, HPCI turbine stop valve failure to open properly.

SUSQUEHANNA STEAM ELECTRIC STATION  
LICENSEE EVENT REPORT 90-007-00  
FILE R41-2  
PLAS -418

TITLE (4) **HPCI Turbine Stop Valve Failure to Open Properly**

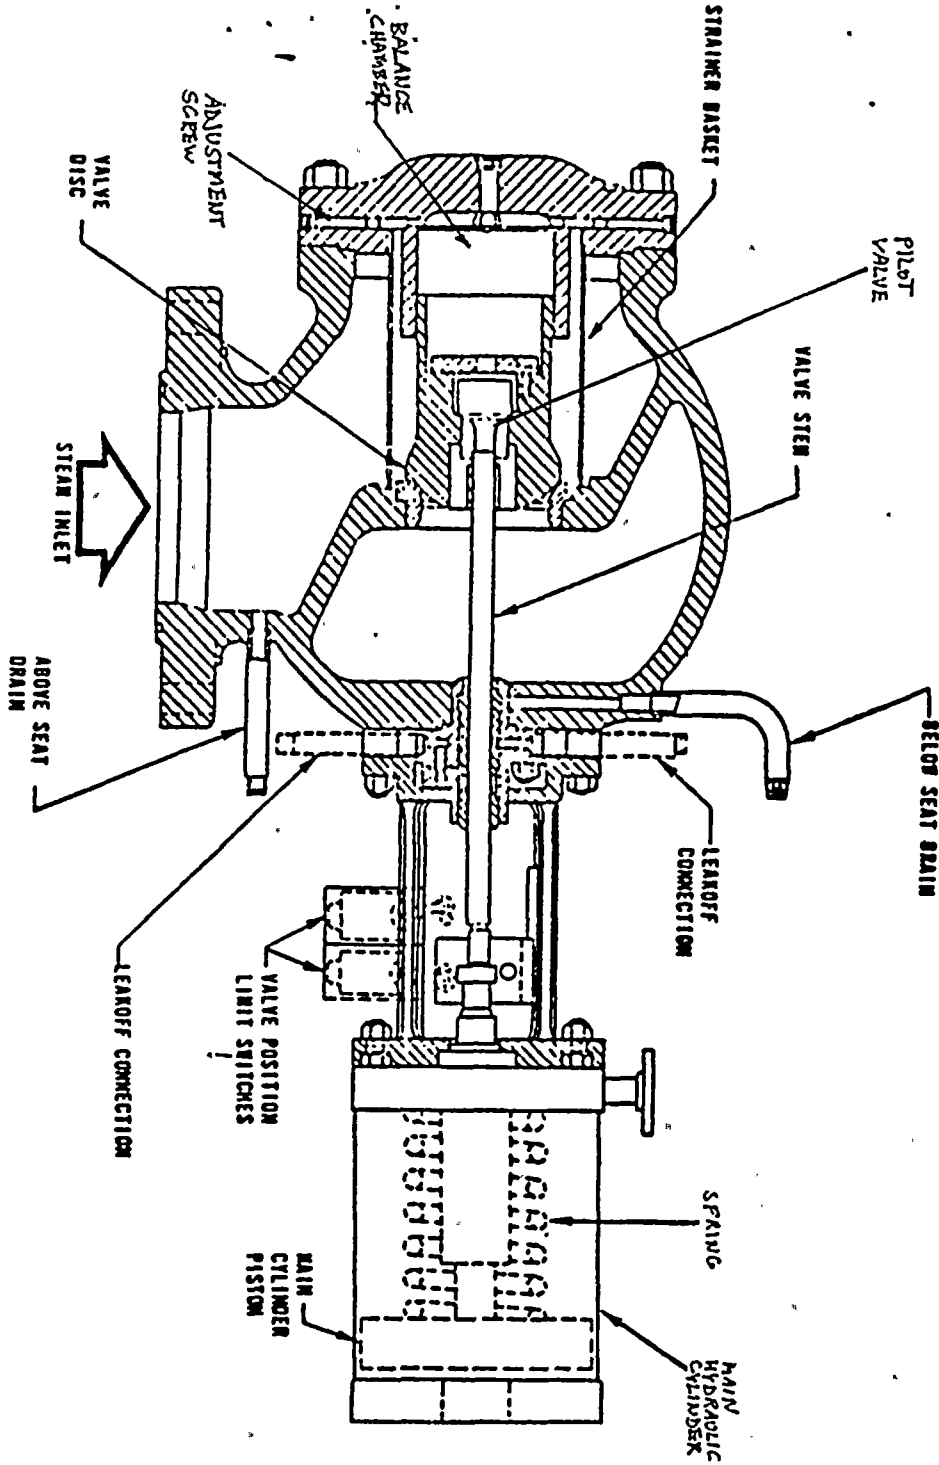
WPC1 TURBINE STOP VALVE FY-15812

The cause of this event is believed to be high balance chamber pressure seen in the HPCI Stop Valve in conjunction with the magnitude of the hydraulic and steam forces that existed when the HPCI flow surveillance test was run.

An explanation of the forces associated with the opening of the HPCI Stop Valve is necessary to understand the cause. Refer to the attached drawing which illustrates the valve design. There are multiple forces affecting the valve's ability to open. Forces which act to keep the valve closed are: (1) the spring force, (2) frictional force, (3) weight of the disc, and (4) balance chamber steam force associated with steam flowing through the pilot valve. Forces which act to open the valve are: (1) the hydraulic force of the control oil acting on the main cylinder piston, and (2) steam force of the steam lifting up on the main disc once the main disc has started to open.

Because the spring force, frictional force, and weight of the disc are of relatively small magnitude and are essentially constant with time, they can be ignored in this discussion. This leaves the following variable forces: balance chamber force acting to keep the valve closed and the hydraulic and steam forces acting to open the valve. Balance chamber force is directly related to balance chamber pressure. Balance chamber pressure is dependent on (1) adjustment screw settings which control the amount of steam entering into the

balance chamber, and (2) component temperatures. Experience has shown that balance chamber pressure can vary as much as 30 psig when conditions change from cold to hot. The hydraulic force is dependent on control oil conditions. This force can vary as oil temperature, control oil valve position, and other factors change within the control oil system for HPCI. The steam force acting to open the valve is variable dependent on steam pressure existing under the main disc as it just begins to leave the closed position.

The establishment of an optimum balance chamber pressure is desirable to accommodate both HPCI Cold and Warm Starts. If the adjustment screws in the balance chamber are set to allow too low a pressure, the main disc could open with undesirably high force, particularly on Cold Starts in which temperature hasn't helped raise balance chamber pressure. Conversely, if the settings allow too high a balance chamber pressure, the HPCI Stop Valve could possibly not open, particularly on Warm Starts in which temperature has helped raise pressure to the point where the opening forces cannot overcome the balance chamber force.

In the event of February 15, 1990, HPCI Stop Valve balance chamber pressure had not changed appreciably from the previous quarterly flow surveillance test in which the valve operated satisfactorily. It is believed that the control oil system dependent hydraulic force was lower than on the previous surveillance or the steam forces were different at the same measured balance chamber pressure with the end result that the stop valve main disc did not open when tested.

On February 16, 1990, Maintenance personnel reset the adjustment screws for the HPCI Stop Valve balance chamber to ensure stop valve opening. The HPCI Stop Valve opened on the subsequent Cold Start and Hot Start testing and the surveillance test was successfully completed. Technical Staff reviewed the GETARS plots for the two runs and recommended no further balance chamber pressure adjustments and that HPCI should be declared OPERABLE. At 0640 hours on February 16, 1990, HPCI was restored to OPERABLE status.

General Electric SIL 480, HPCI Startup Transient Improvement, will be implemented as a modification on Unit 1 in order to prevent recurrence of the problem. This modification is scheduled to be completed during the Unit 1 fifth refueling outage (September - November, 1990). Implementation of the SIL will allow the Control Valve downstream of the HPCI Stop Valve to be fully closed instead of open at the time the HPCI Stop Valve is beginning to open. Since steam flow through the pilot valve and under the main disc will be minimized when the Control Valve is closed, enhanced HPCI Stop Valve performance is expected to be achieved independent of balance chamber adjustment screw settings. This modification has been already implemented on Unit 2 with resultant improved HPCI Stop Valve performance. Unit 1 HPCI Stop Valve performance will continue to be monitored before and after SIL implementation.
