SUBJECT: LER 90-026-00:on 901114,determined that control structure ventilation dampers could fail closed curing LOCA/LOOP postulated scenario.Caused by inadequate original design. Dampers gaged-open.W/901214 ltr.

SUSQUEHANNA STEAM ELECTRIC STATION  
LICENSEE EVENT REPORT 90-026-00  
FILE R41-2  
PLAS -460

TITLE (4)  
**Control Structure Ventilation Dampers Could Fail Closed During LOAC/LOOP**

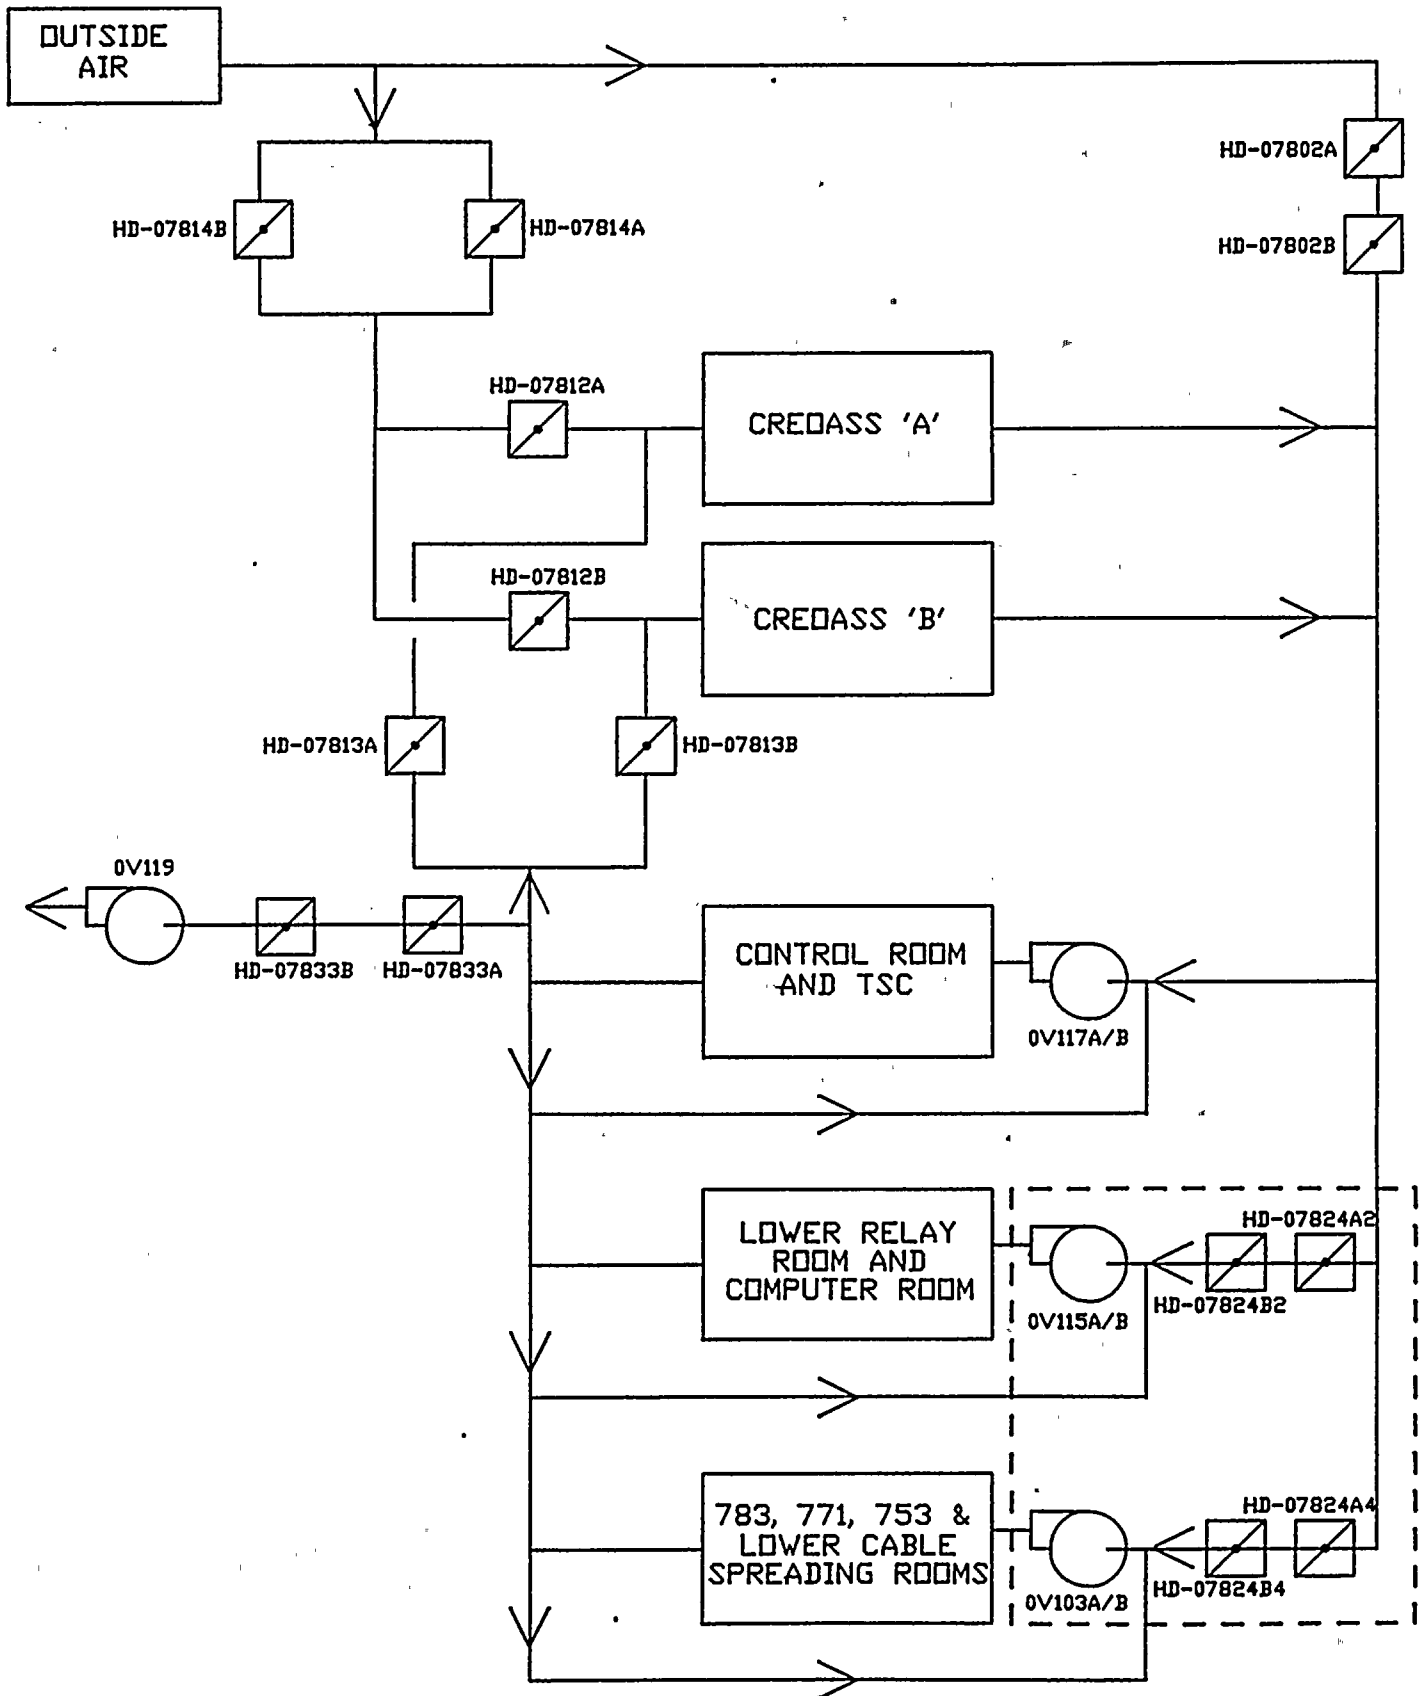
The attached sketch shows the subject dampers and fans. The dampers are HD-07824A2, B2, A4, B4 and fans are OV-103A/B and OV-115A/B. The chlorine isolation of outside air is actually via HD-07802A&B thus the 24A2, B2, A4, B4 dampers do not in fact have to close. The procedural steps to trip the OV-103A/B and OV-115A/B fans were to preclude the possibility of drawing the Control Room to a negative pressure since the 24A2, B2, A4, B4 dampers would remain open.

The cause of this condition was inadequate original design in the Control Structure HVAC system by the Architect - Engineer. The cause of failure to report the condition is attributed to personnel error in applying reporting criteria.

Upon discovery of this condition, immediate corrective action was to gag open the subject dampers to prevent them from failing closed and to implement appropriate procedural changes for Control Structure ventilation for operation in the event of a chlorine isolation signal. In addition, a study completed in August, 1989 concluded that the immediate corrective actions regarding a chlorine isolation signal, taken following discovery of the condition, were, although appropriate at the time, not actually necessary. The conclusion was that the damper isolations were not necessary nor were the fan trips for the plant to properly respond to a chlorine event. Based on this study, a permanent modification was completed to leave the dampers in the gagged open position and procedural controls to trip the fans in the event of a Chlorine Isolation were removed. This condition has been corrected and no new compensatory actions are required.
