SUBJECT: LER 90-028-00:on 901121,determined that postulated single failure could place plant in condition outside design basis. Caused by inadequate original design of control structure chilled water sys.Sys modified.W/901219 ltr.

SUSQUEHANNA STEAM ELECTRIC STATION
LICENSEE EVENT REPORT 90-028-00
PLAS -464 FILE R41-2

Postulated Single Failure Could Have Placed the Plant in a Condition Outside Design Basis

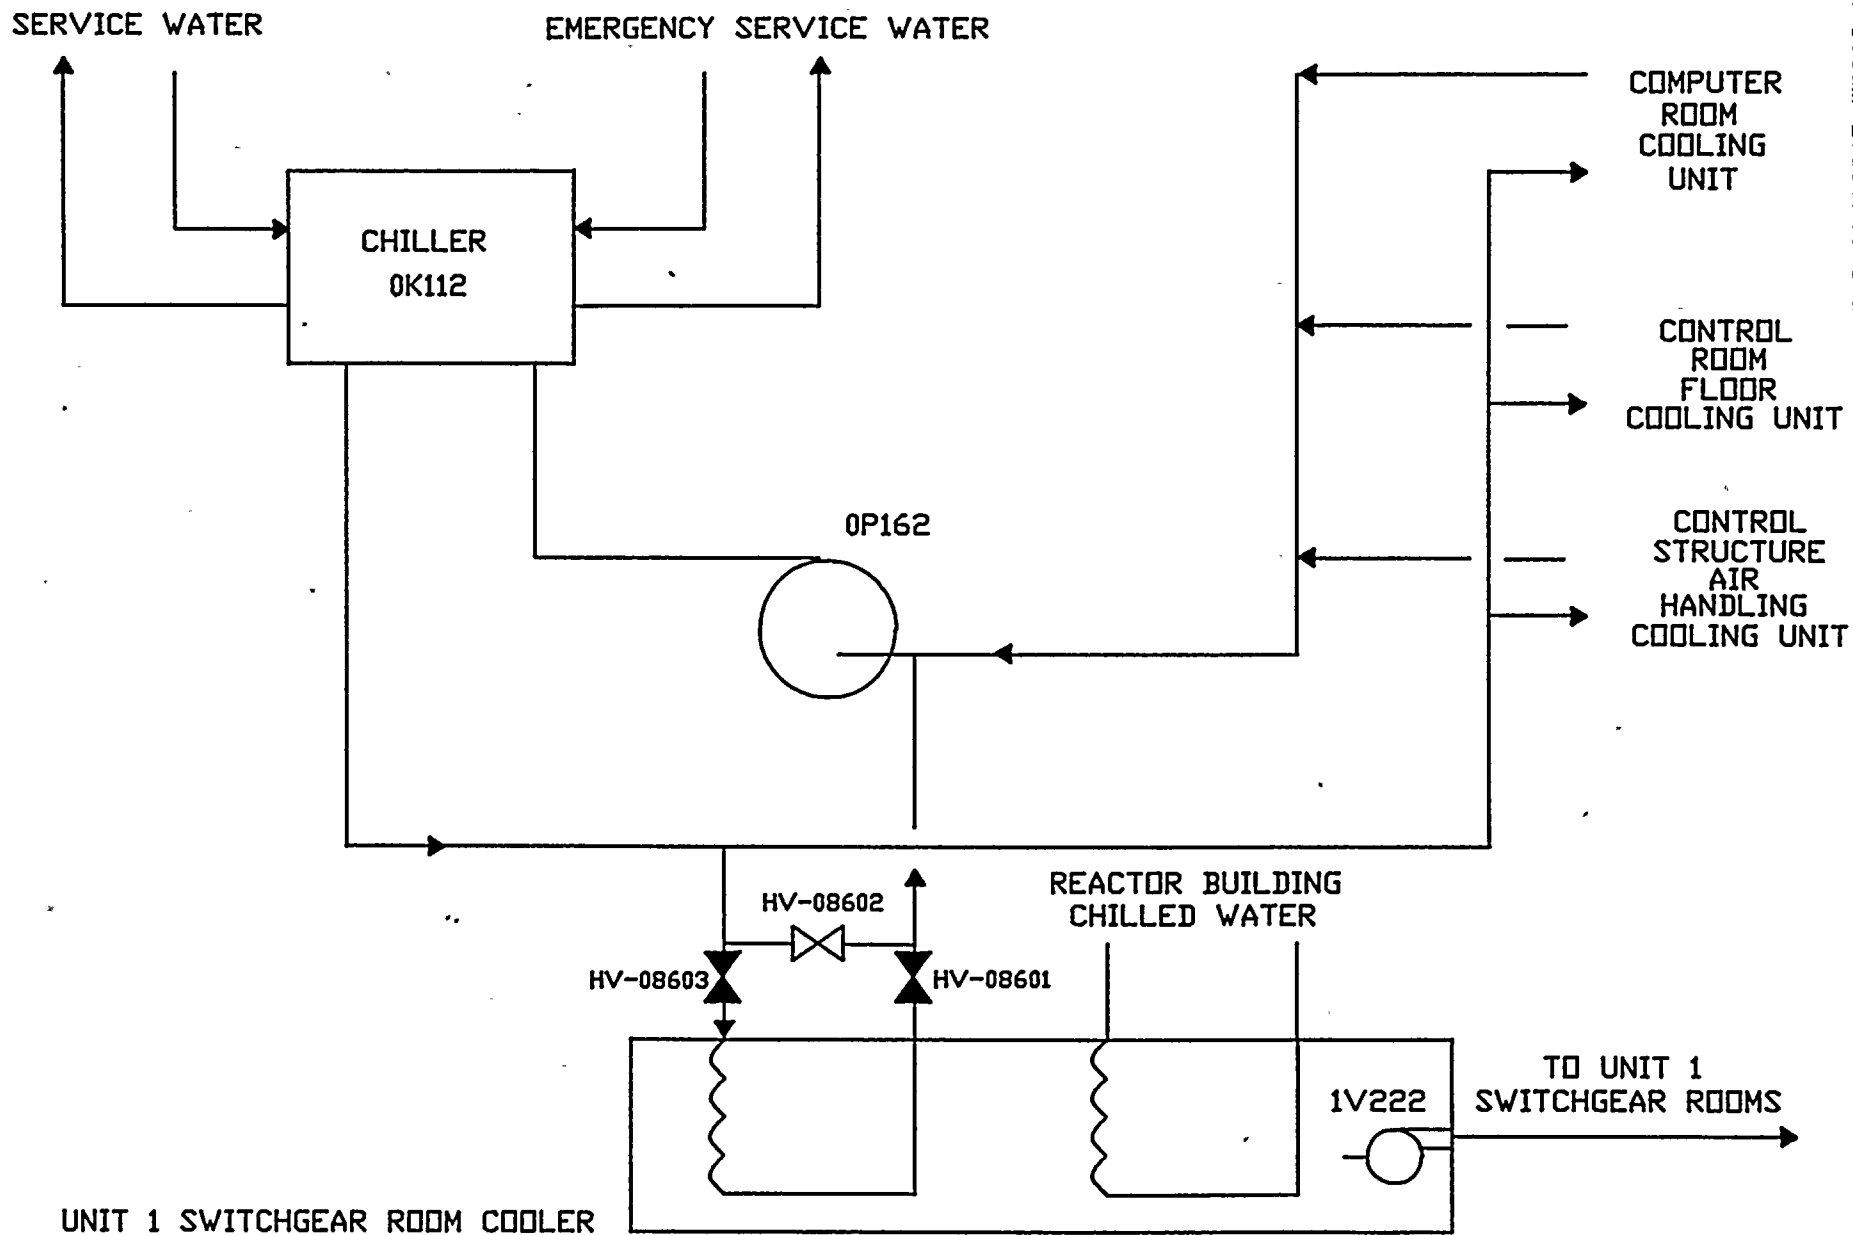
SIMPLIFIED SKETCH OF A SINGLE LOOP OF
CONTROL STRUCTURE CHILLED WATER AND UNIT 1 SWITCHGEAR ROOM COOLING
(NORMAL OPERATING PATH PRIOR TO MODIFICATION SHOWN)

Following a Design Basis Accident (DBA), RBCW is not available; therefore, the CSCW cooling coils are used for the Unit 1 cooling units. The 'A' ESGR cooler is supplied by the 'A' CSCW system; the 'B' ESGR cooler is supplied by the 'B' CSCW system. Each ESGR cooler is 100% capacity unit. A simplified sketch of one loop is provided as part of this report. To establish the flow path to the ESGR coolers during a DBA, the CSCW supply and return valves (HV-08603 and HV-08601) must open and a bypass valve (HV-08602) must close.

On July 14, 1990 Engineering Discrepancy Report (EDR) G00059 was issued describing a condition that existed with the original design of the Unit 1 ESGR Cooling System. It was discovered that in the event of a DBA concurrent with a postulated, independent, single failure of either the chilled water supply, return or bypass valve for the CSCW loop in service, chilled water to the operating ESGR cooler would not be established and the existing system logic would not initiate an automatic swap to establish switchgear cooling from the redundant CSCW train and ESGR cooler. During this postulated event the other chilled water loop remains available for service but there is no clear indication to the Control Room operator that would indicate the need to place the loop in service. This scenario results in inadequate ESGR cooling. The loss of cooling to the ESGRs would ultimately result in room temperatures exceeding those where switchgear operation would be assured.

The cause of this condition was inadequate original design of the CSCW system by the Architect - Engineer for the station.

This condition was determined to be reportable per 10CFR50.73(a)(2)(ii)(B) in that the postulated, independent, single failure of any one of the subject control structure chilled water valves, concurrent with a DBA, could place the unit in a condition outside of its analyzed design basis. The consequences of the postulated event have been analyzed. With current conservative assumptions made within the analysis the postulated event is predicted to ultimately result in conditions above acceptable ambient temperatures, and loss of the emergency switchgear and associated loads. Thus, the unit's ability to provide long-term core cooling during a DBA would be compromised. Modifications to the CSCW system have eliminated this postulated scenario.

A modification to the CSCW system was completed on October 8, 1990. The modification permanently repositioned the chilled water valves to ensure CSCW is always flowing through the ESGR cooler from the in service CSCW loop. This action has eliminated the postulated single failure scenario.
